# Zinsco Electrical Panels

**Fact:** Zinsco electric panels could leave property owners at risk for both fire and electric shock as a result of failing to operate properly as much as 25% of the time.

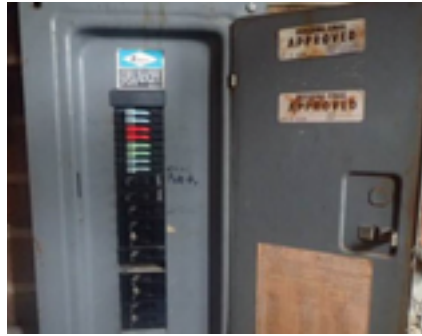
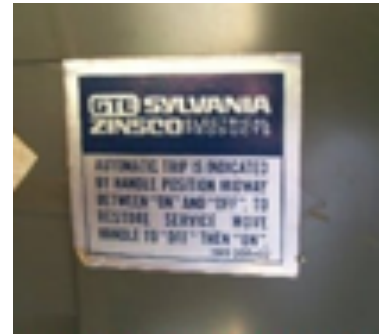
To identify a Zinsco panel, look for a vertical line of color-coded circuit breaker handles down the middle of the electrical box. Zinsco panels also typically have the logo at the top of the panel. Due to the deficiencies found in these panels and the adverse effects the panels can cause, Zinsco electrical panels should be replaced.

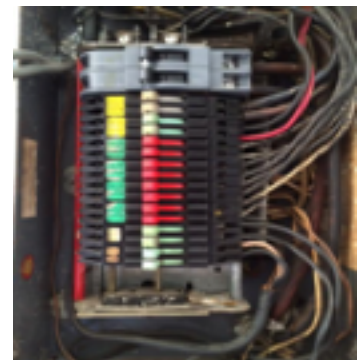
- Certain components in the panel contain aluminum wiring. This presents a safety concern because aluminum wiring rusts, which can decrease the effectiveness of the electrical conductor. Additionally, aluminum wiring can lead to overheating and interfere with electricity flow.
- The bus bars easily corrode and overheat, damaging the connection between the breaker and bus bar.
- The design of the Zinsco electrical panel allows breakers to slide up and down the bus bars if a breaker is absent. This leads to short-circuiting.
- The breakers' interior tripping mechanisms sometimes get jammed. This will indicate that the breaker is off when, in reality, the breaker is still on. Therefore, the breaker isn't providing any overload protection. This can lead to the panel overheating and starting a fire.

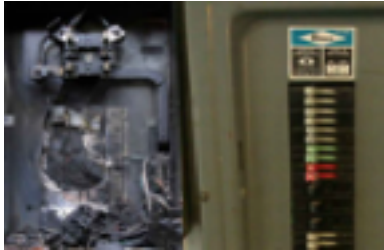
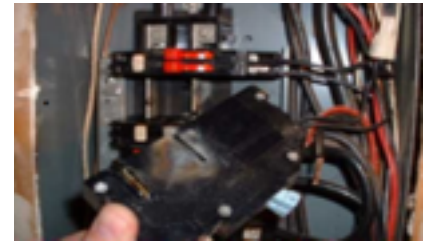
Even after the cover of a Zinsco panel is removed, everything can appear fine and seem to be operating, however, what isn't visible from the front can cause serious issues. Upon exploring the components within a Zinsco electrical box, electricians sometimes find that breakers have melted to the bus bars and, therefore, cannot be removed. This is because an overload of current is being drawn due to the increase in today's electrical demands. In that condition, a breaker would not be able to trip and possibly allow an unsafe amount of electricity into the home. This could lead to a potential fire or increase the risk of an electrical shock.

Most Zinsco panels that are still in use are more than 40 years old. As time has passed, electricians and home inspectors have found that Zinsco panels can work fine for many years, but as electrical demands have increased, these panels can overheat, melt, and arc.

*A licensed electrician should be the only person removing breakers from a Zinsco Panel.* Due to their qualifications, they're able to determine if the breakers have melted to the bus bars. Breakers can appear to be off when they're actually still conducting electricity. In these situations, serious electrical shock risks are present.
