PROJECT PROFILE

Pond Remediation

Spring Dodge Auto Dealership

Houston, Texas

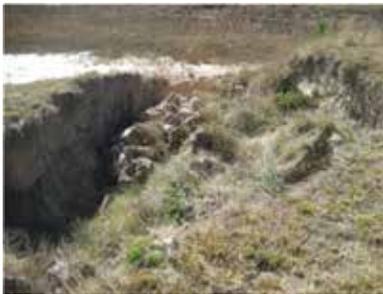
Spring Dodge, an auto dealership in North Houston, faced an enormous task, when large sink holes began forming in areas to the north and the west of their detention pond at the back of the property. The cause of the sink holes was unknown, but they were expanding rapidly; so much so that the sides of the detention pond began to cave in as storm water from adjacent properties flowed over and around the highly erosive soils. Storm events only added to the erosion problems, as storm water carved massive channels through the unstable areas.

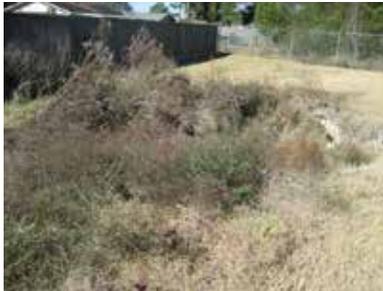
The first area of concern was along the western edge of the pond, where a data cable easement separates the dealership property from a neighboring subdivision. When AT&T had performed some monitoring of the data cable, several holes were bored into the soil to the depth where the cable was buried. When it rained, runoff from the easement area and the neighboring subdivision drained through the bored holes, where it hit a layer of shallow sand seams underneath the top soils. Due to the nature of the sand, storm water easily flowed horizontally through the sand, and found its way through the side of the slopes of the detention pond that could not withstand the force of the flowing storm water. As the flow of storm water through the bored holes increased, the areas expanded and subsequently the sink holes began to form.

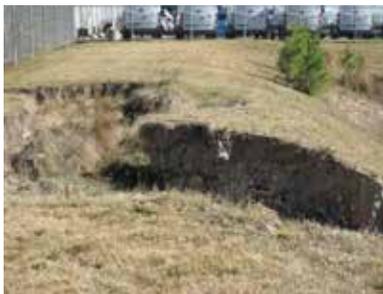
The second area of concern was to the north of the property, which is bordered by a vacant, wooded area, separated from the dealership's property by a chain link fence. In a particularly high flow area, the pressure of storm water began to erode the soil around the fence post that was cemented into the ground. As the soil washed away, the volume of storm water became strong enough to tunnel its way through the soil, where it too found a sand seam underlying the top soils. Another issue in this area of the pond was overland flow of storm water. With the flow of storm water undermining the structural integrity of the pond, the surface area was compromised and the velocity of the overland flow of storm water increased, carving out deep troughs through the bank and the side of the pond.

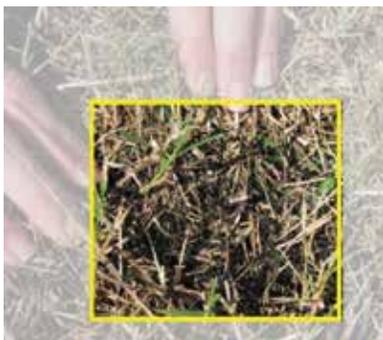
Green Armor

A soft armor system comprised of two parts: Enkamat a turf reinforcement mat, and Flexterra Flexible Growth Medium, a hydraulically applied erosion control blanket. When combined, these two products provide a structural support system for erosion prone, highflow areas, without losing the aesthetic value of vegetation which is lost in traditional hard armor systems.

Another product that was brought in was Enkamat, a nylon Turf Reinforcement Mat that is woven to create a three-dimensional reinforcement for root systems. Enkamat is strong enough to withstand high flow velocities, which is one of the primary causes of soil erosion, and therefore provides the base structure essential to establishing and maintaining vegetation, which is one of the best ways to prevent erosion in high flow areas.
