Shaft Grounding Ring Case Study

250 HP VFD Driven Motor

250 HP Chilled Water Pump

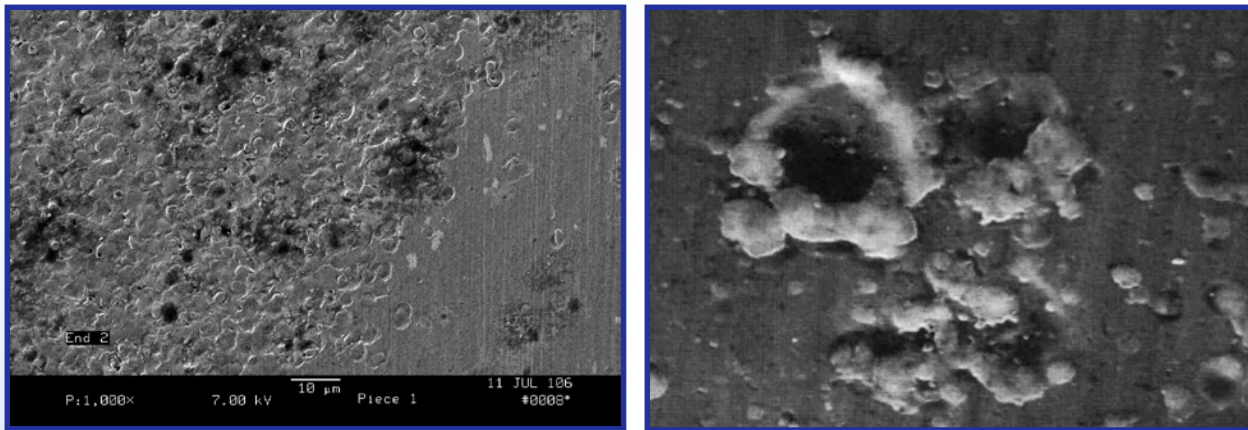
Pitting due to Electrical Discharge Machining as seen under an electron microscope

Voltage arcs through the bearing

- Voltage arcs through bearing, and electrical discharge machining (EDM) produces thousands of pits
- Eventually, the rolling ball bearing causes fluting damage to race
- Bearings degrade, resulting in bearing and motor failure

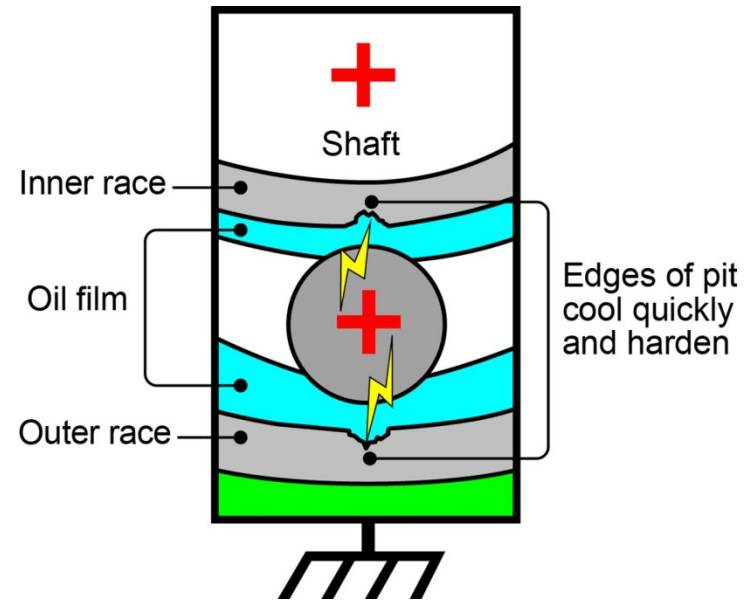
Result in Fluted Bearings

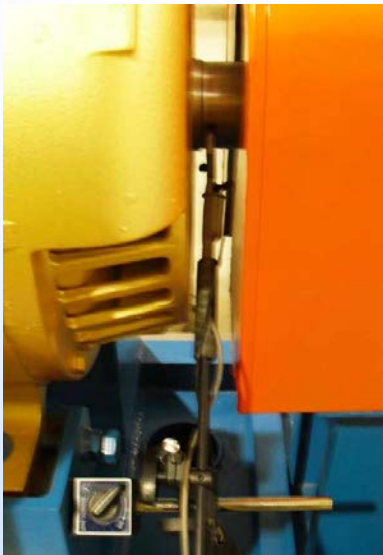
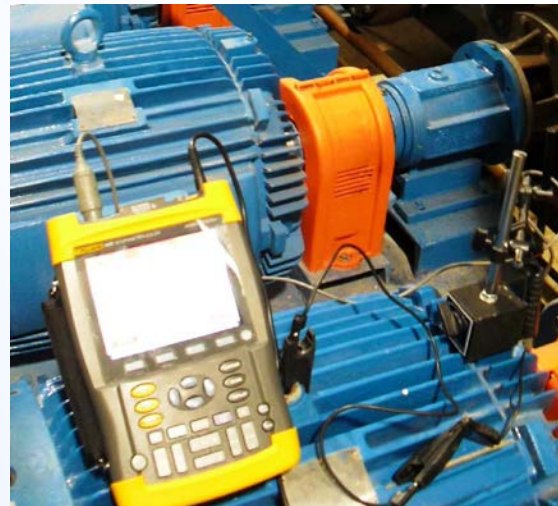
Pump systems tested in case study.

- These chilled water pump systems have been operating for 12-18 months. Audible bearing noise already present 4 out of 12 pump motors.
- Audible noise is typical of the washboard pattern known as “fluting” that is the result of shaft voltages discharging through the motor’s bearings.

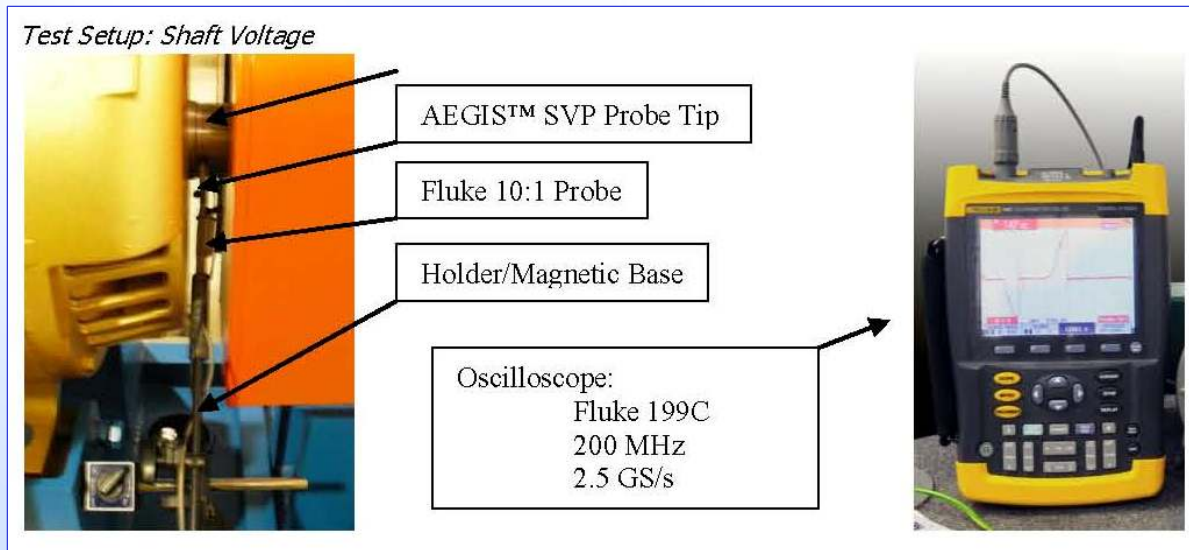
- **Test setup:** Fluke 199C 200MHz Scopemeter with AEGIS® SVP tip on Fluke 10:1 probe applied to the motor shaft while operating.
- **Objective:** Determine if there is an induced voltage on the motor shaft and check for bearing discharge wave form.

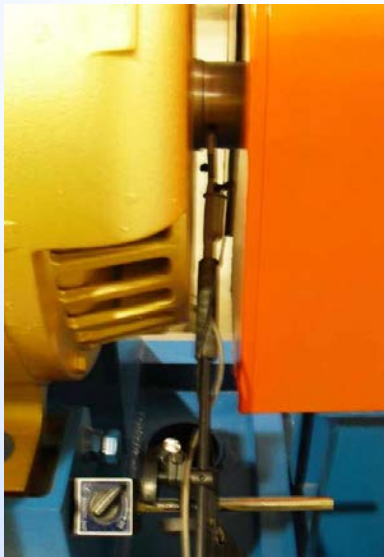
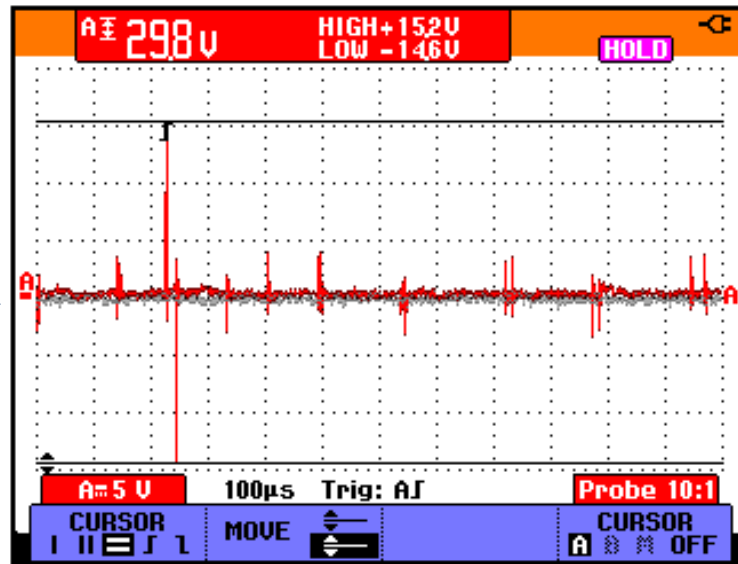
VFD Induced Shaft Voltage

Reading 1: 29.8 v pk – pk with positive and negative voltage spikes present of ~14-15v pk indicates bearing current discharges. Audible bearing noise present indicates “fluting” damage to bearing race.

Fluke 199C Setting: 5 v/div; 100usec/div

- **Reading 1:** 29.8 volts peak to peak
- **Reading 2:** 18.4 volts peak; 16.66 MHz dv/dt

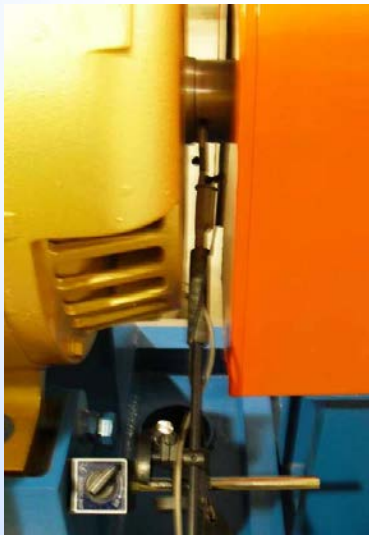
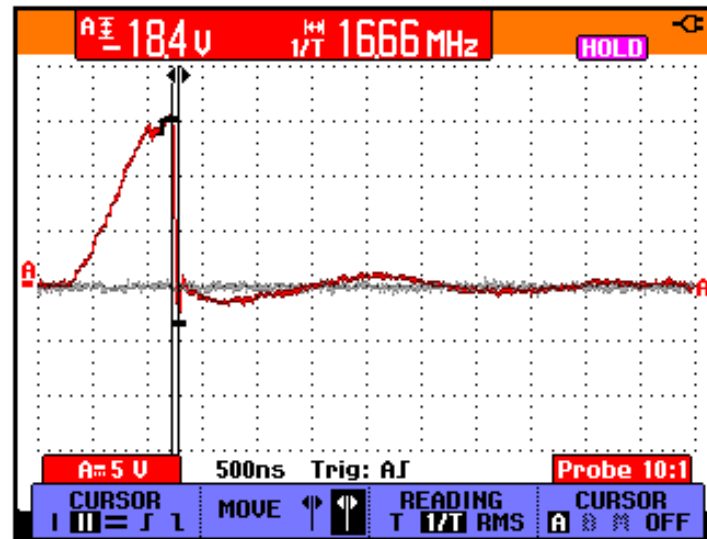
VFD Induced Shaft Voltage

Reading 2: Bearing discharge waveform - 18.4 volt peak - slower voltage rise and sharp discharge trailing edge. The trailing edge voltage drop occurs when oil film breaks down. The 16.6 MHz ultra high frequency dv/dt event causes the EDM pit in the bearing race.

Reading: Shaft Voltage Reading DE Fluke 199C Setting: 5 v/div; 500 nsec/div

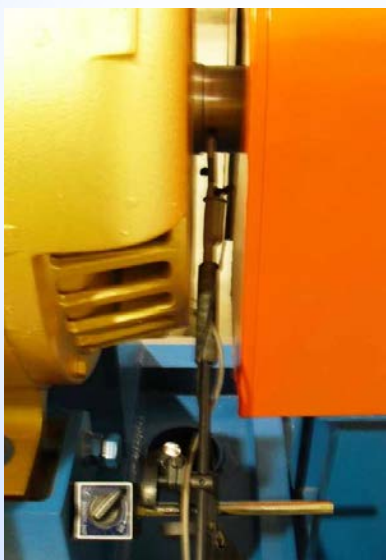
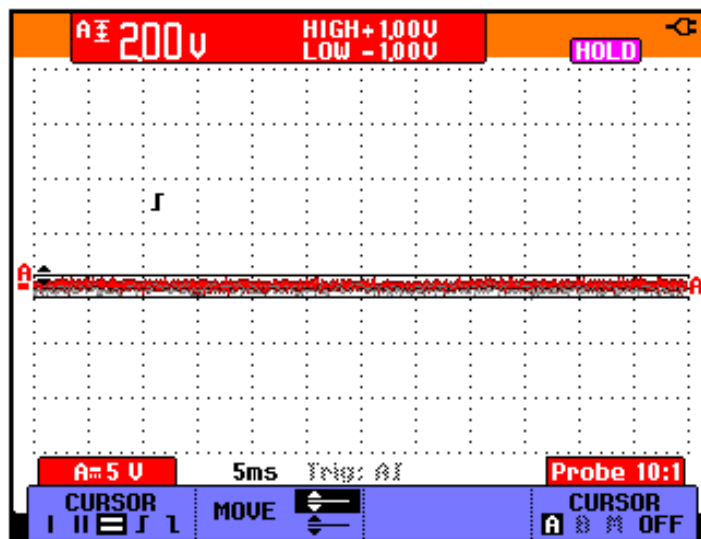
Shaft Grounded with AEGIS® Ring

Reading 3: 2.0 v pk-pk ground noise present on the motor shaft.
AEGIS® shaft grounding provides “path of least resistance.”
No bearing discharges.

Reading: Shaft Voltage Reading DE Fluke 199C Setting: 5 v/div; 5 msec/div

- **Reading 3:** 2.0 volts peak to peak
- Motor bearings protected with AEGIS® Shaft Grounding

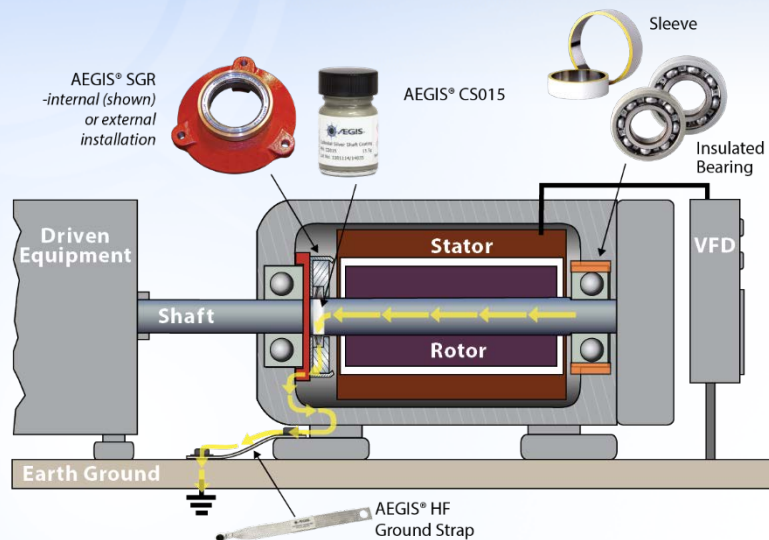
Motors Greater than 100 HP (75 kW) - *Low Voltage*

Install AEGIS® Ring on opposite end from insulation

For horizontally mounted motors with single row radial ball bearings on both ends of the motor:

- Non-Drive end: Bearing housing must be isolated with insulated sleeve or coating or use insulated ceramic or hybrid bearing to disrupt circulating currents.
- Drive end: Install one AEGIS® Bearing Protection Ring .
- AEGIS® Ring can be installed internally on the back of the bearing cap or externally on the motor end bracket.
- Use AEGIS® Colloidal Silver Shaft Coating (PN# CS015) on motor shaft where fibers touch.

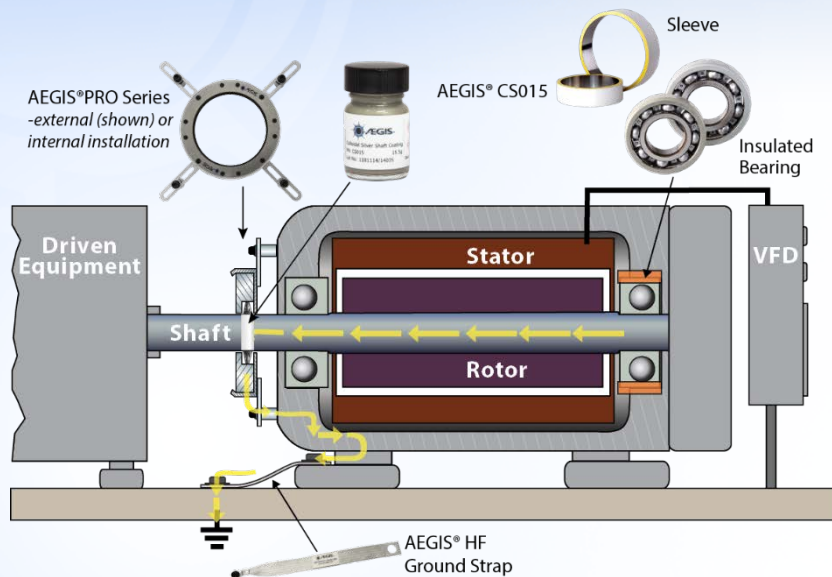
Motors Greater than 100 HP (75 kW) - *Medium Voltage*

Install AEGIS® Ring on opposite end from insulation

For horizontally mounted motors with single row radial ball bearings on both ends of the motor:

- Non-Drive end: Bearing housing must be isolated with insulated sleeve or coating or use insulated ceramic or hybrid bearing to disrupt circulating currents.
- Drive end: Install one AEGIS® Bearing Protection Ring .
- AEGIS® Ring can be installed internally on the back of the bearing cap or externally on the motor end bracket.
- Use AEGIS® Colloidal Silver Shaft Coating (PN# CS015) on motor shaft where fibers touch.
