# Aircraft Takeoff Test Program for Winter 2002-03: Testing to Evaluate the Aerodynamic Penalties of Clean or Partially Expended De/Anti-Icing Fluid

Prepared for  
**Transportation Development Centre**

On behalf of  
**Civil Aviation  
Transport Canada**

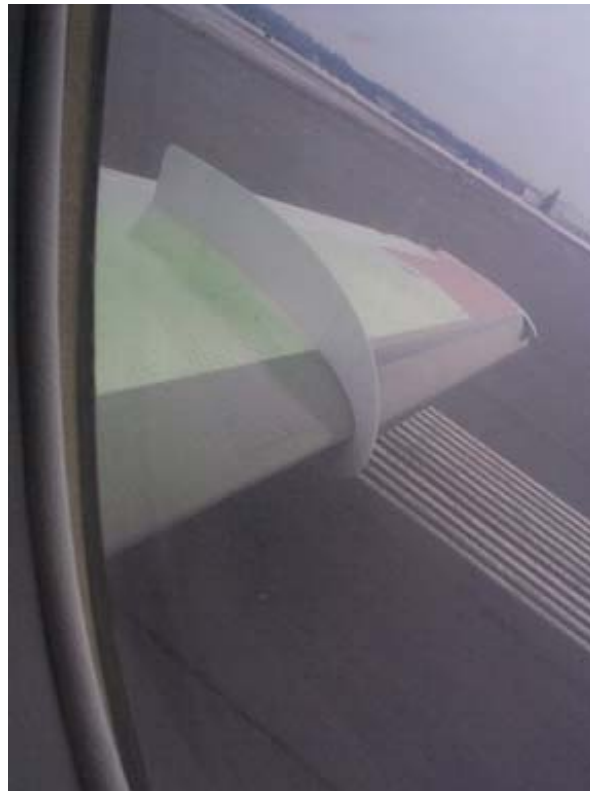
**Photo 2.8: Appearance of Type IV Fluid During Taxi**

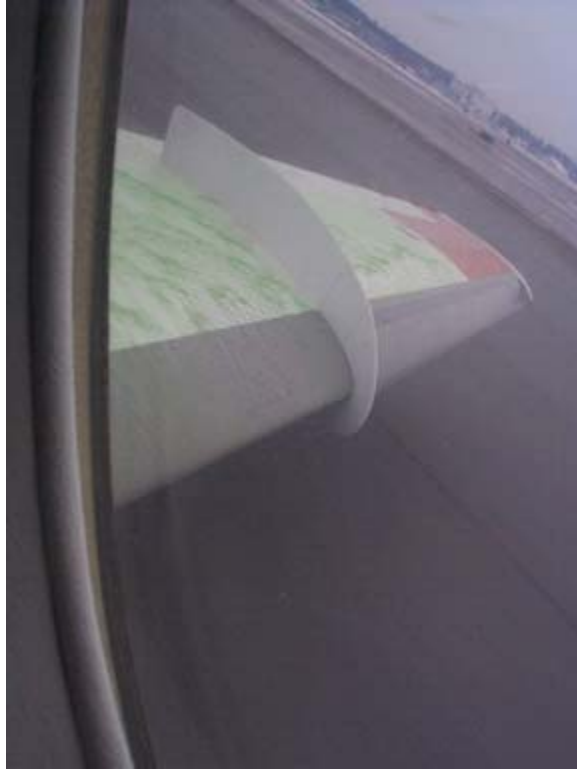
**Photo 2.9: Appearance of Type IV Fluid During Takeoff**

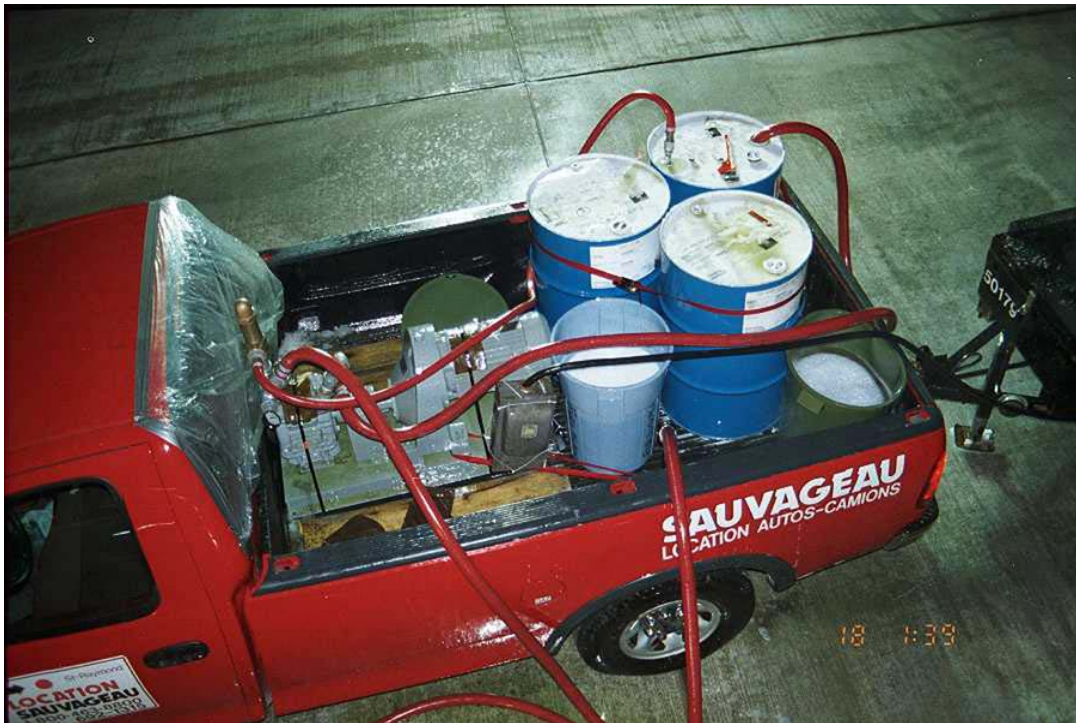
**Photo 2.11: Mobile Type IV Fluid Sprayer Unit**

Most deicing operators only carry and spray fluid of one glycol base. Due to APS test requirements that often require that fluid other than that available at any given site be used, a mobile fluid sprayer was developed by APS personnel (see Photo 2.11). The mobile sprayer was designed to enable outdoor and indoor testing in all conditions using different Type IV fluids as required. It comprises three interrelated components: a fluid reservoir, a fluid pump, and a fluid application nozzle. The components of the mobile sprayer are described below:

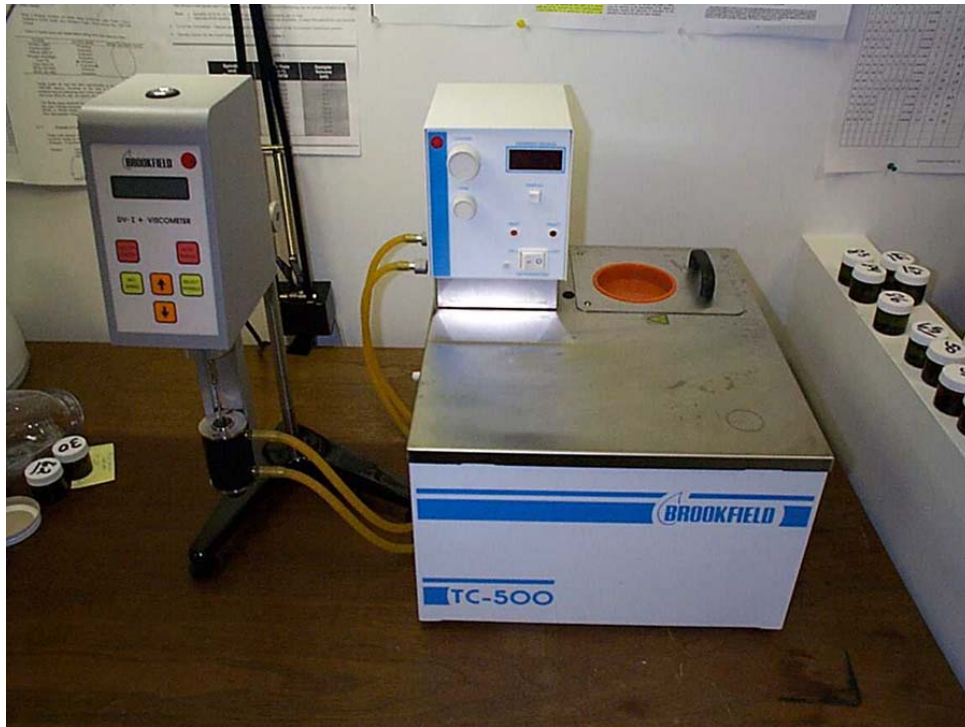
**Photo 2.15: Brookfield Digital Viscometer Model DV-1+ and Temperature Bath**
