Aircraft Ground De/Anti-icing Fluid Holdover Time Field Testing Program for the 1991-1992 Winter

Aviation Planning Services Ltd.

August 1992

TP 11454 E
491-1007A

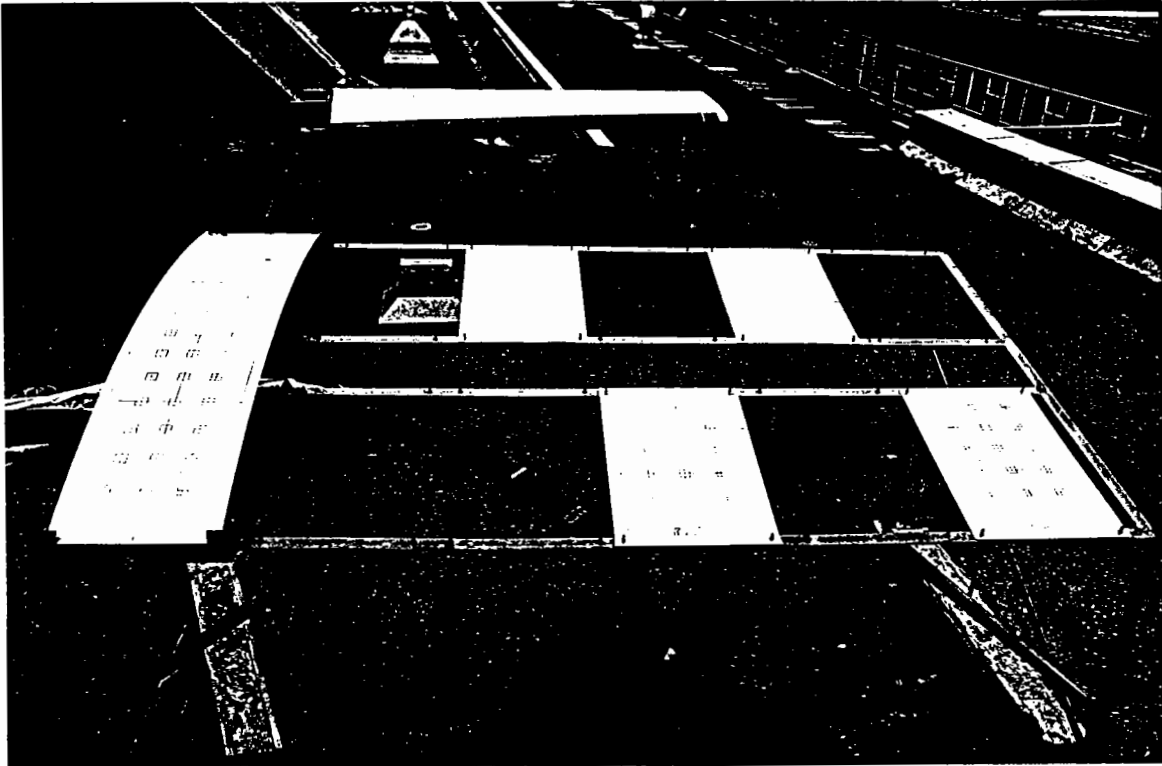
PHOTO 2.1 - Test Sections

Generally, the testing consisted of pouring deicing fluids onto clean test sections, exposing the test sections to various winter precipitation conditions and recording the times elapsed before the test sections reached the end condition. Test sections were: flat aluminum plates, inclined at 10°; curved aluminum plates with a 10 foot or 3.048 m radius of curvature to approximate a full scale wing surface; and a wing section (approximated by a horizontal stabilizer of a Super King Air). Four flat plates, the curved plate and the wing section are depicted in Photo 2.1. Additional flat plate testing was performed incorporating an ice sensor, which measured electrical properties of whichever substance was present on the sensor head.

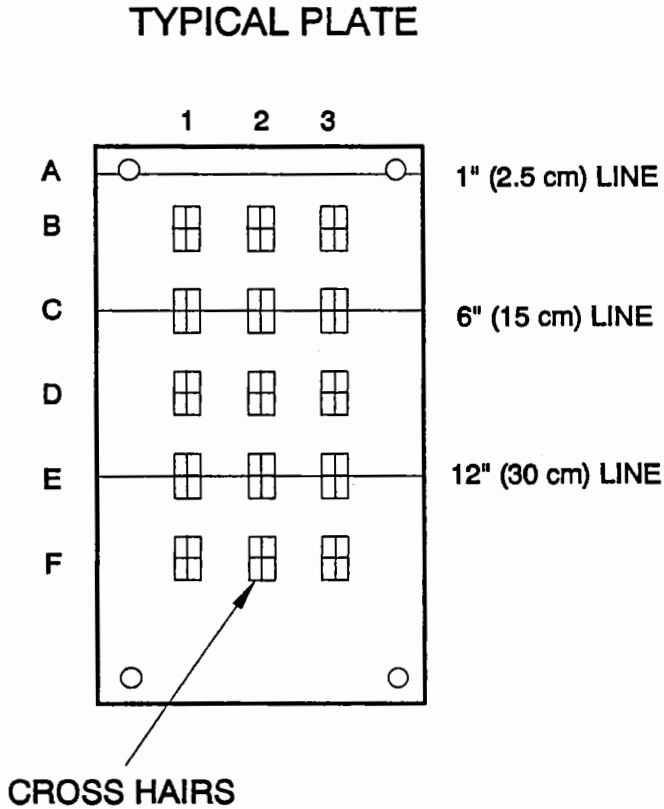
FIGURE 2.1 FLAT PLATE MARKINGS

As mentioned in the Introduction, the procedure evolved from the experiences of various test programs for the 1989-1990 and 1990-1991 winter seasons. In the report of the 1990-1991 program, the subjectivity of the test end conditions was mentioned as a key reason for the scattered nature of the resulting data. It was decided to eliminate two of the previous end conditions: freezing at the one inch line, which was found to often be misinterpreted, and

loss of gloss - a condition where the fluid was said to have failed when it lost its reflective properties - which was a rather nebulous condition and was often associated with high failure times. The remaining end condition, obscuration of crosshairs by snow or ice, was more rigidly defined. In 1990-1991 testing, this end condition was satisfied when five of the fifteen crosshairs on a plate were obscured from the tester's view. Testing experience showed that the visibility of the crosshairs depended on the time elapsed since the crosshairs had been marked, the manner in which the markings were applied, and from which angle the markings were viewed as well as the type and density of snow falling. The 1991-1992 end condition was defined as the point in time when snow (or freezing rain) was no longer being absorbed, or accommodated by the fluid. This was to be when snow was seen to be resting or bridging on top of the fluid, above a complete crosshair, when viewed from in front of the test stand (perpendicular to the plates). The failure time above each individual crosshair was recorded resulting in up to 15 failure points for each test plate. Tests in which all 15 crosshairs did not fail within the 60 minute limit were terminated. It was felt that it would be more advantageous to begin a new test than to spend valuable precipitation time waiting for the failure of crosshairs well down the plate (note that 1990-1991 failure conditions were mostly based on five crosshairs).

A similarly spaced pattern of crosshairs was marked on the curved plate and the wing section and similar failure measurements were recorded.

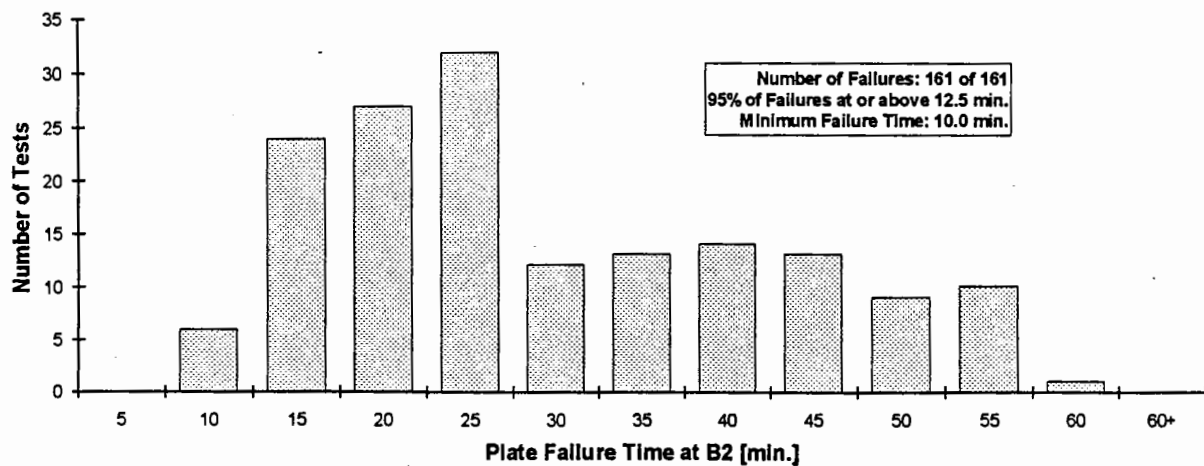
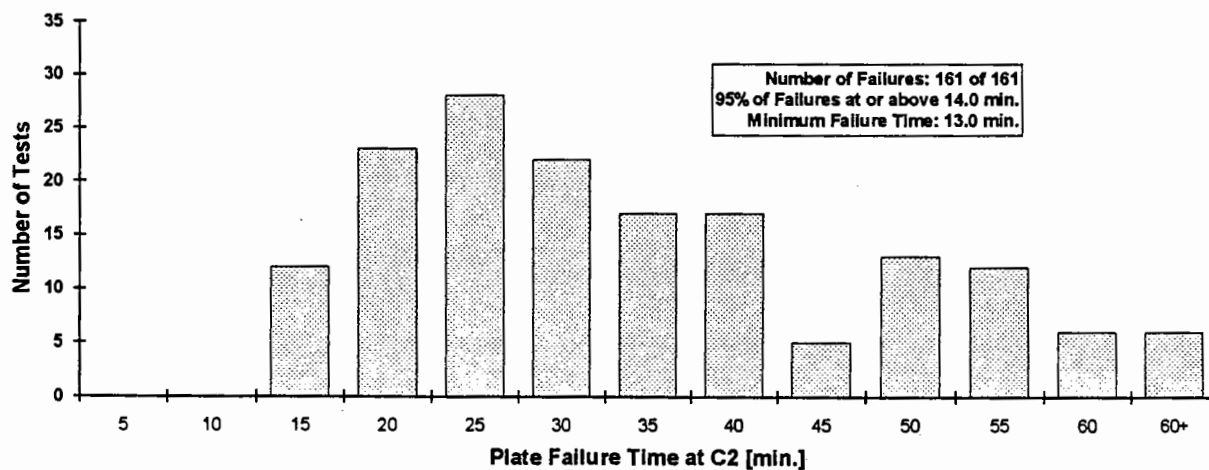
progressively downward manner, beginning at the top of the plate. This, in fact, was the case in over 98% (158 out of 161) of the tests recorded. The "number of failures" decreases as the graphs progressively move down the plate from line B to line F. This is an indication that some tests were terminated more than one hour before the entire plate failed. The interesting point to note about the series of graphs is that the 95% lower limit (i.e. the time above which 95% of failures occurred) and the minimum failure time recorded both increase steadily while progressing down the plate, yet both still remain below 20 minutes.

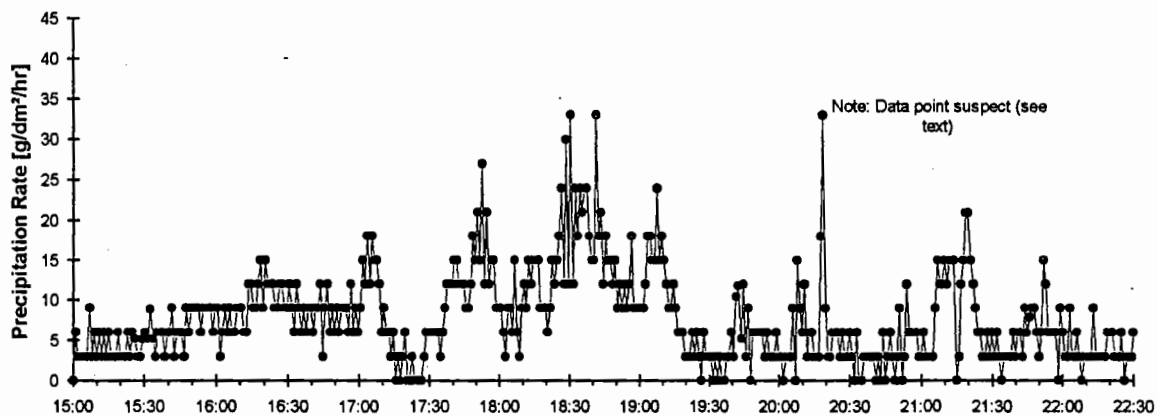
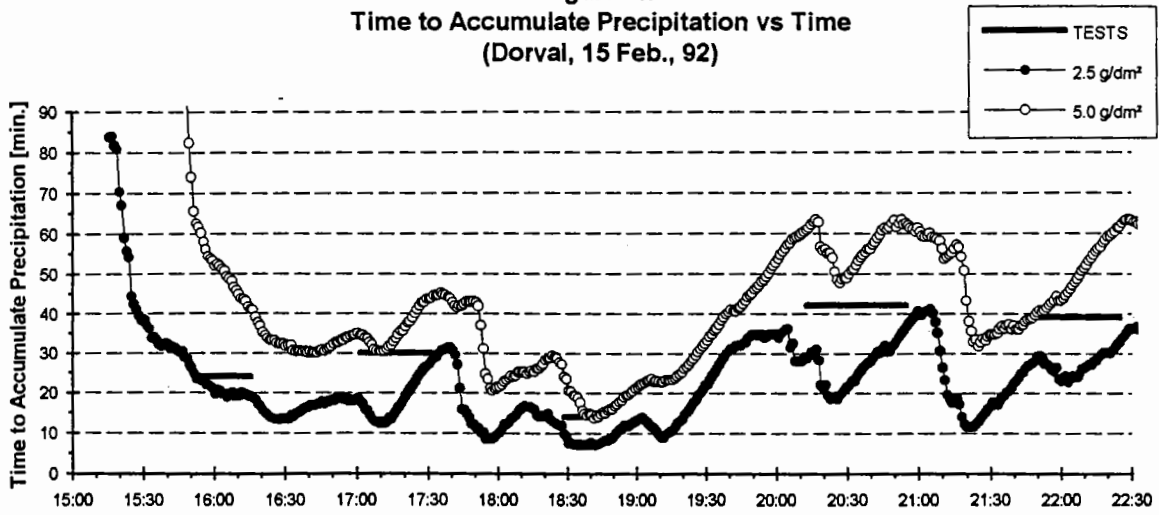
The behaviour of precipitation during a test is probably the most important meteorological characteristic from the point of view of fluid failure. Figure 4.5 displays the calculated precipitation rates over the same February 15th test day as Figures 4.2 to 4.4. On Figure 4.5, each point represents a one minute average precipitation rate. The uncertainty surrounding the encircled test point was caused by a comment noted on one of the test forms. At time 20:20, the tester noted that the precipitation gauge discharge tube was blocked. In clearing this tube the tester may have disturbed the dropping mechanism which, in turn, may have resulted in an inaccurate precipitation count at that time. Despite this uncertainty, the rest of the profile should be considered as valid.

precipitation to be accumulated. On the resulting curve, higher precipitation is associated with shorter accumulation times. Figure 4.7 also contains a curve with the time to accumulate 5 g/dm^2 of precipitation, or twice the qualification value. Lastly, the duration of individual tests was overlaid onto the chart. The solid, horizontal lines signify that a test was performed between the times indicated on the horizontal axis and the location along the vertical axis is the duration of the test.

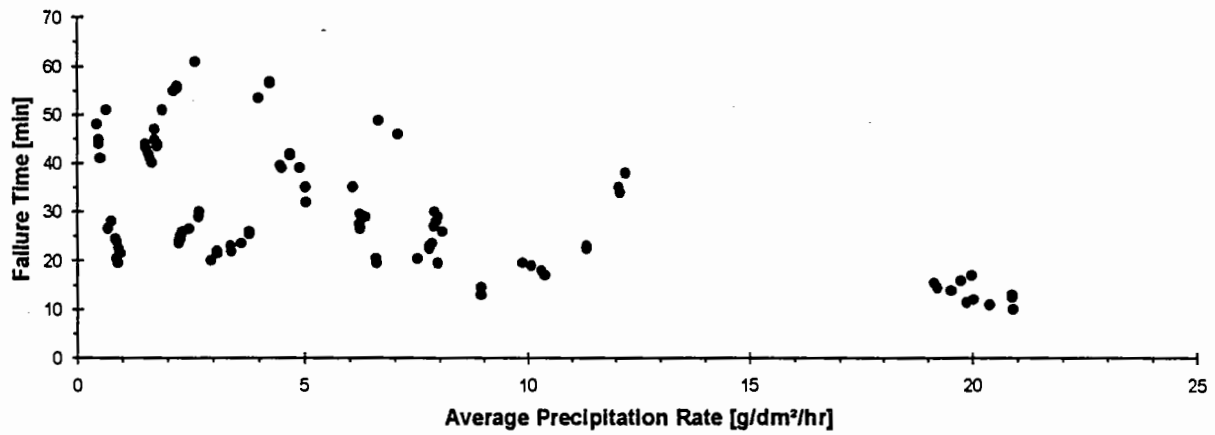
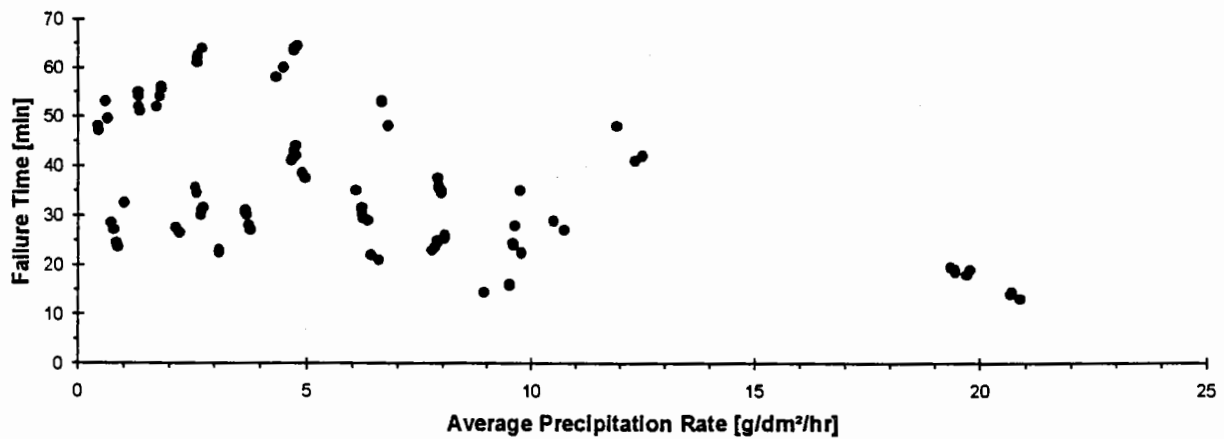
The analysis of the 1990-1991 data used the concept of an effective lower limit curve to provide a minimum failure time for a specific rate of precipitation. While this is a useful way of examining the situation it does not provide as complete a picture as does a failure envelope. What the theoretical failure envelope provides is an upper and lower limit of plate failure time when subjected to specific precipitation rates. Where a failure time lies specifically, within the rather ample envelope, is based on the interactions of all the other variables.

The analysis of the collected data was multi-faceted. Plots of failure time against each of the other variables failed to unearth any strong direct relationships. However, this analysis did discover what appears to be a failure envelope when comparing failure time to rate of precipitation.

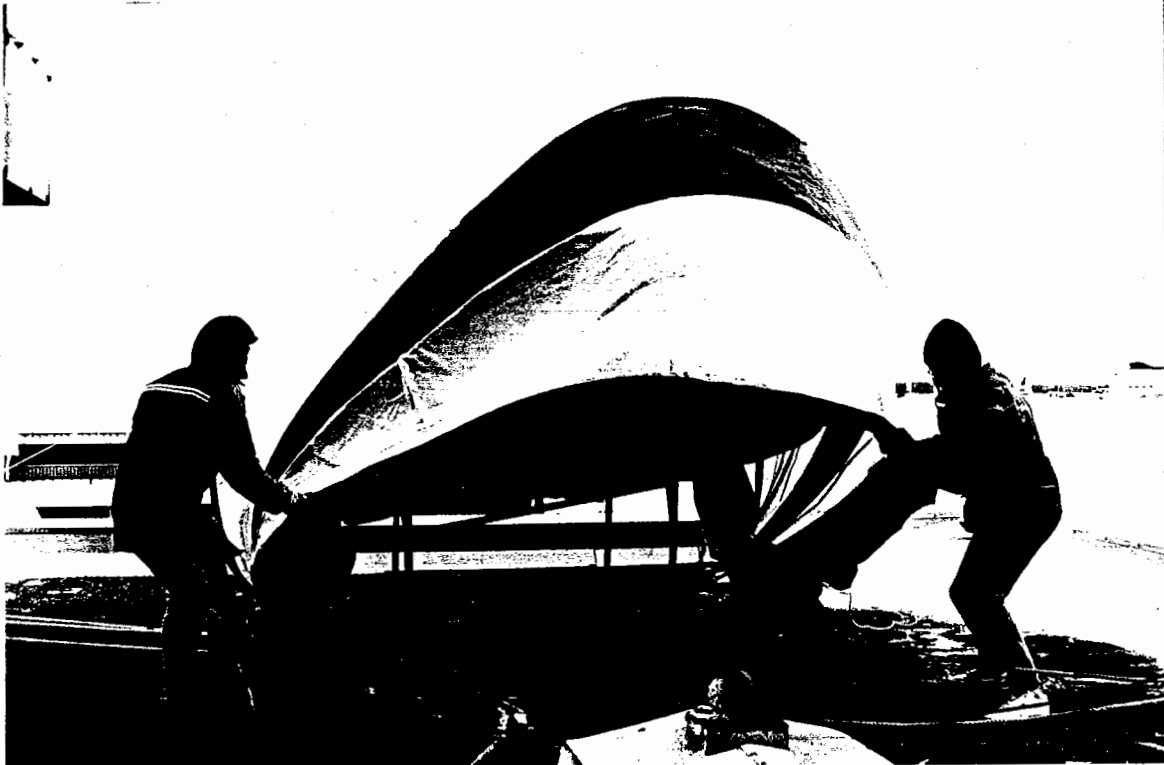
**PHOTO 2 - Collapsible tent**
