# Restoration Case Study

## Creative Passions

**Location: Chesaning, MI**

**Loss Event: Roof Collapse**

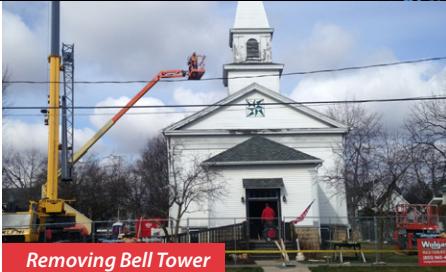
**Removing Bell Tower**

Using a heavy duty crane system, we were able to remove the historic bell tower and relocate it so it could be displayed on the property for public enjoyment of this historic landmark.

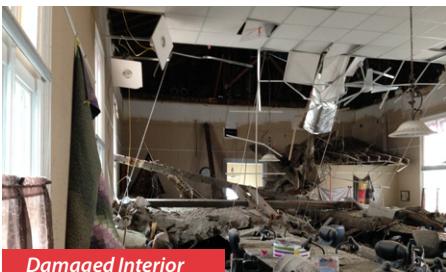
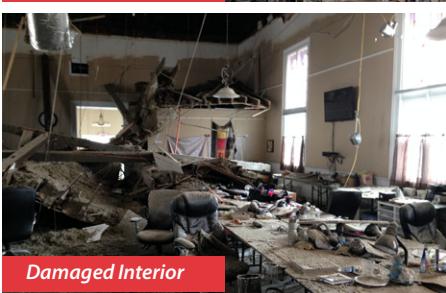
**Damaged Interior**

When the joist system collapsed, it took down the drop ceiling system, HVAC duct work, and damaged the sprinkler system which caused secondary damage when the water flooded the building, including the bedrooms, kitchen, and bathrooms in the level below.

A new joist system was built and installed without removing the existing roof. This presented a unique challenge to the engineers and construction team, but went off without a hitch.

Custom trim and casing was built by our finish carpentry experts to match the original trim and casing and maintain the historic look of the building. A new drop ceiling, duct work, and sprinkler system was installed, as well as various structural repairs.

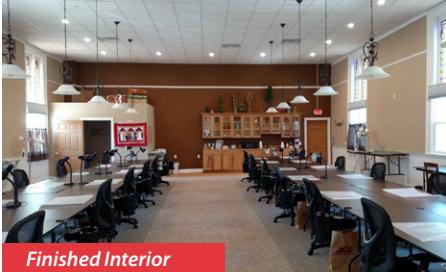
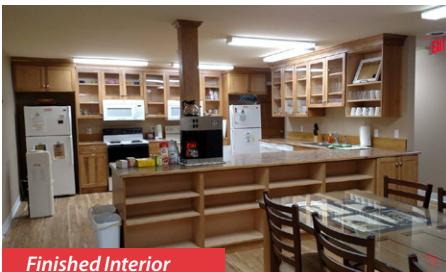
**Finished Interior**
