# Restaurant Suppression Issues, Part 1

## Restaurant Suppression Issues, Part 2.

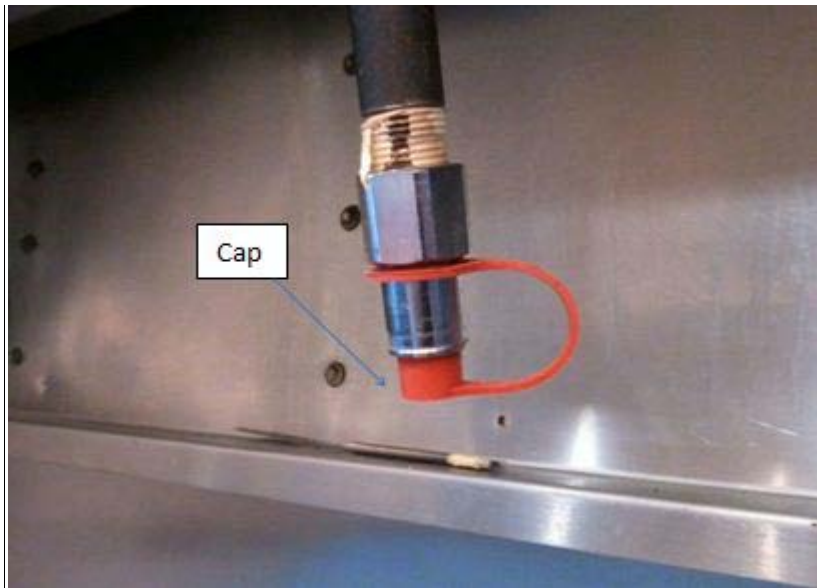
A typical spray cover.

One of the most common items we find in restaurant suppression system that cause a loss of credit is the lack of or removal of the caps on the extinguishing system spray nozzles. Cooking vapors carry oils and grease as they rise. The hood and vent system draws these vapors up, cleans them and exhausts them out the roof fan system. In between the filter and the cooking is the fire extinguishing system spray nozzles. The actual spray nozzle opening is very small and designed to cover a certain area with fire extinguisher. To keep the opening from partially or completely clogging, the system is delivered with a small cap that pops off when the system is triggered. Removal of this cap or failure to replace if it is dislodged will compromise and defeat your clients system causing loss of suppression credit not to mention your customers business!

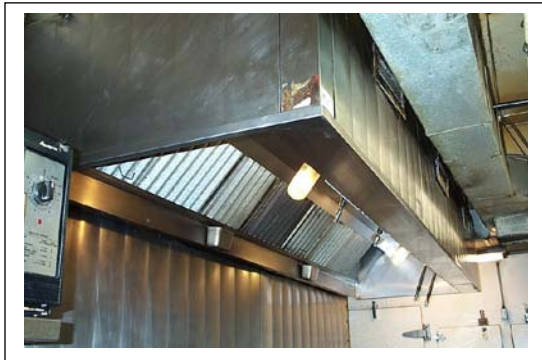
Removable baffles operate on a very simple principle, when air changes direction it slows down. When air velocity decreases, it can no longer carry heavier particles and these particles start to drop off. In a restaurant environment, this means the grease and oils that are released during the cooking process drop out. How does this system do that?

As air is drawn through the baffles by the fans, it moves around the corrugated surface that you see in the photo above. By moving around these corrugated surfaces, the air slows down and drops the oils and grease. These solids then run down the corrugations and into a trough built into the hood and then into the small collection cans spaced at intervals. While not all solids are removed, most are, the remainders are cleaned by other filters further up the line before the air is released into the atmosphere. This is a simple effective system and the parts are easily cleaned in commercial dishwashers.

From time to time, we see restaurant employees place the baffles in the trays improperly. They will place them sideways rather than up and down or make a “herring bone” pattern out of them. Grease and oils are prevented from running down because the baffles are sideways! A buildup of grease in the hood system is a fire waiting to happen.
