Technical Bulletin

400 Series Arm

Coaxial Cable Replacement Procedure

Communication
Systems, Inc.

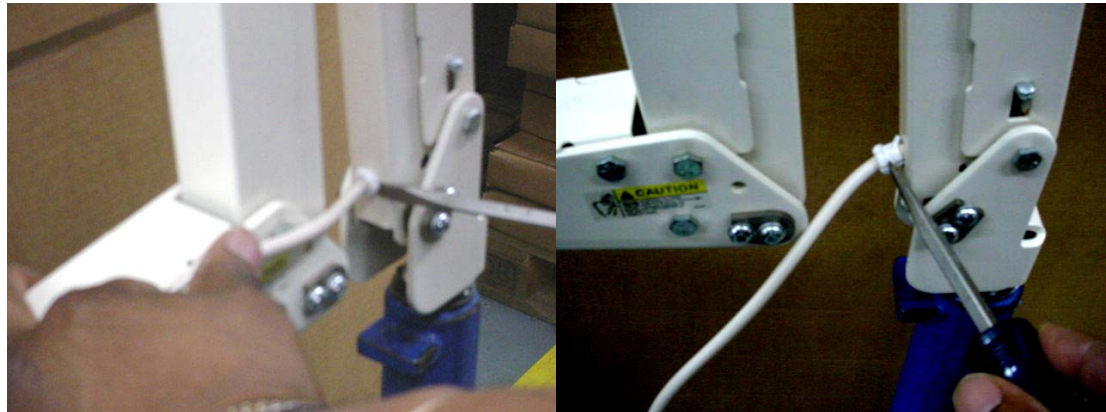
- Remove PDI-122 cable grommet
- Use screwdriver to the push grommet out of the arm section as you pull the cable

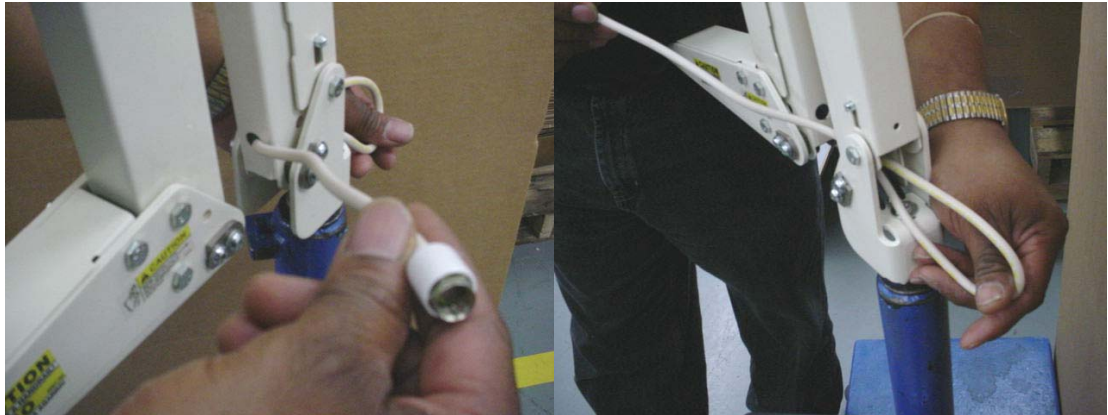
- Cut off the connector and pull the damaged cable through the back of the arm.

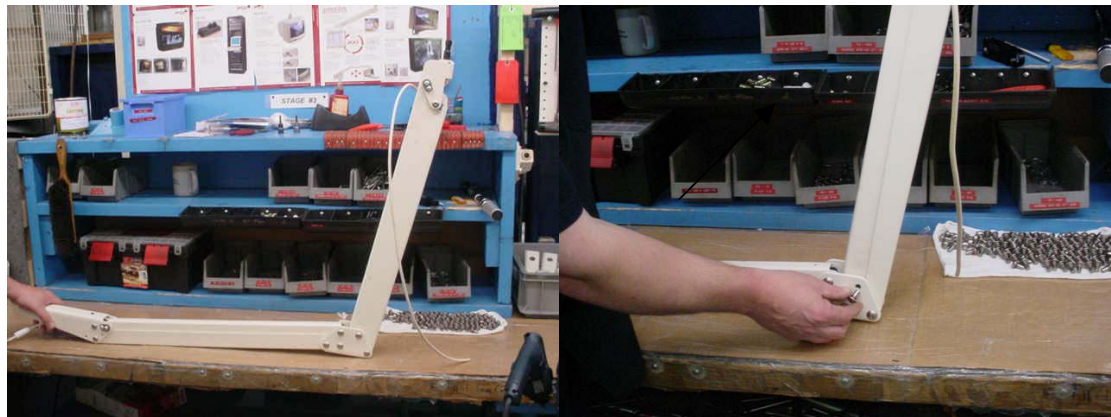
- Next lay the arm on the bench and remove the screws

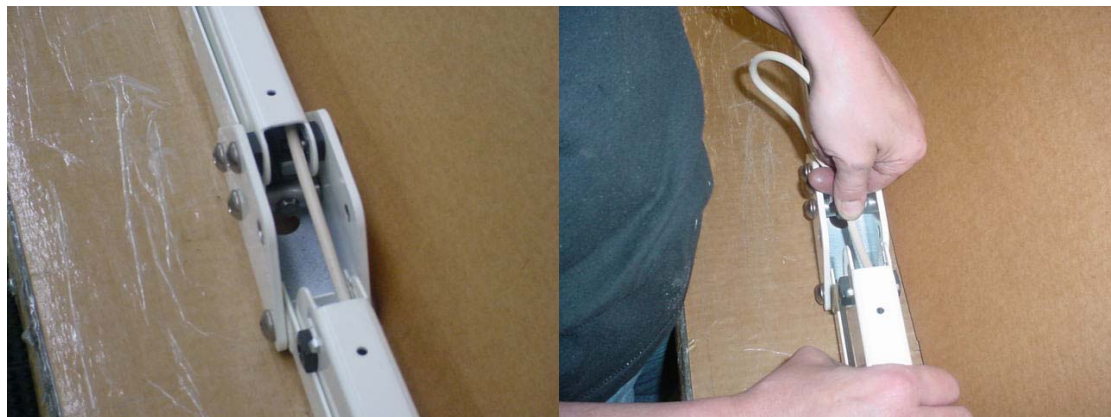
- Next lay the back section down and pull out the damaged cable.

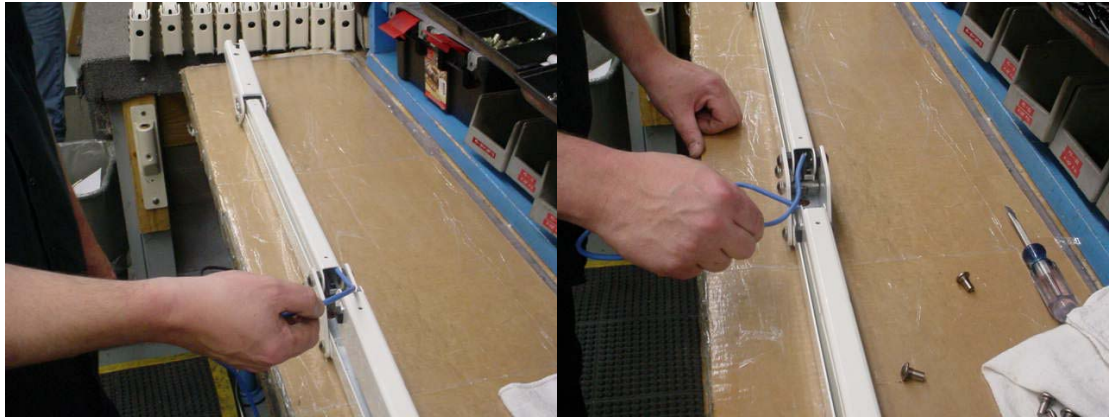
- After cable is completely out of the back section, pull it out of the front section

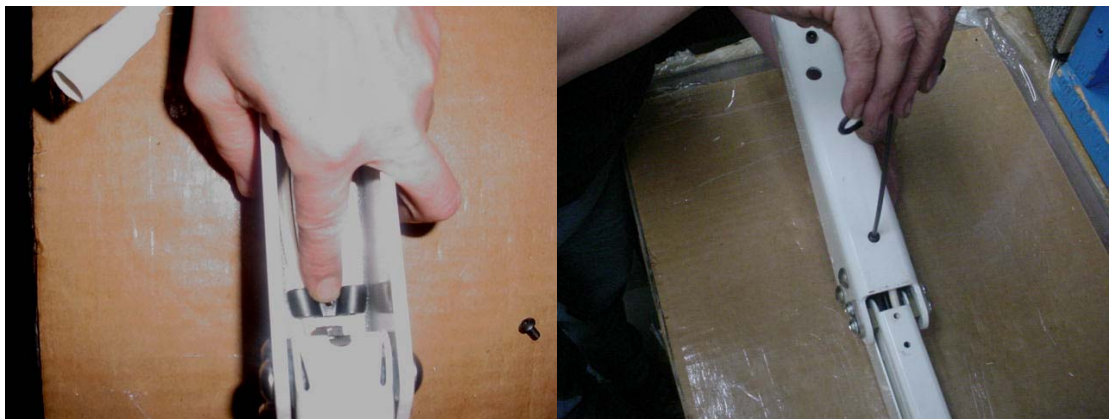
- Insert other end of cable into wire-shield of the rear arm section at the elbow, push through to the base. If the cable stops before coming through see cable obstruction note.
- Re-apply PDI-247 cable clamp inside the nose over the cable, make your cable length about 2 inches past the end of the nose.

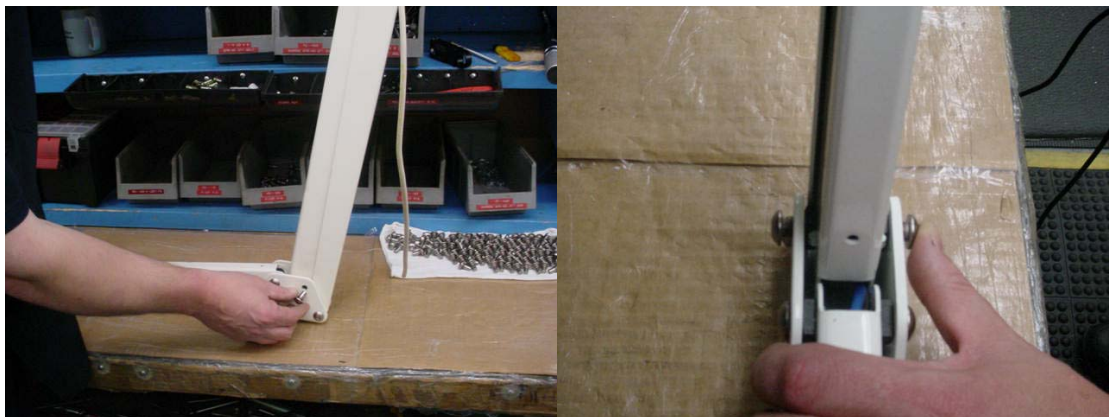
- Re-assemble back arm section with PDI-120 pivot screws, and apply a drop of red 271 loc-tite to the threads of each screw. Torque each screw to 17-1/2 foot lb.s

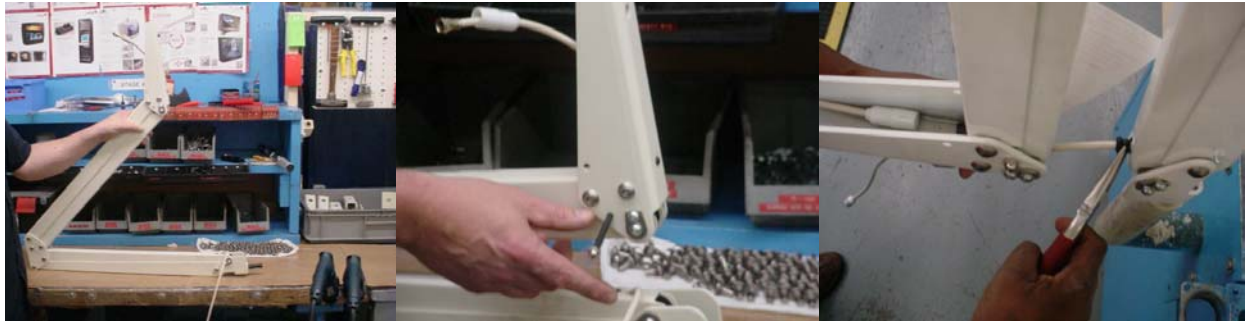
- Fold arm and return the PDI-148 safety pin to the locked position
- Replace the cable grommet at the base of the arm

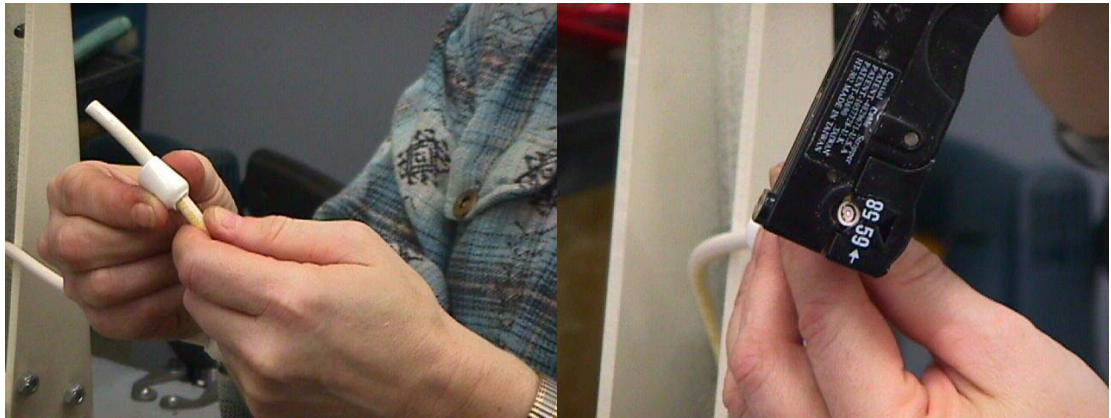
- Put on the cable boots then strip cable
