ELIOS 2 IN ACTION | MINING

MINING DRONES: ELIOS 2 CREATES PHOTOGRAMMETRIC MODELS OF A GOLD MINE PREVIOUSLY IMPOSSIBLE TO INSPECT

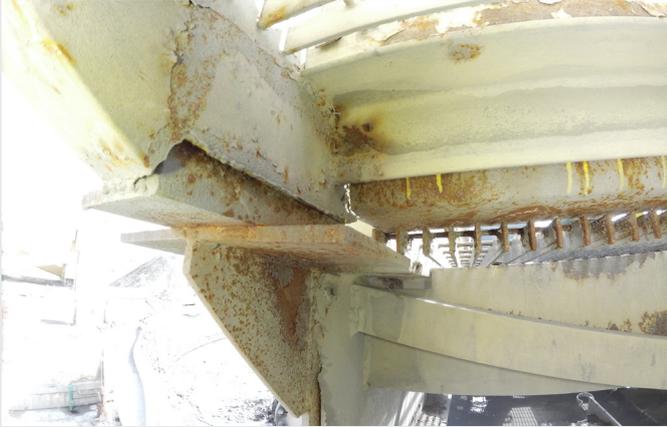
Broken welding on the catwalk of a mill

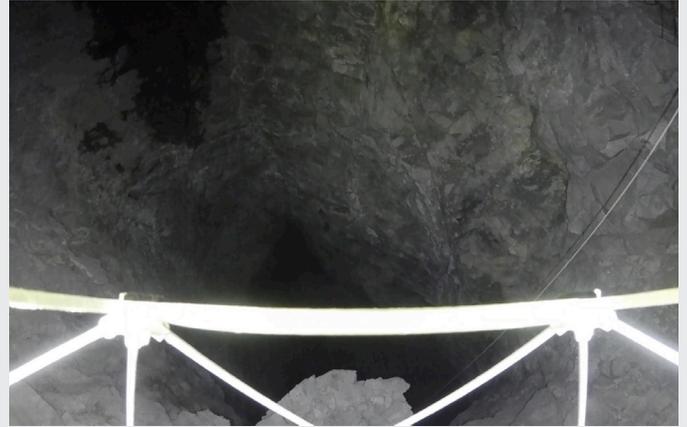
Entering a ventilation raise

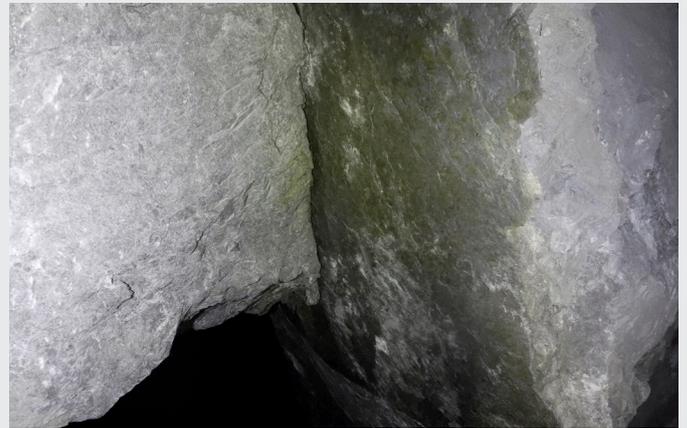
Fault line in a stope

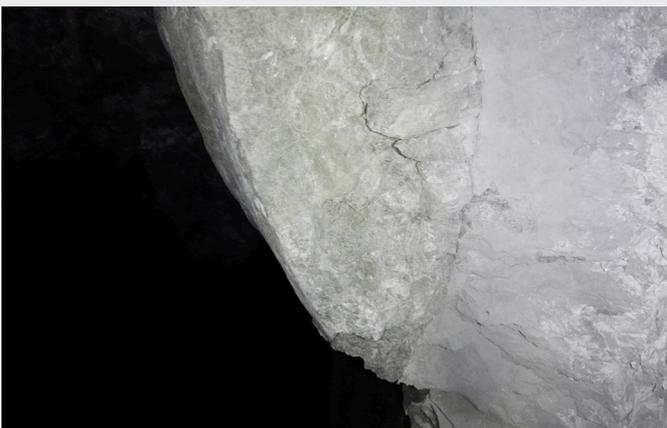
Fault line in a stope

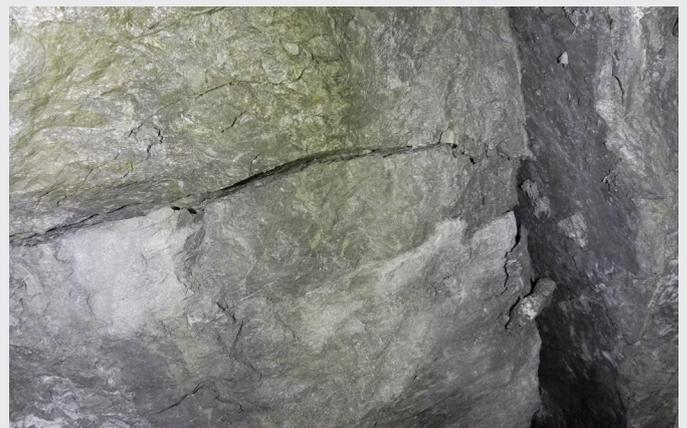
Stope wall close up
