ELIOS 2 IN ACTION | CHIMNEY INSPECTIONS

# ENERGY COMPANY KEEPS PERSONNEL FROM DANGEROUS CLIMBS BY USING ELIOS 2

DTEK, AN ENERGY COMPANY BASED IN UKRAINE, RECENTLY TESTED THE USE OF THE ELIOS 2 FOR CHIMNEY INSPECTIONS AND BOILER INSPECTIONS AT ONE OF THEIR POWER PLANTS. THE DRONE WAS ABLE TO COLLECT VISUAL INSPECTION DATA MUCH MORE QUICKLY THAN THE USUAL METHOD USED WHILE KEEPING PERSONNEL OUT OF POTENTIALLY DANGEROUS SCENARIOS..

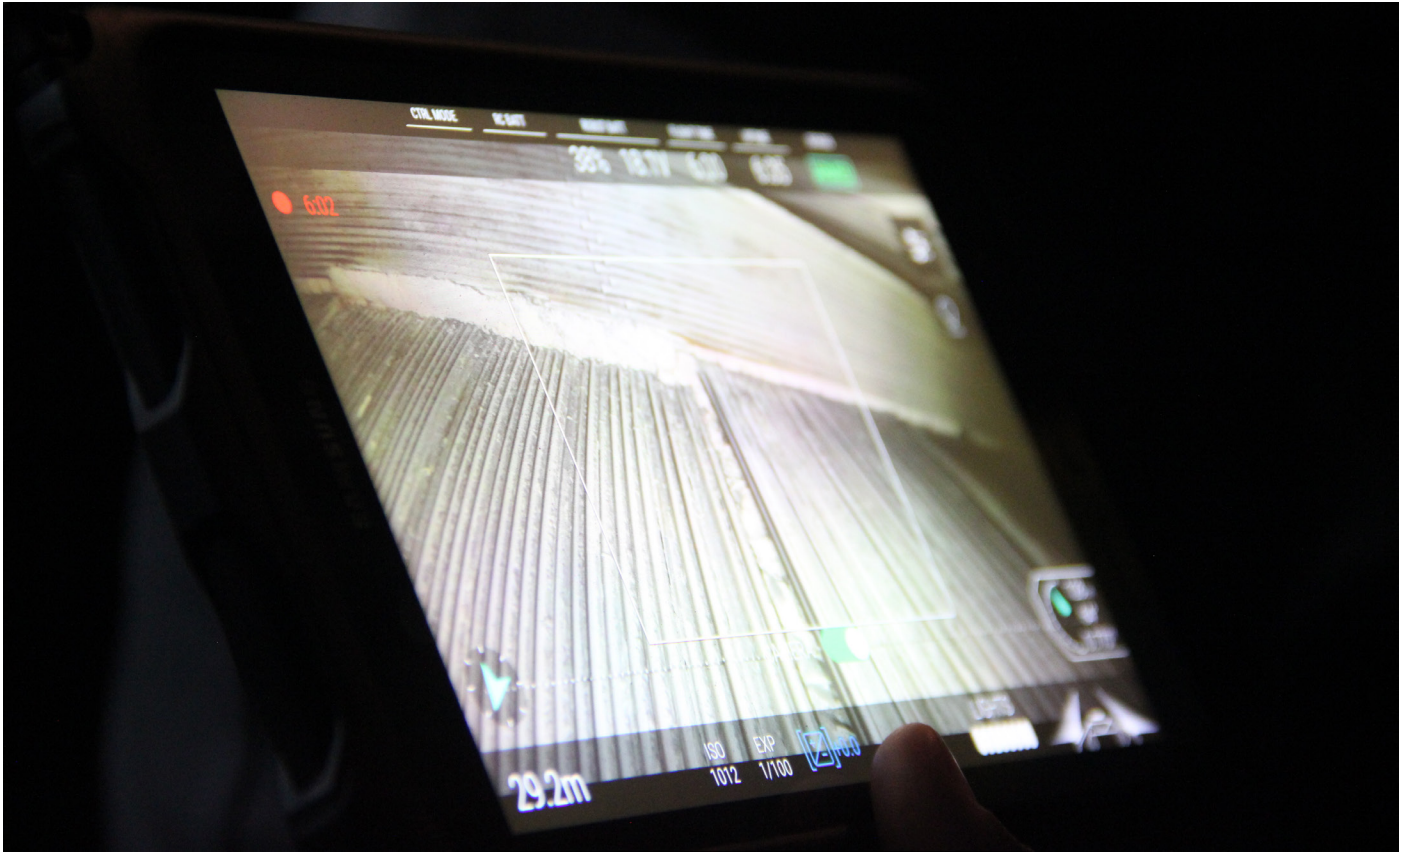
Using the Elios 2, inspectors were able to fly into the boiler and methodically collect visual data

on every part of it. In just one hour, the Elios 2 was able to collect all the visual data needed. If performed manually, the same collection of visual data would have taken a day to complete.
