## Optimising Desalter Performance Is Just One of Tracerco's Specialties We Proudly Provide.

### Case study: Desalter distribution study

# Crude Vacuum Tower Wash Bed Optimisation

## Applications Note – ThruVision™

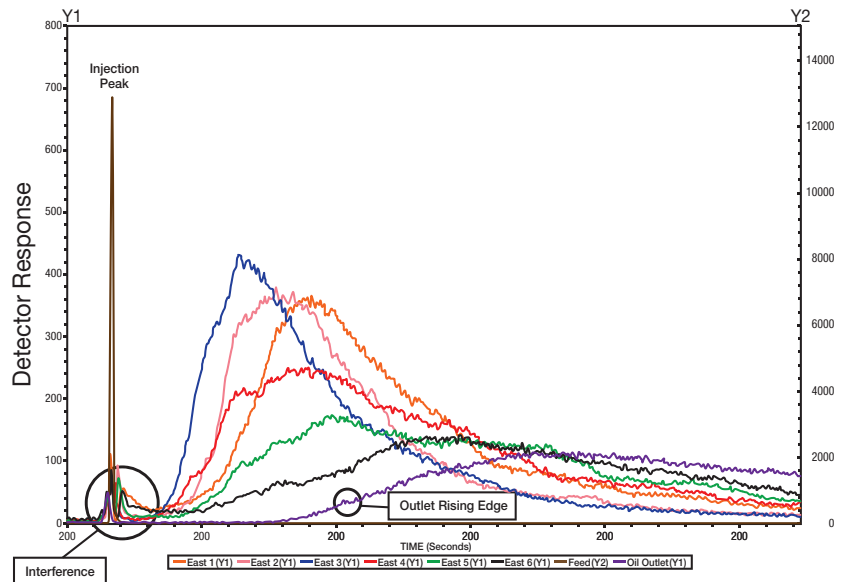
Figure 3 – Test results indicated a significantly slower flow in the North end of the Desalter indicating maldistribution.

The results of the study are illustrated in Figure 3 shown on page 2. The data indicated a much different flow pattern when comparing the detectors on the North side of the vessel (red, green, black) as those on the South side (blue, pink, orange). On the South side of the vessel, the detector response curves were sharp with well-defined leading and trailing edges. By comparison, the detector response curves on the North side of the vessel showed very broad curves with leading

and trailing edges spread out over a very long period of time. This was an indication that the feed distribution was not properly distributing the feed to both sides of the vessel. There appeared to be a much higher flow of feed to the South as compared to the North. If the distribution would have been even, then the North and South detectors would be expected to have shown uniform response curves.

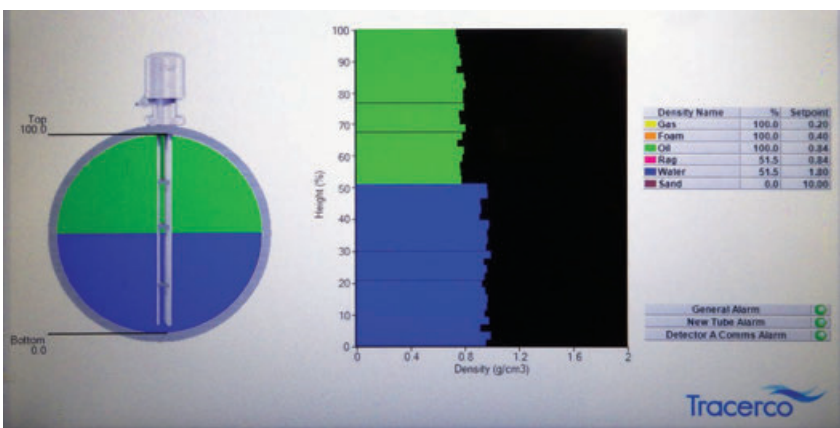
Figure 4 – In this figure you can see from the screen shot from Profiler™ results, you are able to visualise the electrostatic grids and understand how operations is able to maintain at the ideal position.

In Figure 4 you can see from the screen shot taken from Profiler™ results, you are able to visualise the electrostatic grids and understand

how operations is able to maintain at the ideal position.

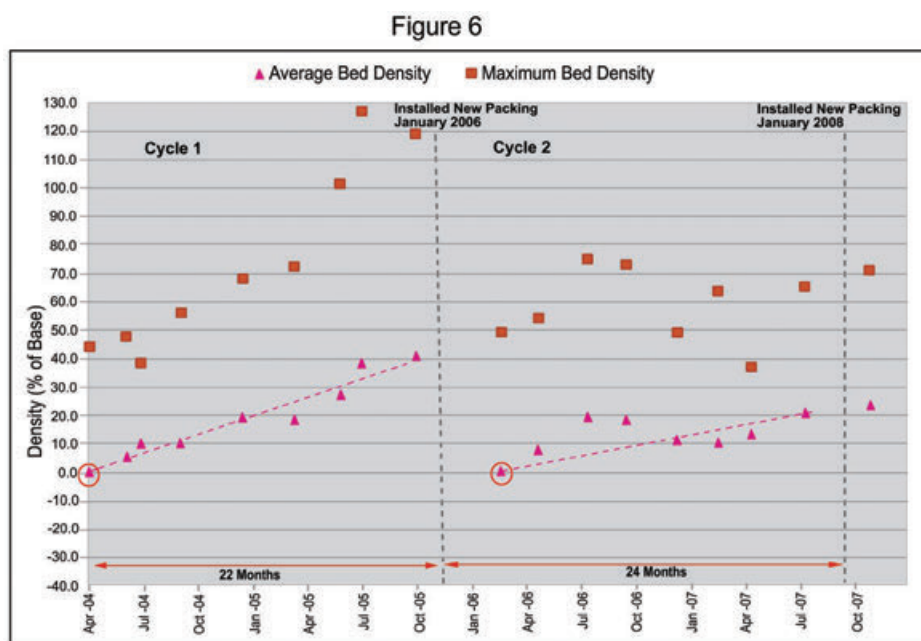
Figure 6 – Cycle 1 wash bed densities when vacuum column operated aggressively; Cycle 2 wash bed densities when vacuum column operated more conservatively.

Thereafter the scans were repeated on a periodic basis, approximately every three months. The vacuum tower wash bed was operated very aggressively during the first cycle - minimum wash oil to maximise HVGO yield. This was purposely done to set parameters for aggressive operation. The first section of the graph in Figure 6 shows the average wash bed densities calculated from the ThruVision™ scan data for Cycle 1. Figure 5b shows the ThruVision™ scan from the end of this cycle run. Over the 2-year period there was a 40% increase in packing density due to coke build-up and/or excess liquid retention.

After the two-year period there was an opportunity shutdown due to a problem unrelated to the coking. Subsequent shutdown and inspection showed the packing severely fouled with coke and the packing was replaced. The next cycle run was purposely operated with less aggressive operation, higher wash oil rates to retard the rate of coking. This cycle run also lasted approximately two years. As seen from the second section of Figure 6, over the two-year cycle run the average packing density increased by a little more than 20%.

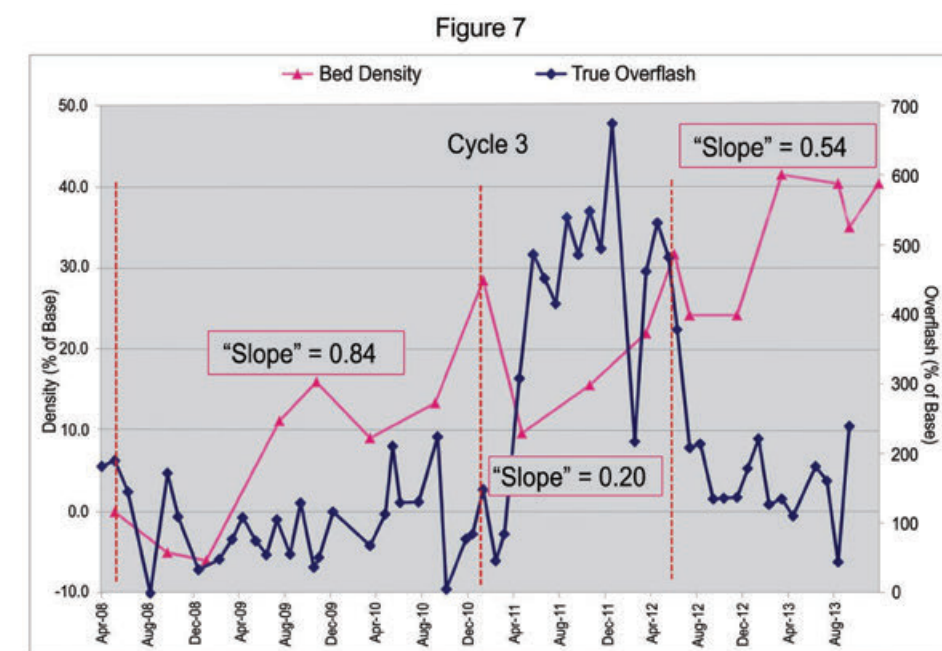
Figure 7 – Trend of wash bed packing density versus true overflash over the 69 month run of Cycle 3.

rate at the expense of some HVGO yield. Then in mid-2012, management advanced the planned end of the cycle run. At that time, operations reduced the over-flash rate to increase HVGO yield. Knowing the wash bed packing was going to be replaced allowed operations to tolerate an increased coking rate. However, to have a little cushion the decision was made to not be as aggressive as was done during Cycle 1. Figure 7 shows the over-flash rate versus the packing density during this entire 69-month cycle run.

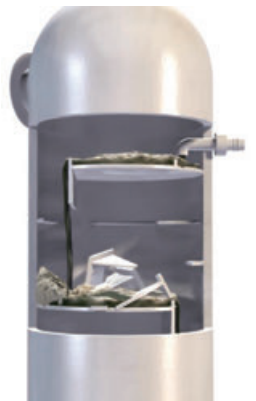
Figure 8 – Tru-Scan™ results decided the course of action for the refinery during their turnaround. Modifications to the tower were made instead of preparing to replace damaged trays which scan results found were not necessary.

The  $\Delta P$  of the Depropanizer was higher than normal. Operations suspected flooding, probably as a result of some tray damage to the lower trays due to the high base liquid level. The scan results did show the high base liquid level covering the reboiler return nozzle. As a result of the reboiler return vapor mixing with the base liquid there was a lot of liquid entrainment below the bottom tray (Tray 1 in Figure 8). The bottom trays were flooding but had no apparent damage. These scan results decided the course of action for the refinery during the turnaround. Plans were made to modify piping so the reboiler would operate correctly with the proper base liquid level instead of purchasing trays when scan results indicted the existing trays were not damaged.

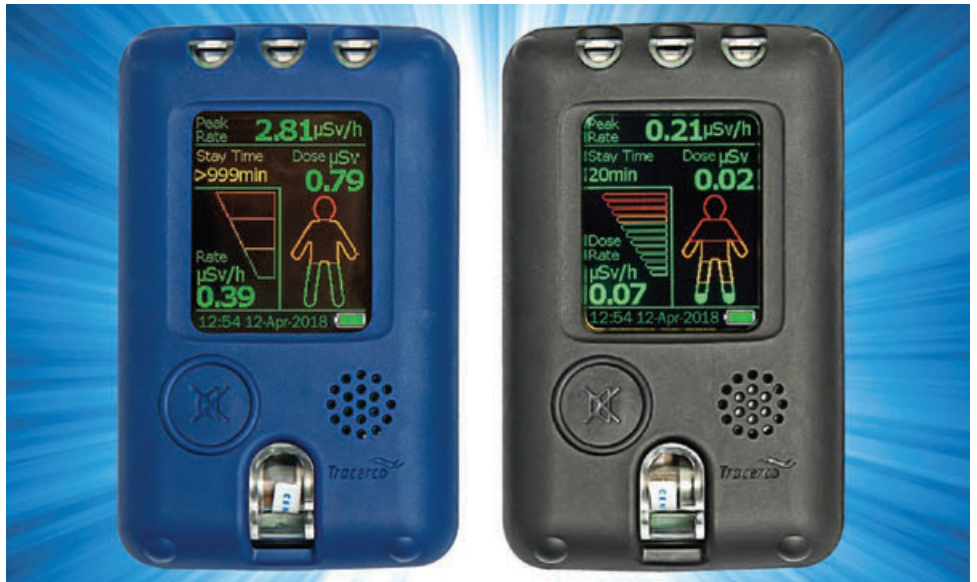
The PED-ER+ has the same unique features as the PED-ER in terms of portability, an IP67 rating and the ability to provide immediate data on an intuitive, large clear display, however it also boasts a number of additional features. Most notably, the PED-ER+ can be used as both a Personal Dosimeter and a handheld dose rate survey meter, ensuring that the safety of both the worker, and those personnel that are in the area of the event is never compromised. Pop-up message alarms (when dose limits are reached), to the user, also allow personnel to organise, plan and respond to radiation more efficiently.

The PED-ER+ comes complete with Bluetooth technology, meaning live dose rates can be transmitted to an Android device located in a safe area. This allows the management and monitoring of situations to be undertaken in real time, away from a potentially hazardous event. The addition of GPS tracking also provides location data alongside dose data, giving a map of potential radiation hazards when data is downloaded.

As per our existing PEDs (the PED-IS, PED Blue and PED+), the PED-ER has been designed to keep things simple. With one button operation and an easy to follow menu system, the device can be easily operated with no training needed. Audio and visual alarms with a vibration function, also ensure that personnel are immediately notified if a set dose rate is reached or exceeded.
