## Baseline Scan Data Provides a Valuable Historical Reference Point for Analysis

## Isolate Mystery Flare Flow and Reduce Flow Rate Measurement Errors

# Locate Leaks in Waste Heat Boilers to Minimize Downtime

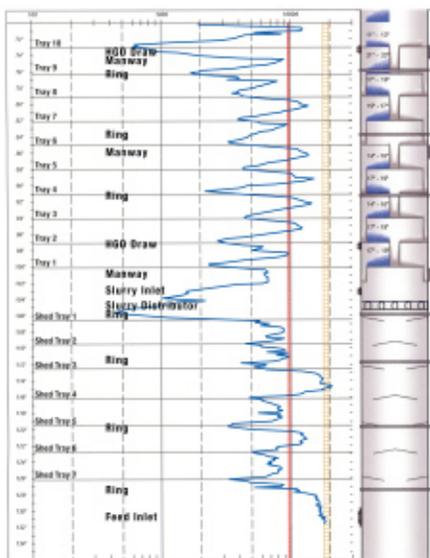
Figure 1 - A baseline scan of the Main Fractionator indicated that start-up had gone smoothly with all trays present and holding suitable levels of liquid.

The baseline scan results for the lower section of the Main Fractionator are shown in Figure 1, page 1. Fortunately the scan showed that the startup

had proceeded smoothly as all trays were present and holding suitable levels of liquid. The trays appeared to be operating with moderate-to-severe entrainment but this would be considered “normal” or acceptable mode of operation and not cause undue alarm when seen on future scans. The most important benefit from the scans however was the documentation of the scan response from the insulation support rings. A couple of trays, Trays 4 and 9, appeared more dense than the other trays but this was now documented being due to the presence of the support rings and not falsely due to any presence of coking.

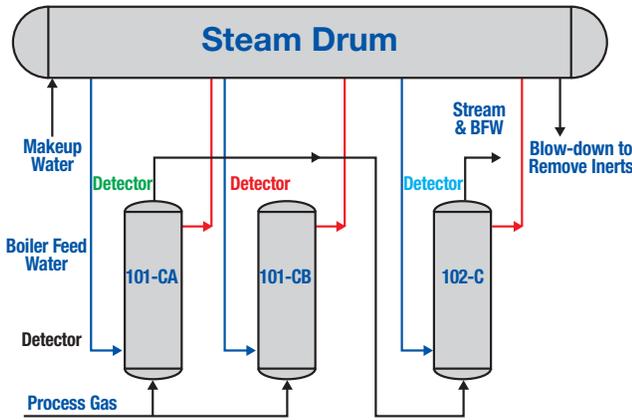
Figure 7 - Detector placement for TRACERCO Diagnostics™ Leak Study on a WHB.

Waste heat boilers (WHB) present a special problem in that the tracer is carried by the Boiler Feed Water (BFW), which would leak into a hot gas stream. WHB are tested by injecting a dissolved ionic salt into the steam drum. (Figure 7)

radioisotopes or chemical tracers directly into the process to provide real-time data. Sensitive, externally placed detectors monitor the flow of tracer material (Figure 7) from heat exchangers, condensers, and reboilers.

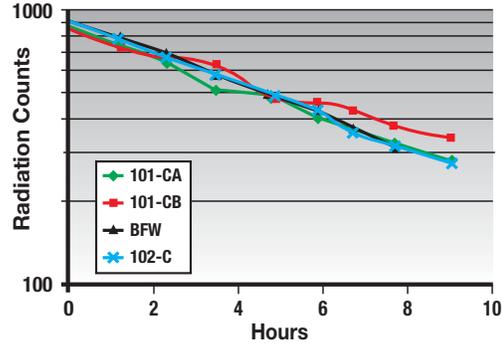
Figure 8 - Test results indicated that the 101-CB exchanger had a slower rate of decay.

These results illustrated in Figure 8 show that the response of the detectors on the BFW line and on two of the three WHB was constant. The 101-CB exchanger, however, had a slower rate of decline, due to the deposition of the tracer on the process side of the exchanger. This was determined to be the leaking WHB.

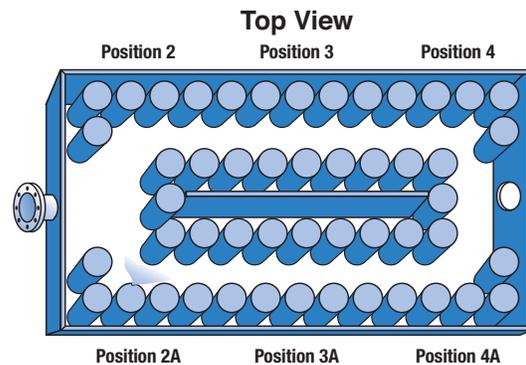
Figure 9 - Top View illustration of detector placements.

A customer had converted an old box-fired heater into a WHB by sealing the box and piping in hot process gas. BFW passed through the tubes. A leak of the BFW was suspected. Water soluble tracer was injected into the BFW. Readings were taken at three positions along both sides of the box and on the process outlet line (Figure 9).

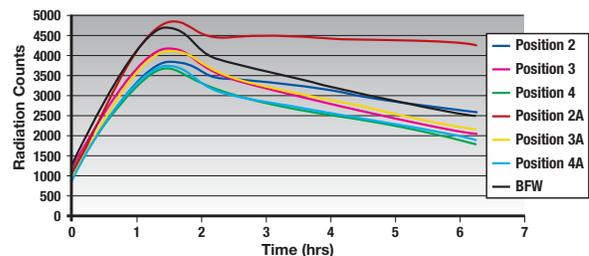
Figure 10 - Results indicated tracer was accumulating on the inlet end of the box at position 2A.

The results showed that tracer was accumulating on the inlet end of the box at position 2A (Figure 10). Tracer did not accumulate anywhere else.

When the customer opened the box, he found that one of the tubes on the outer wall of the box had split, spraying water toward the interior. But all of the water flashed quickly and the tracer stuck to the inside of the box and on the outside of the adjacent tubes within 5 feet of the split tube.

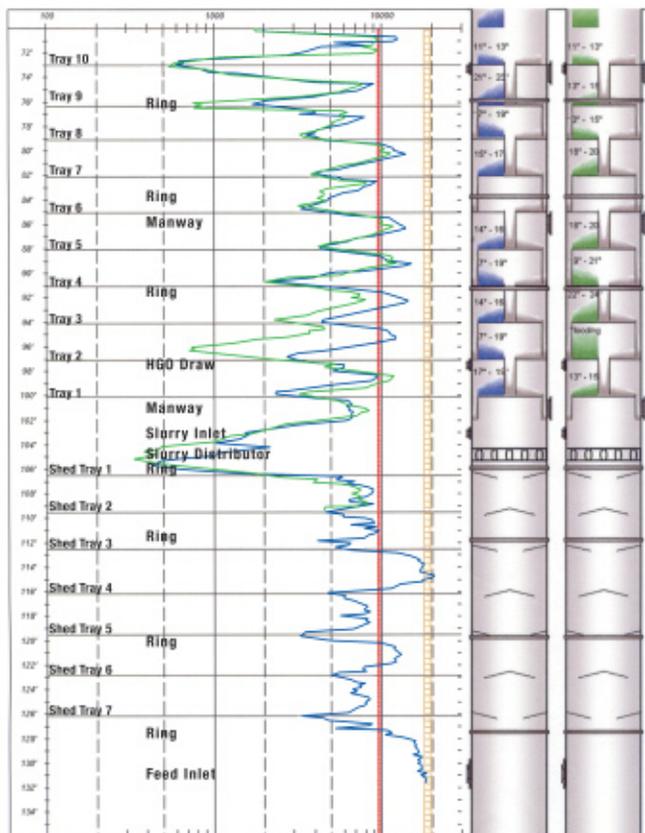
Figure 2 - When compared to the baseline scan a second scan of the Main Fractionator indicated Trays 2 and 3 showed observable differences in the liquid level on these trays.

ing. The results of this scan are shown in Figure 2 along with the baseline profile obtained earlier. This scan showed observable differences with Trays 2 and 3. Previously the baseline scan showed Tray 2 holding 17 – 19 inches of liquid; now Tray 2 was flooding; Tray 3 had been holding 14 – 16 inches of liquid; now Tray 3 was holding 22 – 24 inches. Other than these differences the results showed that the Main Fractionator was mostly in the same condition as when the column was scanned previously. Since it was known from the baseline scan what Trays 2 and 3 looked like under normal conditions then this amount of liquid could be concluded with certainty as excess liquid building up on Tray 2, most likely from the formation of coke.

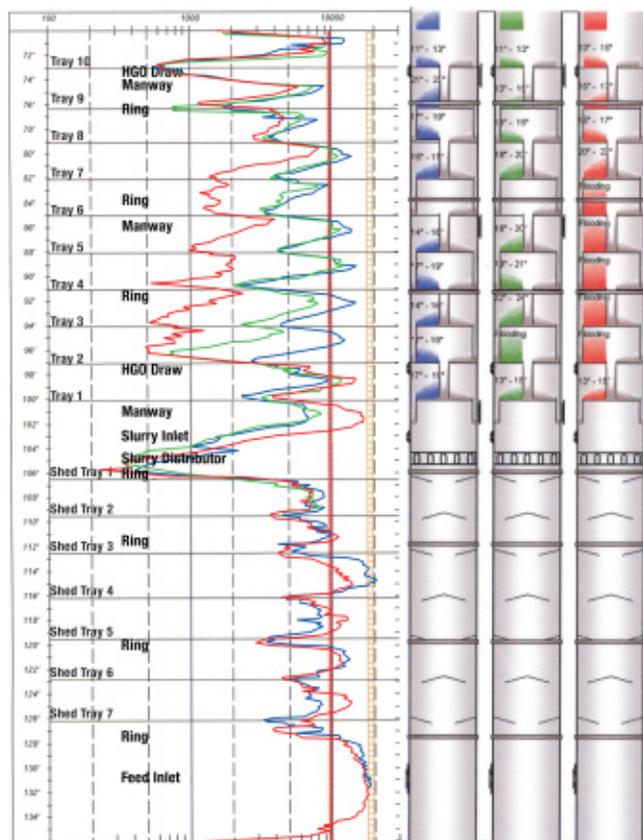
Figure 3 - Comparing scan results from January 07 to the June and December 06 scans indicated that flooding had increased from Tray 2 in June 06 to Trays 2 - 7.

condition. An increase in P had been observed and Operations and Maintenance needed to know the extent of flooding so they could begin preparations for a shutdown. Figure 3 shows the scan results compared to the baseline data and the previous scan.

This scan showed the column's operation was definitely worse. The flooding had increased from

just affecting Tray 2 seven months ago to now flooding Trays 2 through 7. At this point the rate of trays succumbing to the flooding would likely increase so a shutdown was needed as soon as possible to rectify this situation. But now the refinery personnel were aware of the "approaching storm" and had time to plan, organize, and execute a solution before the "storm" hit.

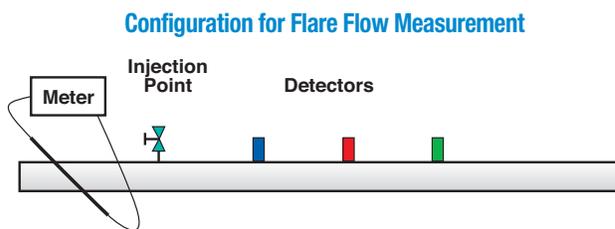
Figure 4 Illustrates the placement of detectors that are mounted externally on the pipe and placed downstream of the injection point.

A 3/4 inch nozzle on top of the flare line 4.5 feet downstream of the flow meter was used as the tracer injection point. Detectors were positioned downstream of the injection point. (Figure 4).

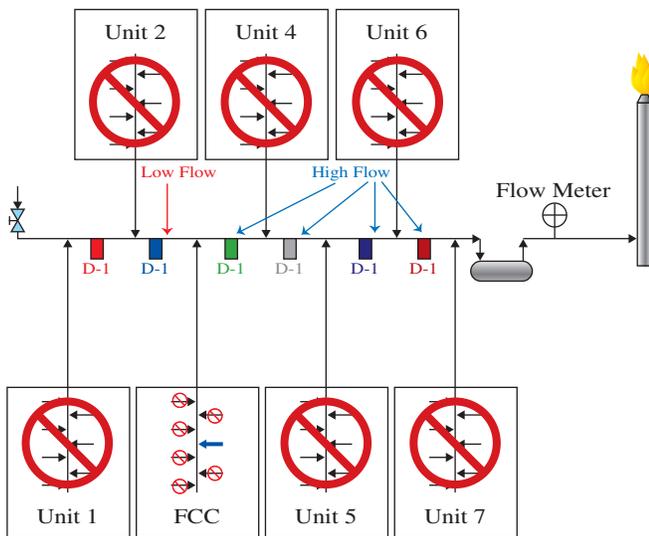
Figure 6 - Flow studies were performed through several portions of the flare line to isolate which unit contained a leak.

To locate the leak, flow was measured through several portions of the flare line to isolate which unit had the mystery flow. The FCC Unit was found guilty. Measuring flows in the FCC Unit flare line identified a leaking PSV on the Main Fractionator as the culprit.

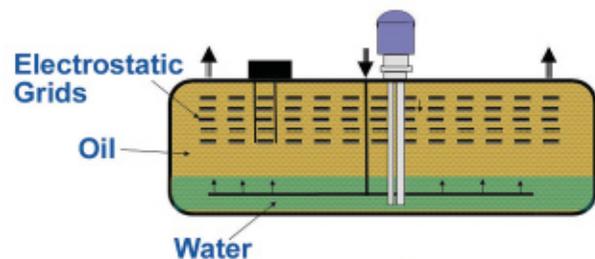
Illustration of The **TRACERCO Profiler™** housed in dip-pipes and installed within a vessel through a single flange.

The **TRACERCO Profiler™** measures the vertical distribution of phases contained in desalter vessels and is designed to withstand the elevated operating temperatures typically experienced within a desalter.
