Portfolio Case Study

Case Study Overview

The following case study reports on heavily impacted sites owned and managed by a large, U.S.-based asset owner. The owner's total portfolio size spans over 410 MW of solar PV assets across the United States. The owner has multiple O&M vendors with teams stationed throughout the country. The PV systems within the portfolio range from 100 kW to 300+ MW, with a majority of their sites between 10-40 MWs.

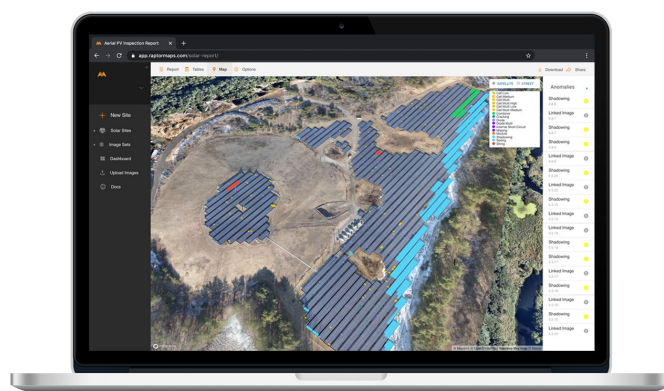
Some anomalies to note were instances of tree line shading, which affected over 2,200 modules, and combiner issues, affecting 324 modules. In addition, there were 3 strings and 68 individual diode faults discovered.

Anomaly	Anomalies (%)	Modules (%)	Est. Affected DC (%)	Est. Affected DC (%)	Est. Annual Impact (kWh) (%)	Est. Annual Impact (\$1) (%)
Cell Low	37	37	3.95 kW	0.07%	7201.95 kWh	\$180.05
Combiner	52	324	103.68 kW	1.78%	189216.00 kWh	\$4730.40
Cell Medium	12	12	1.28 kW	0.02%	2335.77 kWh	\$58.39
Cracking	12	12	3.84 kW	0.07%	7008.00 kWh	\$175.20
Diode	68	68	7.25 kW	0.12%	13236.01 kWh	\$330.90
Diode Multi	1	1	0.21 kW	0.00%	389.34 kWh	\$9.73
Shading	257	2297	244.99 kW	4.20%	44710.46 kWh	\$1117.62
String	3	54	17.28 kW	0.30%	31536.00 kWh	\$788.40
Totals	442	2805	382.48 kW	6.56%	698027.68 kWh	\$17450.69

The owner's O&M subcontractor used the deliverables to identify the most impactful and easily remediated anomalies within the site. The deliverables enabled them to set up a plan to resolve all non-shading related anomalies within two weeks of the site inspection. The team started with the malfunctioning combiners to resume the 1.78% of lost production. The O&M team was already aware of the shading issues impacting the site, however, the shading impact had never been quantified. The O&M team used this new data to create a plan to resolve the onsite issues causing the shading and performance loss.

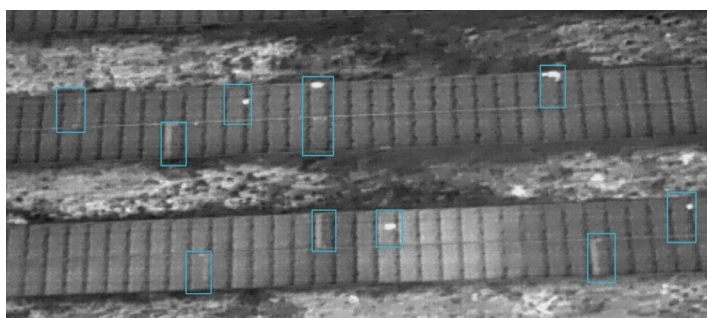
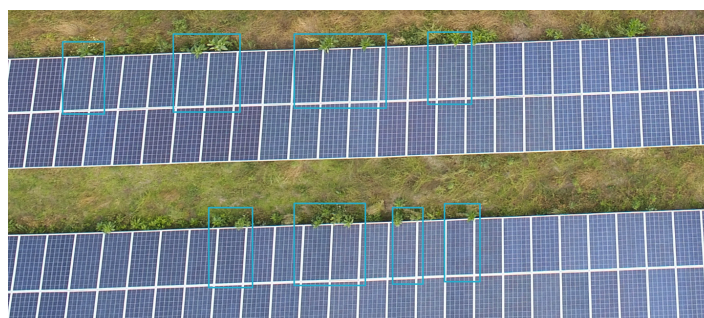
The report identified and located 10 malfunctioning strings, 379 diode faults, and over 400 cases of vegetation across the northwest side. The annual loss of production from the anomalies identified would total more than 600,000 kWh.

Anomaly	Anomalies ⁽¹⁾	Modules ⁽²⁾	Est. Affected DC ⁽³⁾	Est. Affected DC ⁽⁴⁾	Est. Annual Impact (kWh) ⁽⁵⁾	Est. Annual Impact (\$) ⁽⁶⁾
Cell	457	457	4798 kW	0.39%	103157.43 kWh	\$2578.94
Cell Multi	586	586	92.30 kW	0.75%	198434.25 kWh	\$4960.86
Cracking	11	11	3.46 kW	0.03%	7449.75 kWh	\$186.24
Diode	379	379	39.79 kW	0.32%	85550.69 kWh	\$2138.77
Module	3	3	0.95 kW	0.01%	2031.75 kWh	\$50.79
Shadowing	26	350	36.75 kW	0.30%	79004.60 kWh	\$1975.11
String	10	190	59.85 kW	0.49%	128677.50 kWh	\$3216.94
Vegetation	412	412	43.26 kW	0.35%	92999.70 kWh	\$2324.99
Totals	1884	2388	324.33 kW	2.64%	697305.68 kWh	\$17432.64

The O&M team used the reports and the visual spectrum images from the inspection to assess all 400 cases of vegetation and were able to instruct their vegetation management vendor to the exact locations for removal. The O&M manager also deployed field technicians to investigate the high number of modules affected by diode faults and remediate the 10 string anomalies impacting 0.5% of system performance. Along with this improvement, the O&M vendor utilized Raptor Maps' flight guidelines and data processing to perform preventative maintenance inspections regularly to maintain optimal site conditions.

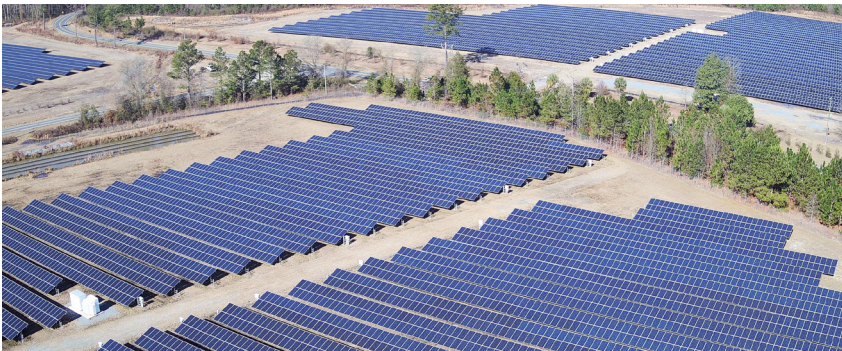
On top of the 50 inverter faults, the inspection identified 8 offline strings which were estimated to reduce production capacity by 84 kW. There were also 64 module level issues and 594 sub-module level anomalies. These reduced the PV system's production by 95 kW from the site's full operating capacity.

Anomaly	Anomalies ⁽¹⁾	Modules ⁽²⁾	Est. Affected DC ⁽³⁾	Est. Affected DC ⁽⁴⁾	Est. Annual Impact (kWh) ⁽⁵⁾	Est. Annual Impact (\$) ⁽⁶⁾
Cell	284	284	30.76 kW	0.04%	66141.72 kWh	\$1653.54
Cell Multi	241	241	39.16 kW	0.05%	84199.38 kWh	\$2104.98
Cracking	3	3	0.98 kW	0.00%	2096.25 kWh	\$52.41
Diode	67	67	7.26 kW	0.01%	15603.86 kWh	\$390.10
Inverter	50	10034	3261.05 kW	4.16%	7011257.50 kWh	\$175281.44
Module	35	35	11.38 kW	0.01%	24456.25 kWh	\$611.41
Shadowing	14	14	1.52 kW	0.00%	3260.51 kWh	\$81.51
String	8	261	84.83 kW	0.11%	182373.75 kWh	\$4559.34
Totals	702	10939	3436.93 kW	4.37%	7389389.21 kWh	\$184734.73

The O&M team knew that the site was facing inverter issues due to internal monitoring signals, but the number and location of them were unclear. Upon the report being delivered, the vendor prioritized their onsite task to resolve the various inverter faults causing the 4% daily performance loss. The report equipped them with the data needed to deploy the necessary number of technicians and resources to the affected areas of the PV system. In addition, they were able to deploy technicians to remediate the string and module faults on schedule.

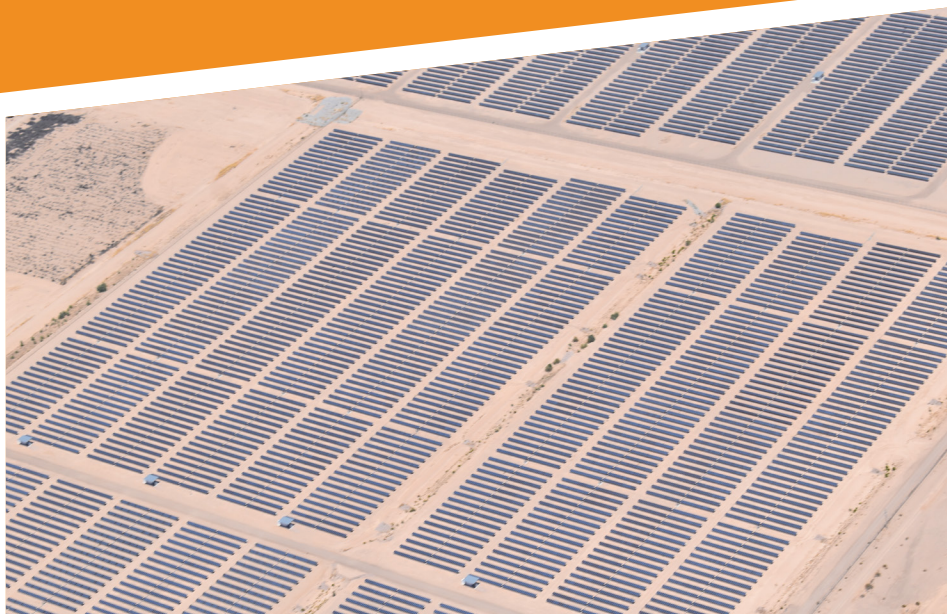
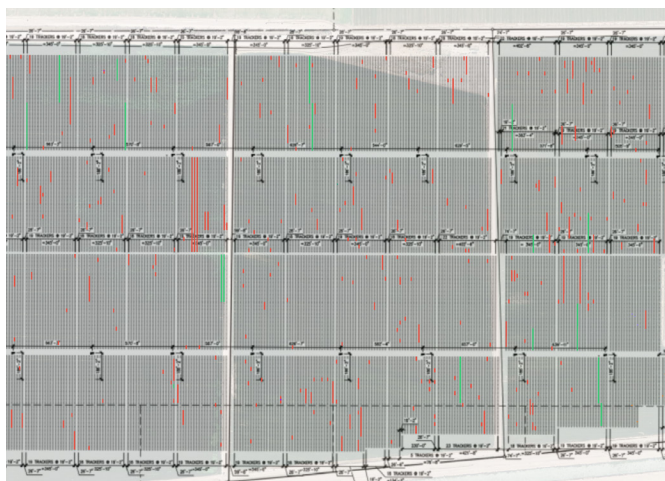
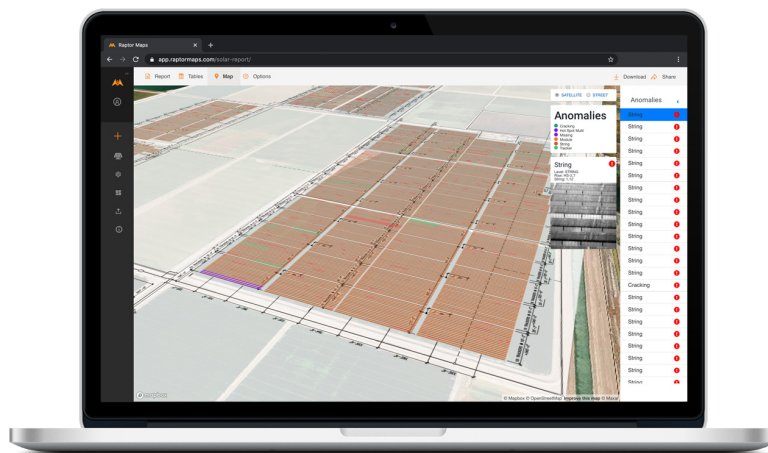
The two major anomalies uncovered were string and tracker issues. The string faults were the most impactful, with more than 2,700 individual string anomalies, impacting 3.48% of the total site production and costing almost \$300,000 in annual PV system revenue*. On top of that, \$8,000 of annual revenue was lost due to tracker faults.

The O&M team utilized the interactive map available in the Raptor Maps platform and also printed out the PDF and Excel spreadsheet reports to create a resolution plan. Due to the large size of the site and scattered anomaly locations, the site manager was able to deploy their team to the required areas, prioritizing mobilization based on performance impairment. The team was able to resolve all major issues within a few weeks and return the site to optimum production levels five times faster than if they had used older and more labor-intensive methods of field investigation.

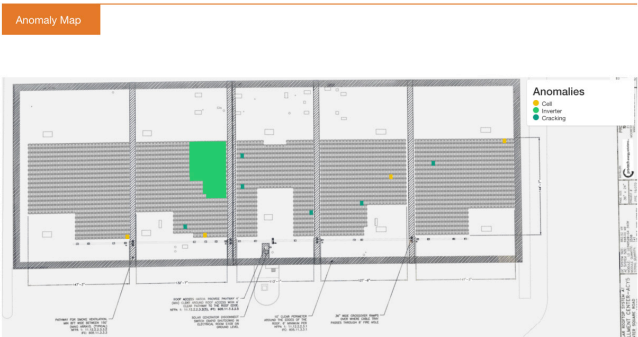
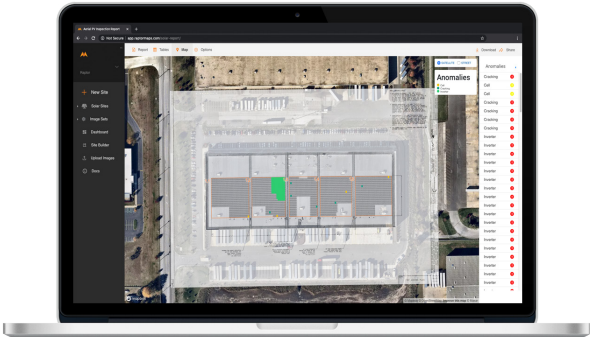
Anomaly Map

The rooftop solar PV system was inspected through Raptor Maps' turnkey services. Raptor Maps deployed a licensed drone pilot to the site within two days of the inspection request and executed contract. The Raptor Comprehensive level of inspection took one hour to perform, including pre-flight setup, flight time, and equipment breakdown. The Raptor Comprehensive inspection provided the O&M vendor with 3cm/px GSD radiometric infrared JPEG data and 1cm/px GSD high-definition visual spectrum JPEG data, exact temperature deltas for each module, complying with IEC TS 62446-3 regulations for aerial thermography. This inspection uncovered the following anomalies: 4 hot cells, 6 cracked modules, and 1 inverter offline.

Anomaly	Anomalies *(1)	Modules *(2)	Est. Affected DC *(3)	Est. Affected DC *(4)	Est. Annual Impact (kWh) *(5)	Est. Annual Impact (\$) *(6)
Cell	4	4	0.45 kW	0.05%	747.93 kWh	\$18.70
Cracking	6	6	2.04 kW	0.24%	3366.00 kWh	\$84.15
Inverter	1	126	42.84 kW	4.98%	70686.00 kWh	\$1767.15
Totals	11	136	45.33 kW	5.27%	74799.93 kWh	\$1870.00

The O&M team focused their resources on fixing the offline inverter and cracked modules, which would result in over 80,000 kWh of lost production, and \$1,800 in lost revenue annually. Utilizing the interactive map in Raptor Maps software, which shows the locations of each anomaly over satellite imagery and PV system as-built, the O&M manager overseeing the site sent the exact number of repairs and supplies needed to remediate the site's issues. Due to this site being on a rooftop, performing the inspection via aerial thermography prevented any inspection related injuries and minimized the amount of time any deployed technicians were on the roof.
