Specifying ChemLine® 784/31 Coating for Hydrochloric Acid Tanks at Viking International

ChemLINE®
CASE STUDY

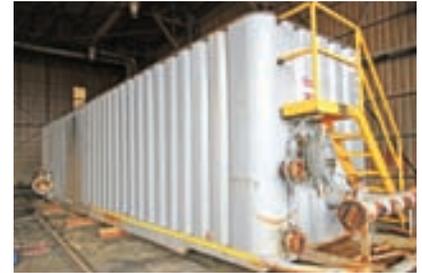
HCl storage tank at Viking Chemicals.

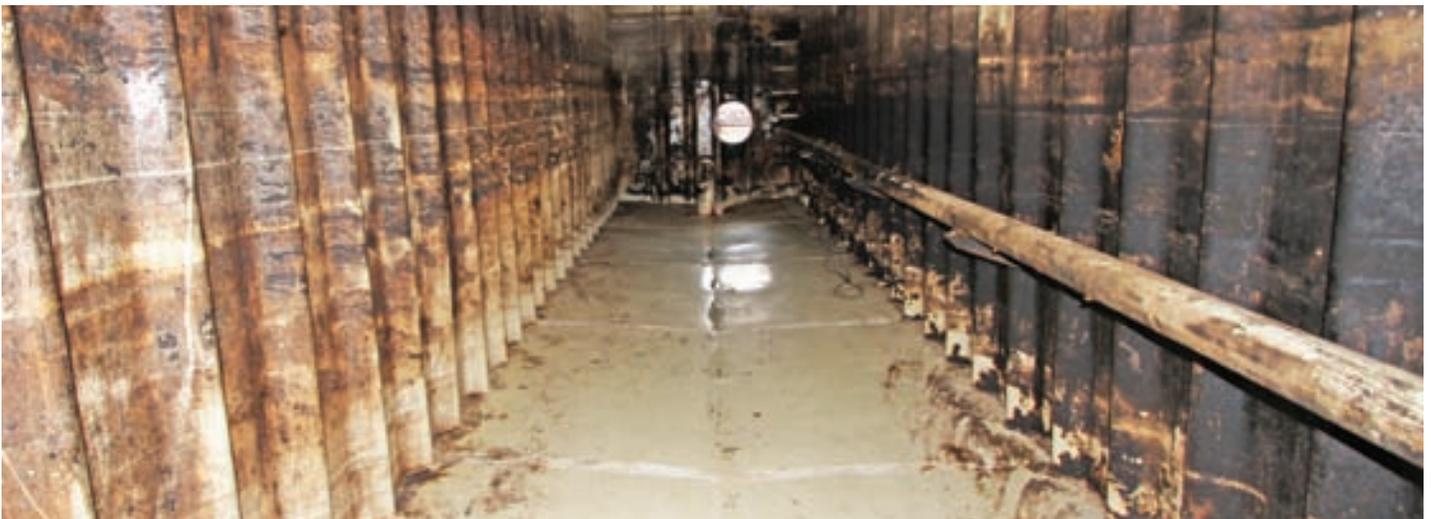
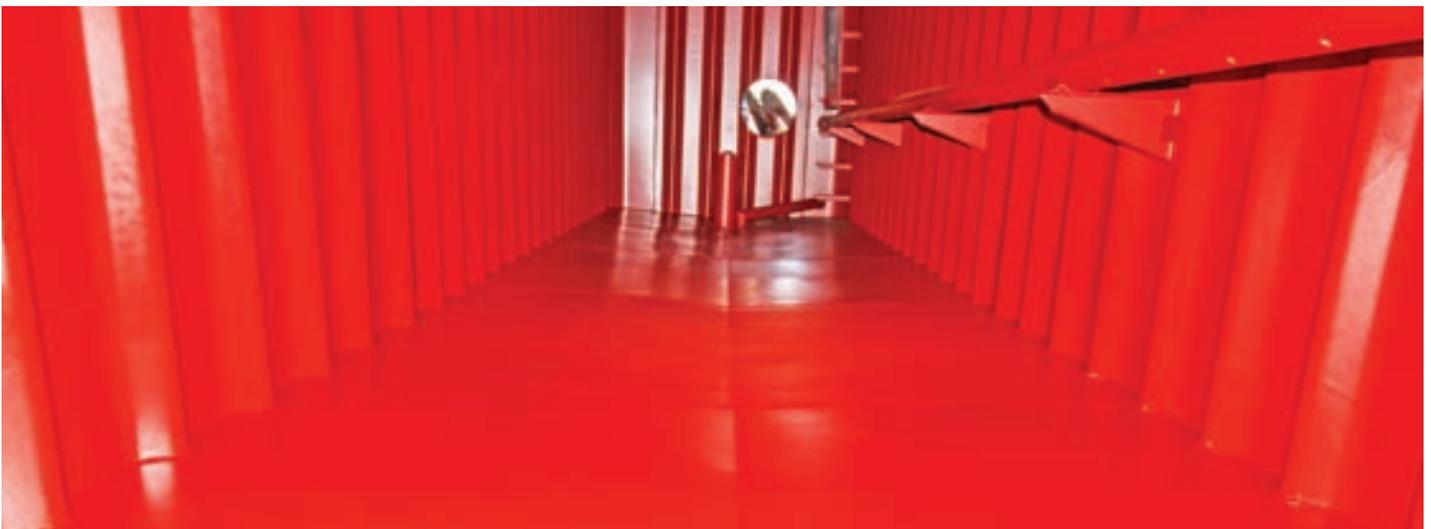
A tank destined for future HCl storage for Viking Chemicals (top photo), first needs to have the existing dirty greasy epoxy lining blasted and removed, and then chemically cleaned and prepped by MarineLine Turkey at its application facility. (Lower photo) the tank is then lined with two coats of ChemLine® 784/31 delivering a protective solution for storing corrosive Hydrochloric Acid.

MarineLine Turkey first needed to remove the existing epoxy lining from the internal tank surfaces that had layers of dirt and greasy build-up from past DPP storage. The process followed various steps:

- 1 The tank surface started with chemical cleaning using a chemical detergent with a high pressure water jet.
- 2 The tank surface was pre-blasted to remove the existing dirty epoxy lining.
- 3 The tank surface was again re-washed and checked for hydrocarbon and chloride residues.
- 4 The tanks were then re-blasted again and prepped for coating application.
- 5 Next, the coating application was done in two coats; first a grey base coat at 7-8 mils, followed by a 7-8 mils red-coloured top coat to prevent any discoloration from the HCl.
- 6 The ChemLine® tank coating was then heat cured at 177°C for eight (8) hours to enhance crosslinking of the polymer.
- 7 MarineLine Turkey carried out all the application and heat curing work at its Tuzla, Turkey application facility.

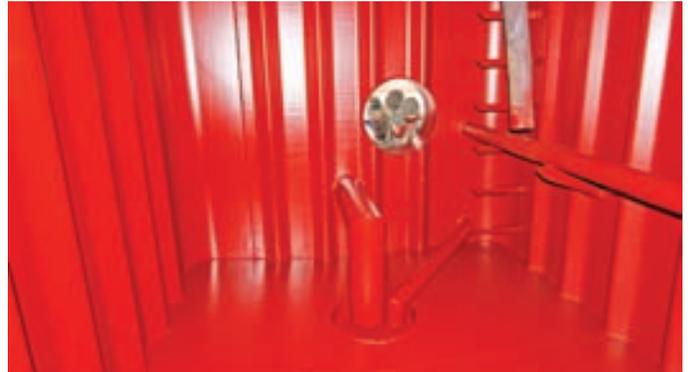
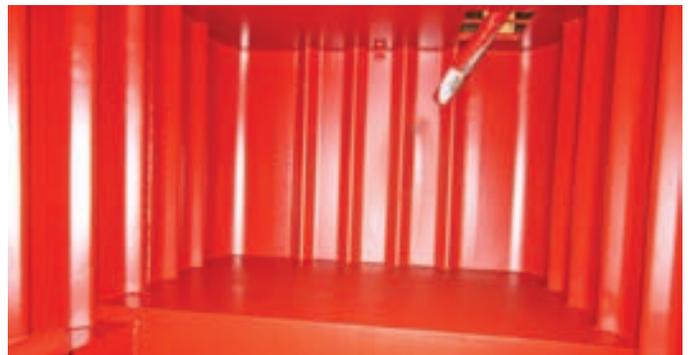
Up close inspection photos after the final coating shows the very clean, smooth surface that will effectively protect the tank from corrosion against HCl service.
