Industrial Tank Protection

ChemLINE®
CASE STUDY

Tank Reconstruction and Lining Project in Turkey

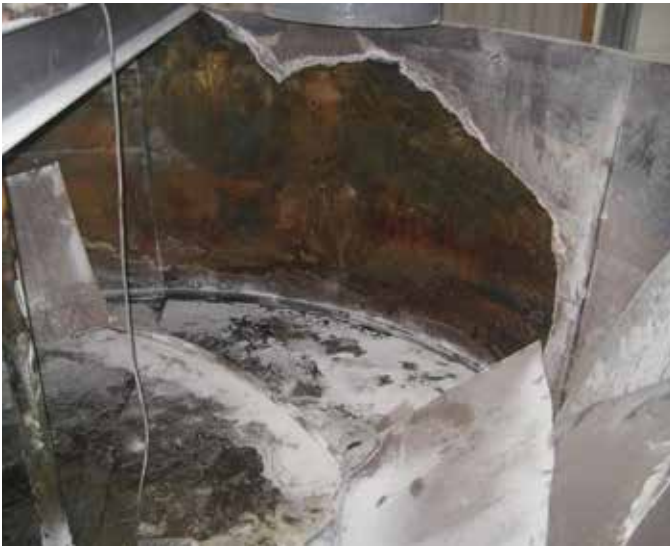
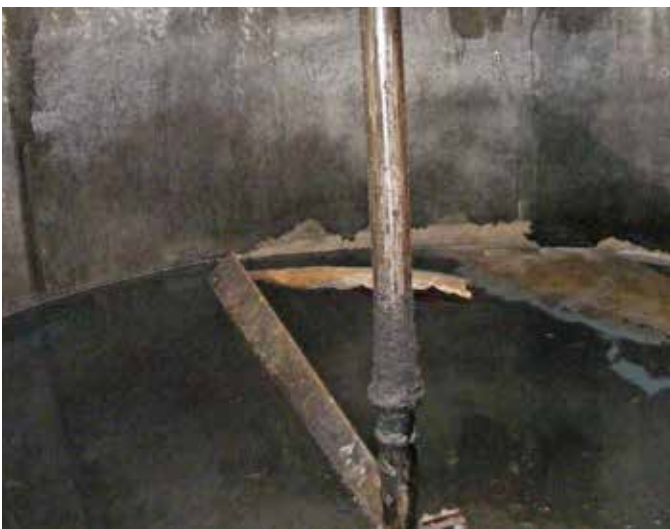
In a tank project for a customer, APC/MarineLine Turkiye was asked to look at a problem with carbon steel tanks that were previously lined with fiberglass but had corroded severely due to reactions with Zinc Sulphate at high temperatures. New fiberglass lining was being applied every three months just to handle this service. After the tanks were then repaired to original condition, APC/MarineLine Turkiye lined them with ChemLine® coating to deliver a much better solution for the customer.

(Left, top and below) As seen here, severe corrosion issues were encountered due to reactions with Zinc Sulphate at high temperatures in these tanks. (Right, top and below) The ChemLine® coating applied internally in the tanks, rectified the corrosion problem. This photo is after four months of the ChemLine® coating in service, with no problems.
