SUBJECT: Fuel Filler cap alignment decals.

M20C	2623 - 2690
M20D	201 - 241
M20E	101 - 263

Service Bulletin No. 5

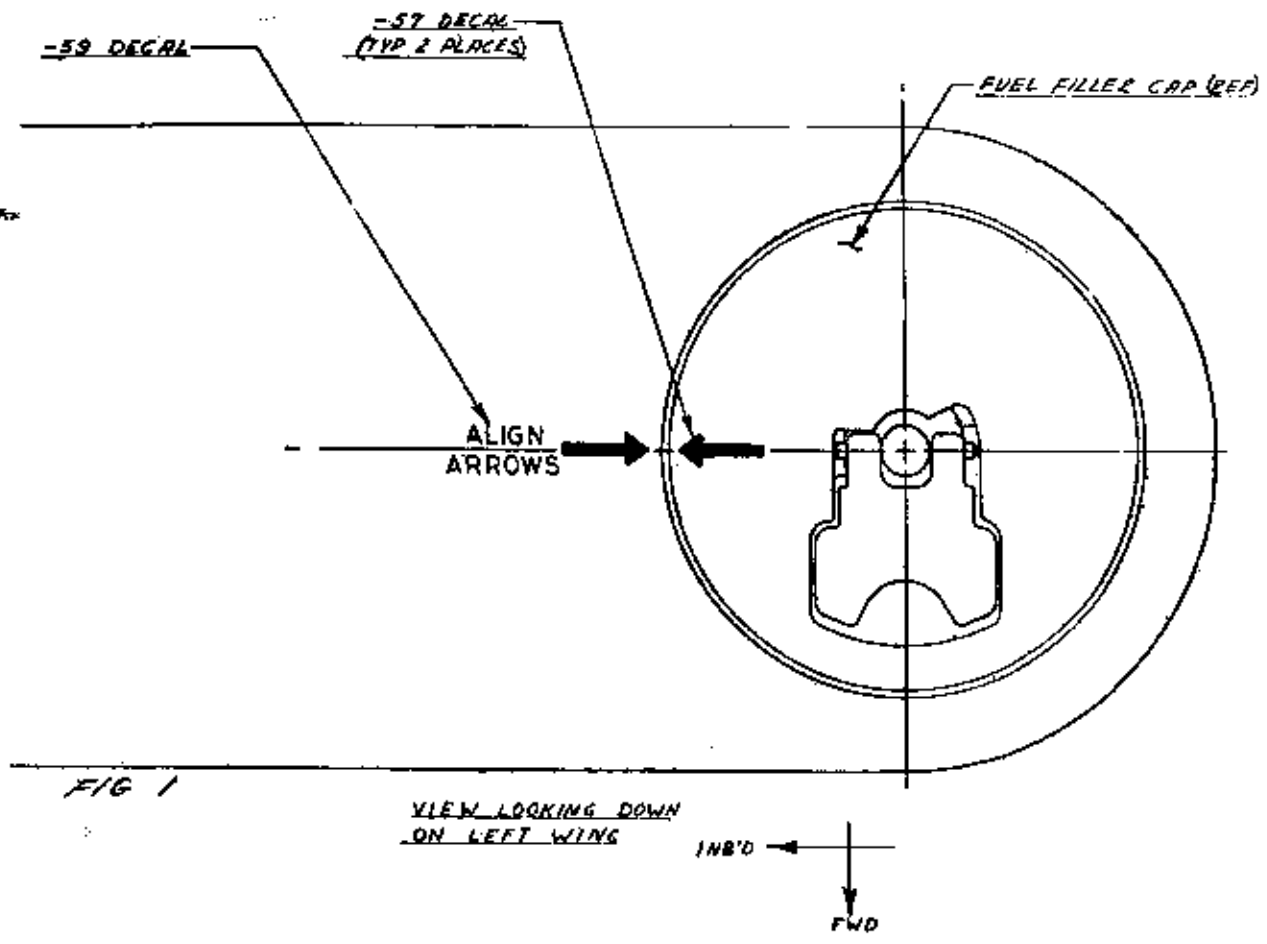
1. Make sure the fuel filler caps are on properly.
2. Place the decals for the left wing per Figure 1.
3. Place the decals for the right wing per Figure 2.
