SI M20-69

SUBJECT: MOONEY M20J FUEL PRESSURE HOSE RETROFIT.

MODEL/SERIAL NUMBERS AFFECTED: MOONEY M20J S/N 24-0378 thru 24-1377.

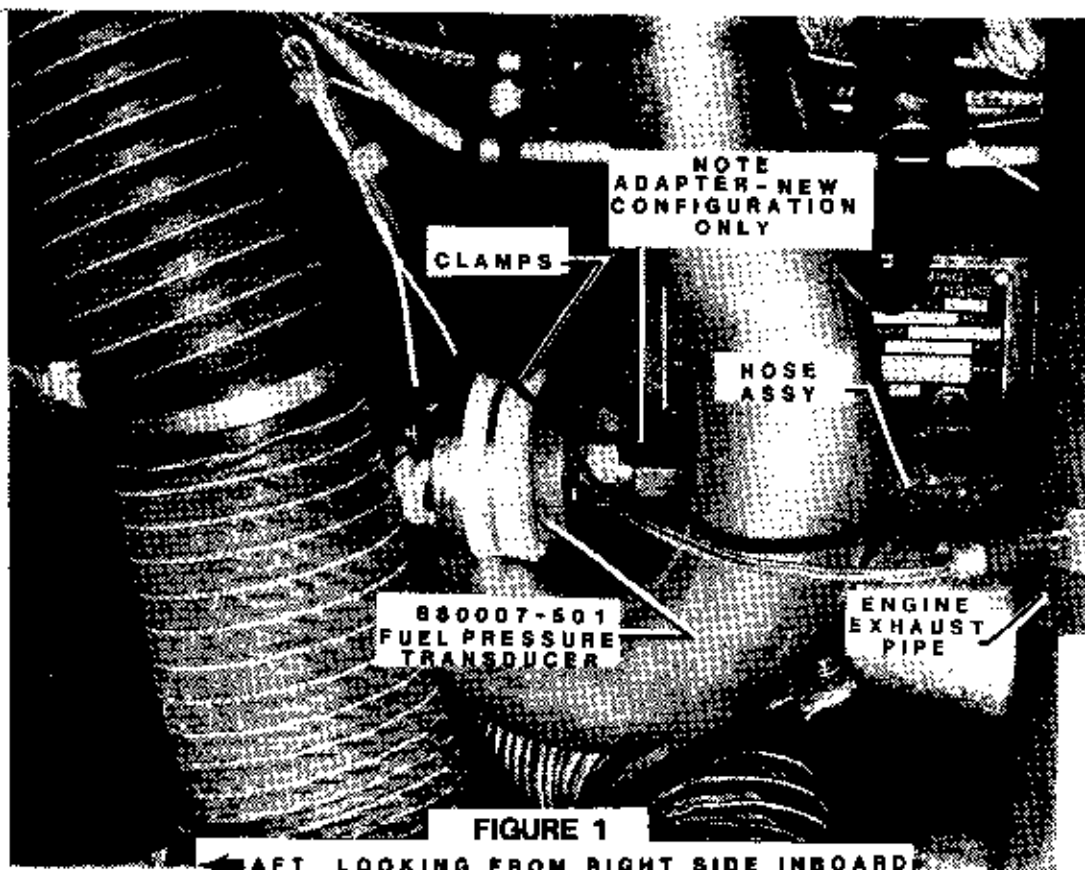
1. Remove top and bottom cowling per Service and Maintenance Manual.
2. Remove and discard existing aluminum clamps from fuel pressure transducer, P/N 880007-501 and induction tube (See Figure 1).

3. Remove electrical wiring from the transducer terminals.
4. Remove fuel pressure transducer, 880007-501 from existing hose assembly, S94B90145 (See Figure 1).

7. Attach one of the new MS21919WCH25 steel clamps to the transducer and the other to the induction tube so they will fit together to secure the fuel pressure transducer. Use the existing hardware to attach the clamps (see Fig. 1).

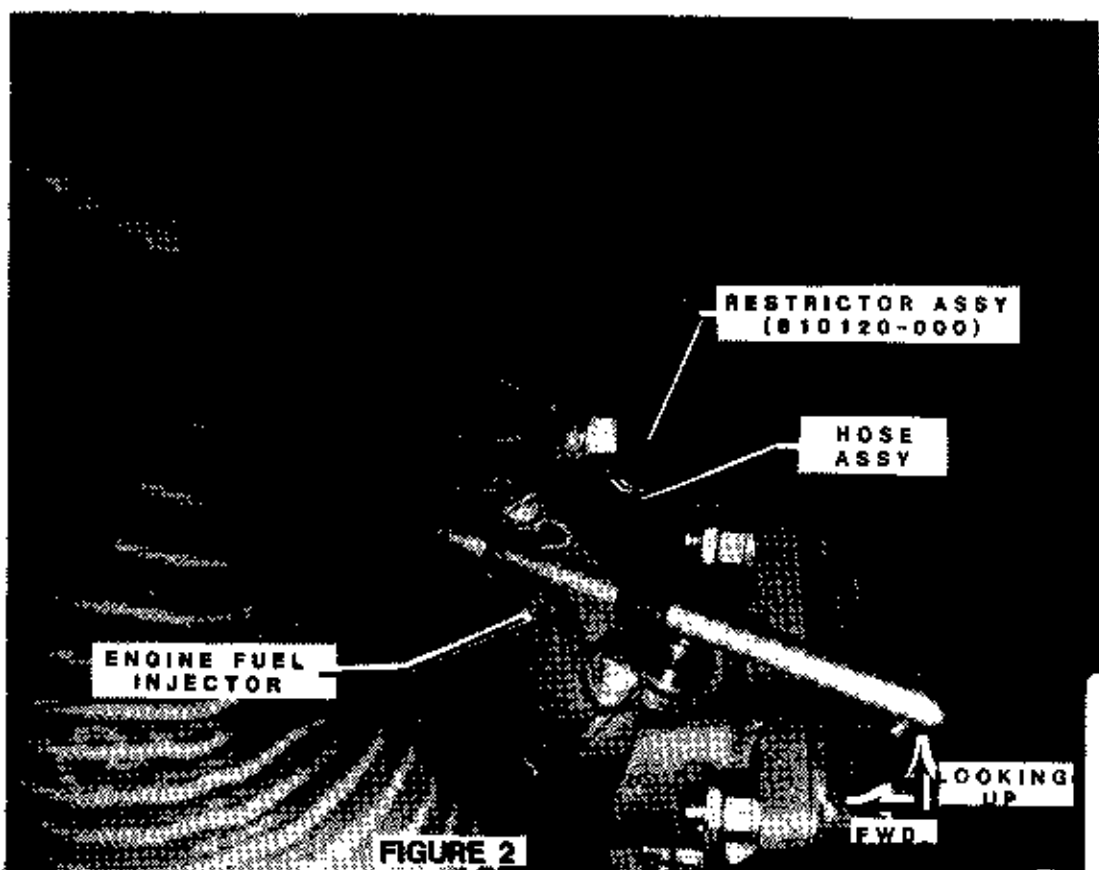
5. Remove existing hose assembly, S94B90145, from restrictor (610120-000) on engine injector; leave restrictor on engine (see Fig. 2). Discard S94B0145 hose assembly.

6. Attach new hose assembly, P/N 600375-27 to MS51503-B3 adapter and transducer, 880007-501. Attach the other end of hose assembly 600375-27 to the restrictor, 610120-000, on engine injector (see Fig. 2).
