# Transmission Tower Foundations Get a New Life in Water

*Dominion Energy applies creative techniques to combat foundation degradation in marine conditions.*

## **Project Scope**

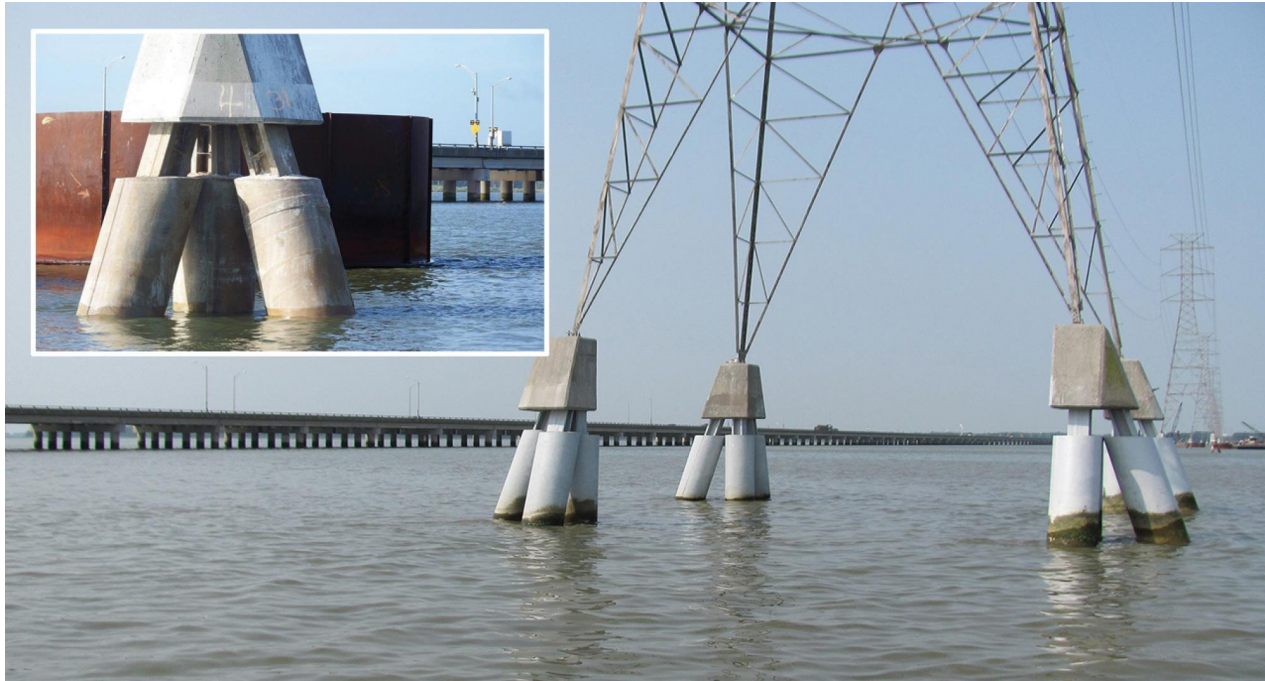
*In the finished upgrade, problem areas are fully encapsulated with corrosion-protection systems from the concrete cap bottom to about 4 ft below the mud line.*

Dominion Energy used components of an encapsulation system developed by Fox Industries/Simpson Strong-Tie but applied them in innovative ways. The encapsulation of the piles from the splash zone to several feet below the mud line consisted of a split-form 36-inch (0.9-m)-diameter ultraviolet-resistant fiberglass jacket with tongue-and-groove connections. The jacket was positioned around the rebar cage and connected with stainless-steel screws. A hose was positioned inside the jacket to tremie in a nonshrink underwater cementitious grout extended with aggregate. This grout mix has special properties and corrosion inhibitors to deal more effectively with marine-type environments.

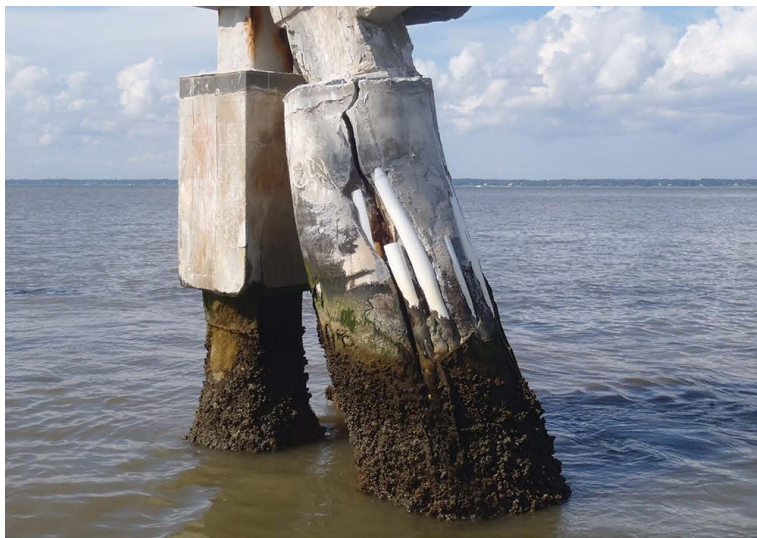
Failed fabric from the encapsulation system, previously installed at one structure location, did not perform well in open water conditions and on battered piles.

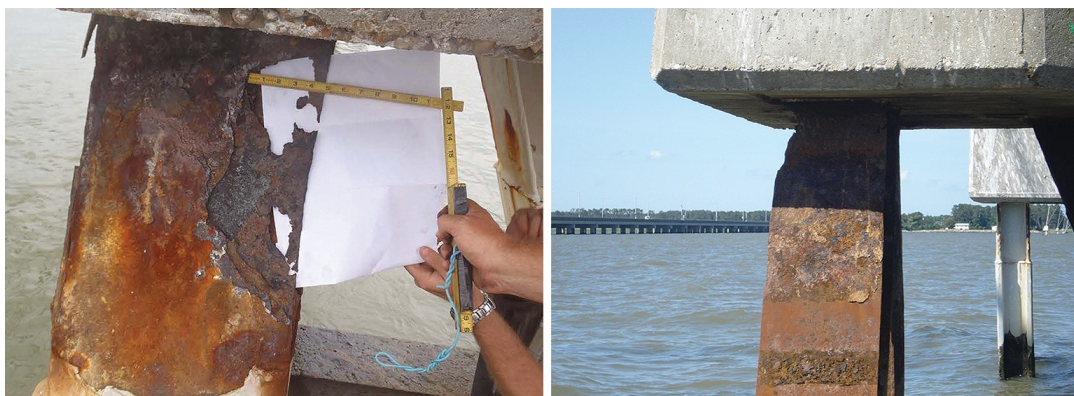
Localized corrosion occurred under cracked splash zone compound areas (left), and abrasive blasting revealed additional negative performance issues with the splash zone compound (right).

In the early 1990s, the utility covered a portion of the H-piles with a fiberglass jacket-epoxy grout encapsulation system to further protect them against the harsh marine environment. A compound also was applied to the remaining section of the H-piles in the splash zone. However, this compound did not provide adequate protection. This resulted in the H-piles corroding at the compound-coated areas and the encapsulation

system jacket ends, causing the epoxy grout to begin de-bonding from the H-piles.

The 2013 inspection showed a significant number of the H-piles in the splash zone had experienced partial to total plate-thickness loss. A structural upgrade of the H-piles was required to prevent foundation failure. The actual extent of the corrosion was not revealed until abrasive blast cleaning of the piles was performed. All foundations at the 18 tower locations were in far worse condition than the report indicated.

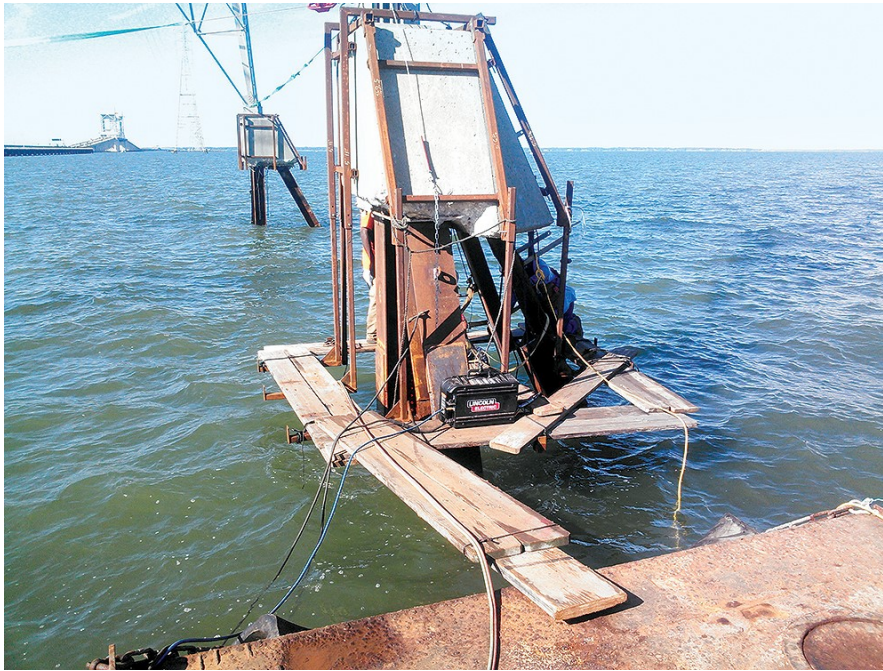
A portion of deteriorated H-pile is removed and a half H-pile replacement section is set into position.

Once it was determined an H-pile had experienced an average thickness loss of 0.125 inches to 0.189 inches (3.2 mm to 4.8 mm), or an average thickness loss of 40% to 45%, the utility deemed it necessary to replace that portion of the H-pile section. The process included six steps:

3. Removing half of the H-pile section that did not satisfy minimum thickness requirements and installing its replacement section

4. Removing the other half of the H-pile section and installing its replacement section

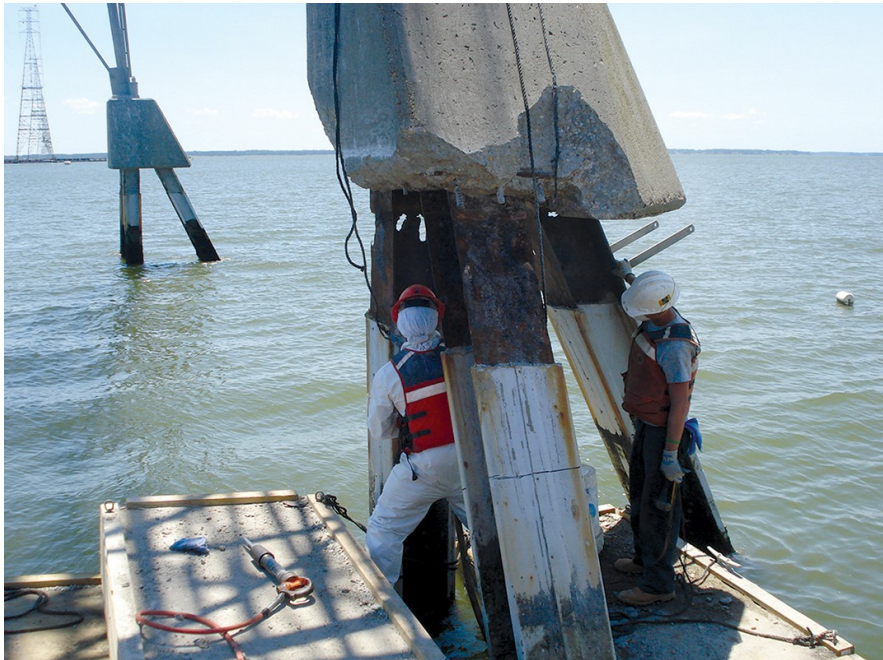
In preparing for H-pile section replacement, workers remove a portion of the concrete cap bottom and cut back portions of the existing encapsulation system.

1. Installing temporary bracing
2. Removing concrete from the cap bottom to perform portions of the

required upgrading and welding work

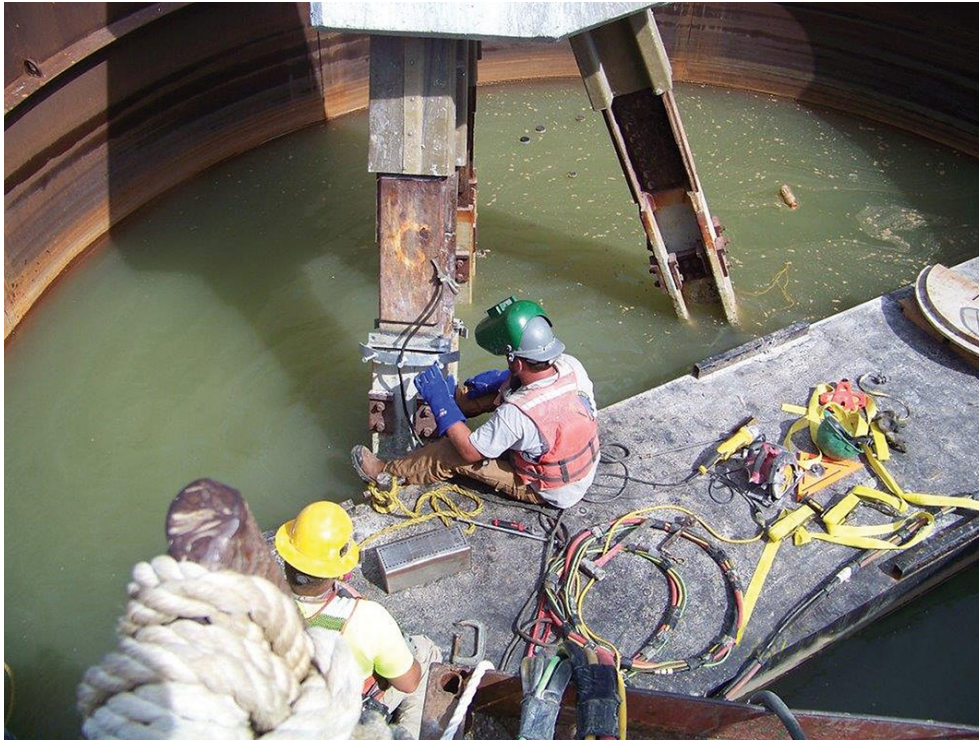
A crews installs the upper shear clips required for pier addition.

To begin the installation, the existing H-piles were cleaned using a high-pressure water jet. The 1991 encapsulations around portions of the existing H-piles were allowed to remain in place. Steel shear clips were installed to ensure adequate transfer of load occurred from the pier addition to a good competent section of the H-pile. A hot-dip galvanized rebar cage then was

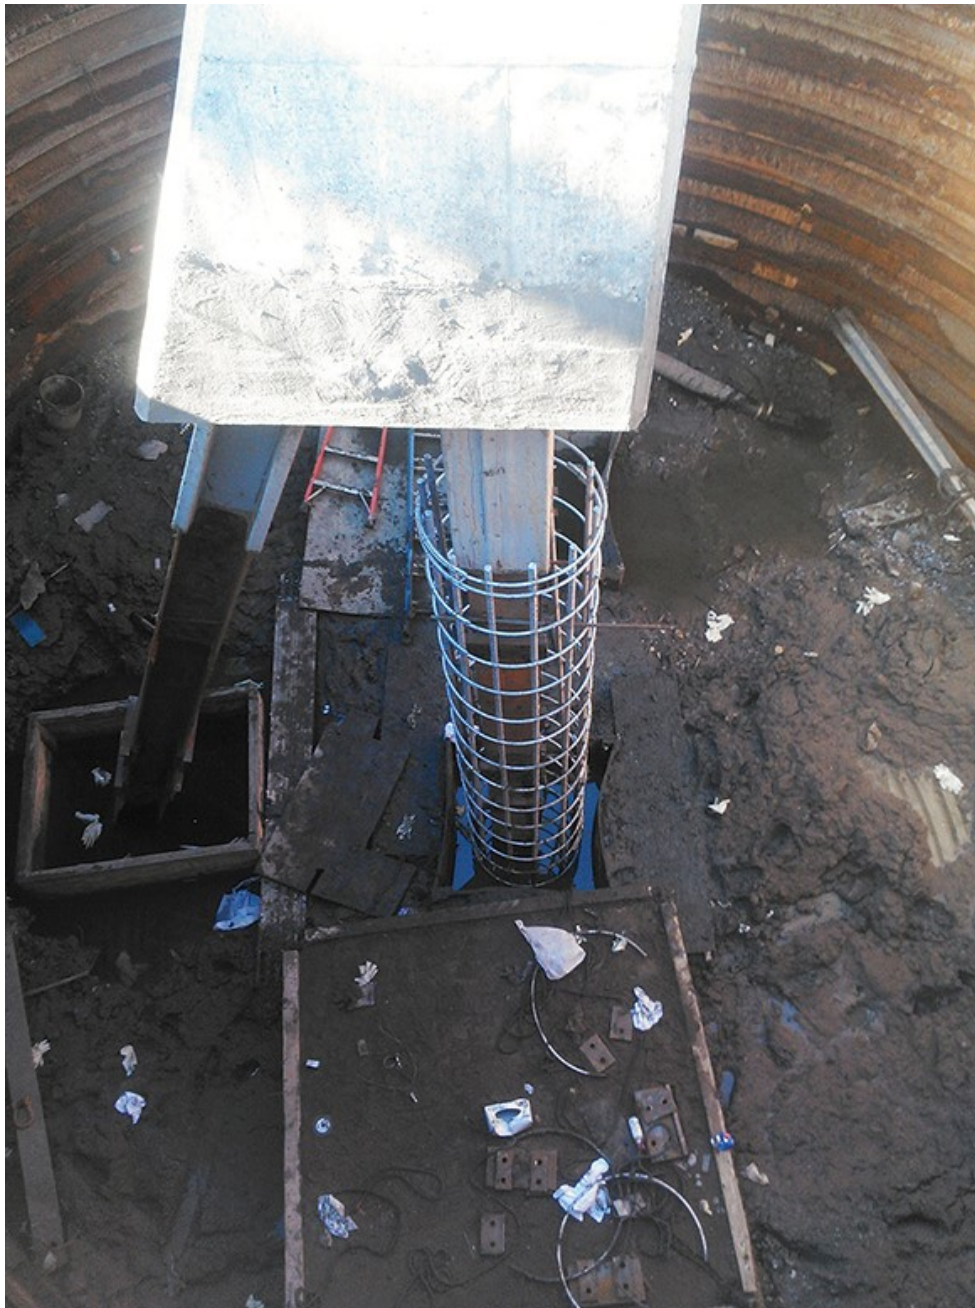
In this view of the pier addition, the rebar cage is in position and ready for jacket installation, followed by grout and concrete placement. It is a good representation of the use of the cofferdam and the advantages of being able to do upgrade work in dry conditions.

The reinforced concrete pier additions also were technically complex. They were designed to encapsulate and structurally transfer load from the upper upgraded H-pile sections to the existing H-pile sections without thickness loss located near the mud line zone.

installed around the existing H-piles.

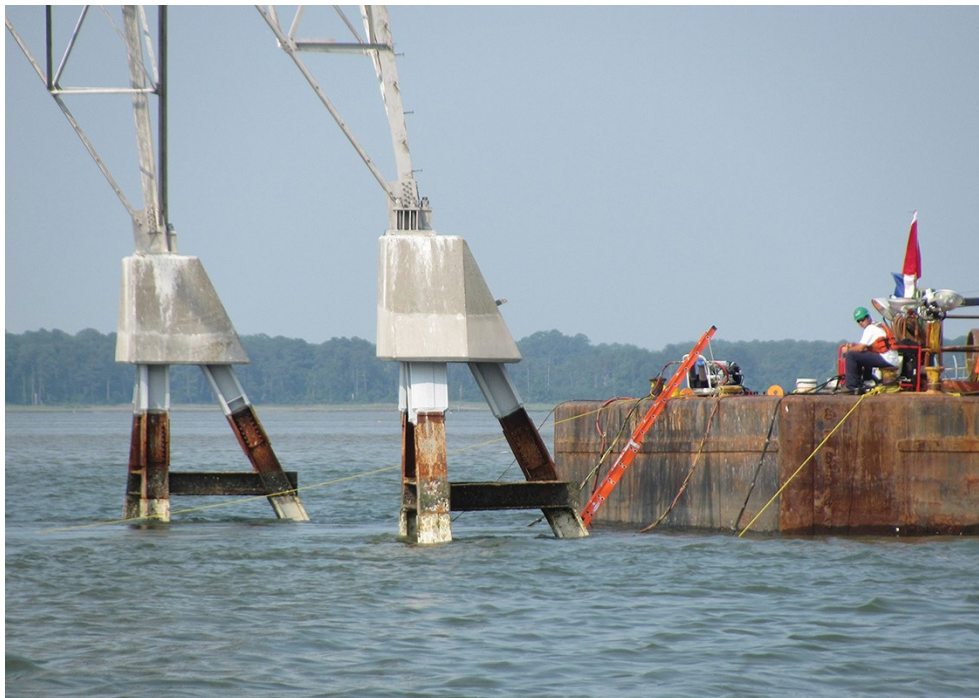
Horizontal braces are used on the H-pile installations on five tower locations in water that ranges from 25 ft to 40 ft deep.

In addition to the engineering work completed in-house for the H-pile section replacements and corrosion protection systems, Dominion Energy engineers also developed a new replacement horizontal brace system, located between H-piles of an individual foundation, that could be encapsulated fully following its installation. In the early 1990s, horizontal steel braces used on foundations at five tower locations in deep water were encapsulated with a reinforced-concrete grout mat that also covered the interior opening between the horizontal braces. This reinforced-concrete grout mat eventually cracked, de-bonded and fell off due to the fluctuation of the tide and movement of the foundation system. The original horizontal brace system, which used open H-pile beam members and connection plate attachments to the vertical and battered piles, was impractical to repair and encapsulate.

The new brace system used rectangular hollow structural sections instead of open shape sections. In addition, the new diagonal horizontal member of this brace system was offset toward the direction of the vertical H-pile. These changes and modifications aided in making possible the encapsulation of the brace system with an epoxy-fiberglass protection system. Although the offset of the new diagonal member places additional

torque load in the battered piles, this is negated by the torsional resistance of the H-piles with the reinforced concrete pier additions.

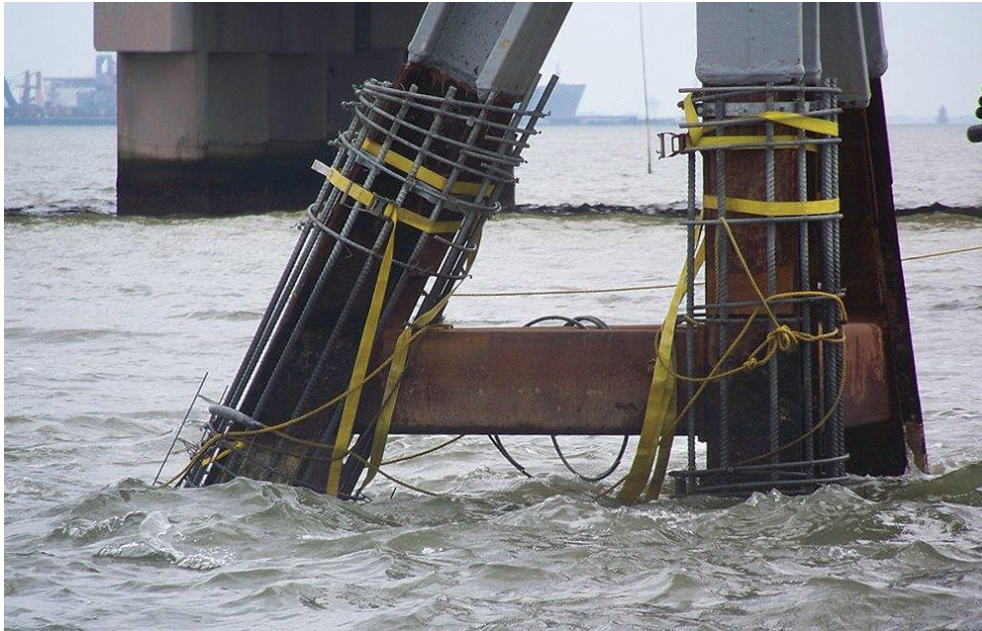
New horizontal braces are installed, and rebar cages are positioned for the concrete pier additions.

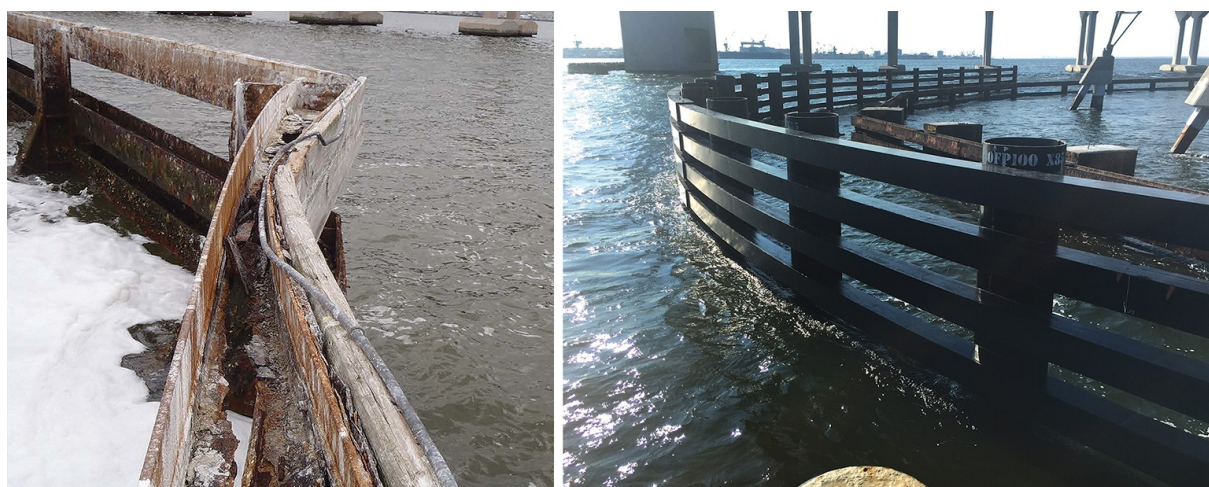
Dominion Energy replaced a fender protection system constructed in 1968 of marine-grade, corrosion-resistant steel H-piles and wales (left) with a new fender system made of fiberglass material.

Energy also replaced a fender protection system constructed in 1968 of marine-grade corrosion-resistant steel H-piles. The fender system was not forgiving when impacted and difficult to repair when struck by a barge or ship.

Many repairs and modifications had been made to the fender system over the years because of excessive corrosion and collision damage. Dominion Energy worked with GAI Consultants Inc. to design a new fender system with two different impact zones, heavy and light. Composite material was used for the round piles and wales that consisted of high-strength directional fiberglass materials and a resin system. Manufactured by Composite Advantage, the FiberPILE material was selected because its structural properties absorb energy better than materials such as reinforced concrete and steel. This composite material also is not susceptible to corrosion.
