## High-voltage Test Report – Cross Arm Insulation (ENI)

ENI Engineering have approached University of Canterbury (UC) for testing services to ascertain the insulating properties of a new insulation system (as shown in Fig. 1) for steel cross arms for use in electrical distribution networks. UC performed the following HV tests on 24/07/2018.

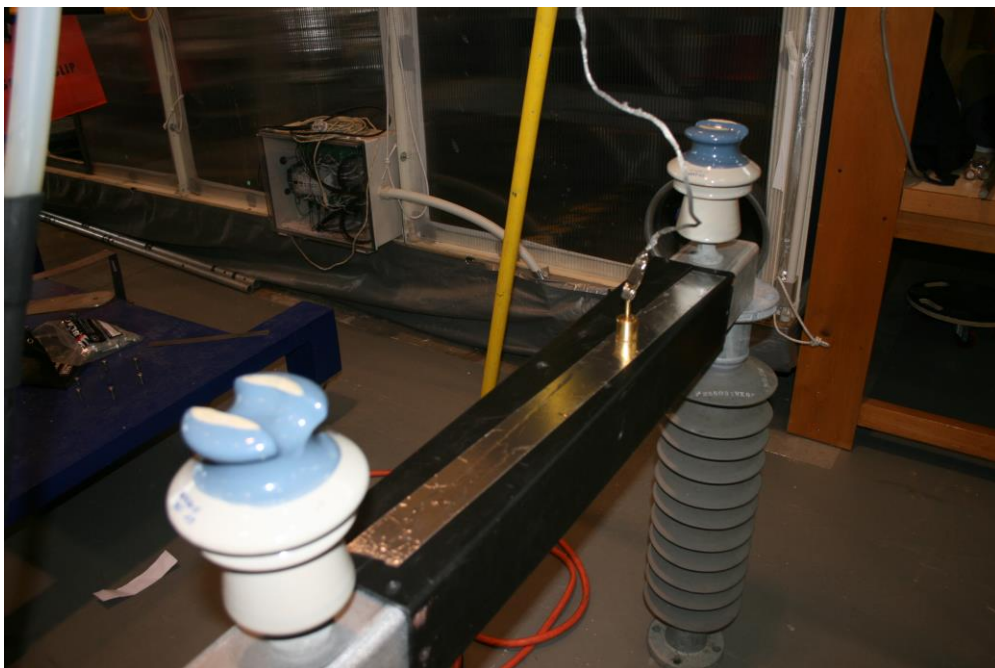
Fig.3 Set-up during the measurement of dielectric losses and capacitance of the insulation

The measurement of the dielectric losses and capacitance of the insulation was conducted at 10kV ac with a frequency of 50Hz. A length of aluminium tape, as shown in Fig. 3, was attached to the surface of the sample to increase the surface area of the electrode, increasing the capacitance to be measured into the range of the measurement equipment (Megger Delta 4300 was used for this measurement). The ac voltage was applied at the rate of 1 kV/s. The measurement results under different voltages between 2kV and 10kV have been plotted in Fig. 4. Both the dielectric loss and the capacitance increases with the applied voltage. The higher the voltage is, the greater the increase rate of both parameters is.

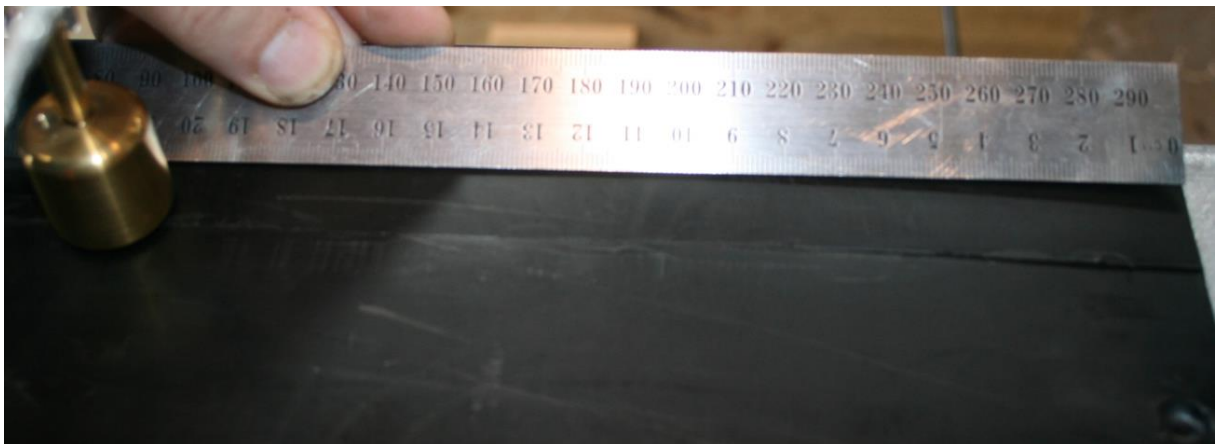
(a) 100 mm

(b) 150 mm

(c) 200 mm

Fig.6 Position of the HV electrode during each group of test

The surface flashover voltage was measured at a horizontal distance of 100mm, 150mm and 200mm to ground, as shown in Fig. 6, for dry, wet and wet with a salt solution (1g/L NaCl) cases. The actual shortest horizontal creepage distance (including the thickness of sample) is 105 mm, 155 mm and 205 mm for the three groups of test, respectively. The applied voltage was increased at approximately 1 kV/s until flashover. Five flashover tests were performed at each distance and surface condition. The dry tests were conducted first and then the wet tests, and finally the test with the salt solution. Both dry test and wet test were conducted at the same end of the sample, whereas the test with the salt solution was conducted at the other end of the sample.

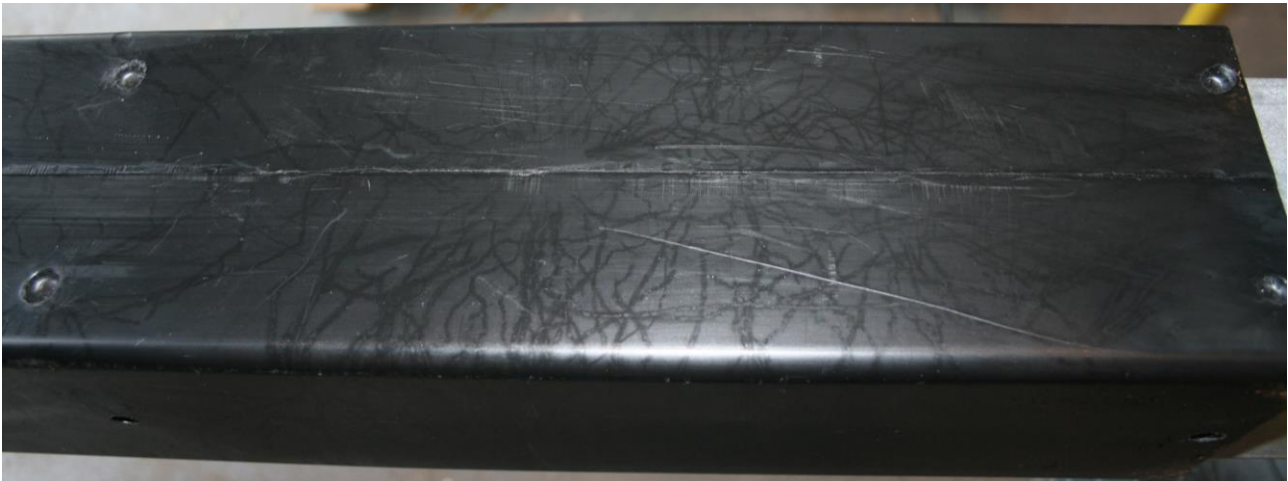
Fig.11 Clear trace of treeing after the wipe of water on the sample's surface

An interesting phenomenon was observed after the wet test. Clear trace of treeing could be seen after the wipe of water on the sample's surface, as shown in Fig. 10. This is because of the damaged surface during the flashover, which would affect the surface roughness. The difference of surface roughness results in the clear trace of damaged surface.
