Project Case Study - California Mall

Project Type: Large, Multi Tenant Shopping Mall
Location: California, USA
Sprinkler Systems: 1,400,000 sq. ft. of coverage area
 54 wet pipe risers, average size
 1,000 - 1,500 gallons
Nitrogen Introduced: September, 2016

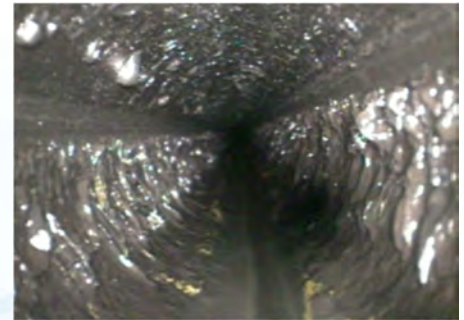
Oxygen Corrosion in Branch Line

The root cause for corrosion within the systems was oxygen attack of the black steel piping. The majority of leaks have occurred at the air/water interface in the branch line piping over the tenant spaces. The unique characteristics of mall operations result in frequent tenant space modifications and build-outs. The high frequency of system draining events causes frequent introduction of fresh air into the system piping, resulting in extremely high localized corrosion rates.

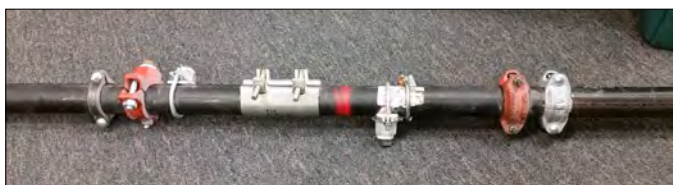
Multiple Leak Repairs on a Single Branch Line

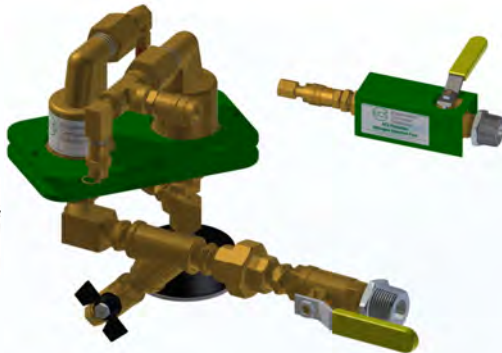
ECS Nitrogen Inerting Vent

1. A high capacity ECS Nitrogen Generator, gas storage tank, and 1¼" nitrogen supply line to provide a permanent, on-demand source of nitrogen gas to each of the 8 sprinkler riser rooms
2. ECS Nitrogen Inerting Manifolds installed in each riser room to easily distribute nitrogen to each wet pipe sprinkler riser
3. ECS Protector Nitrogen Injection Ports on each of the wet pipe sprinkler risers
4. ECS Protector Nitrogen Inerting Vents on each of the wet pipe sprinkler systems

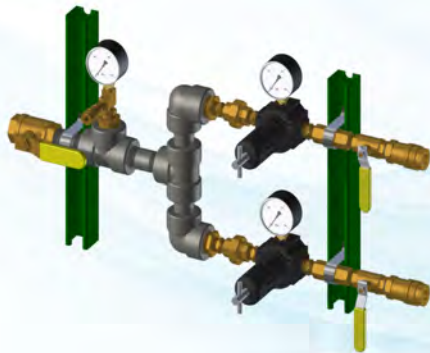
ECS Nitrogen Inerting Manifold

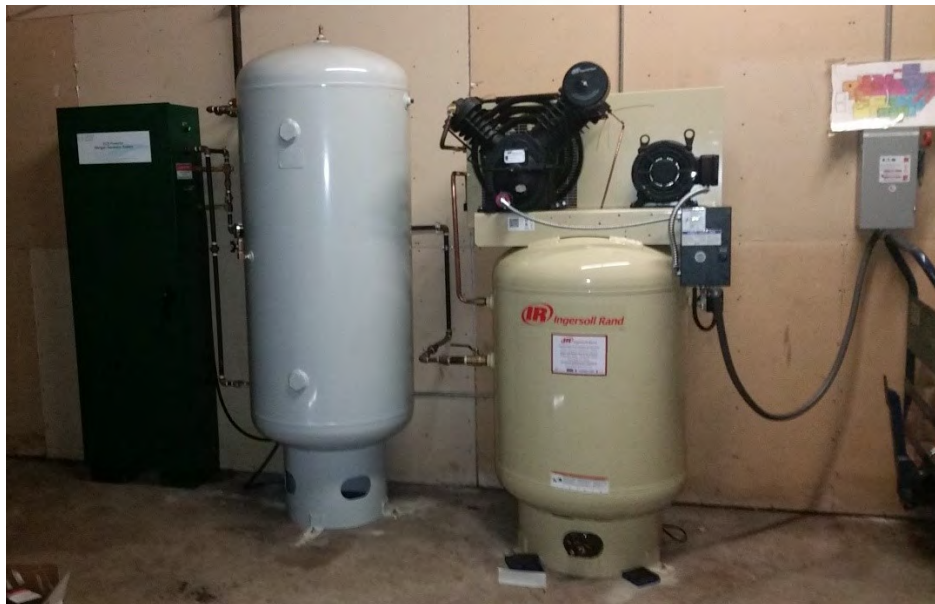
ECS Nitrogen Generator, storage tank, and air compressor feeding nitrogen supply
