Project Case Study - Florida Regional Mall

Project Type: Large Warehouse Facility
Location: Florida, USA
Sprinkler Systems: 1.19 million sq. ft. of gross leasable space, 36 wet pipe fire sprinkler systems
Nitrogen Introduced: December, 2012

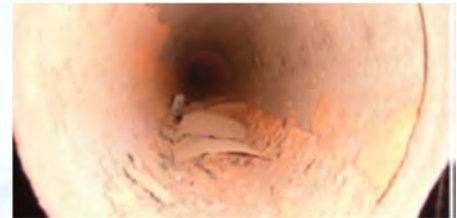
Iron Oxide Deposits on Bottom of Main

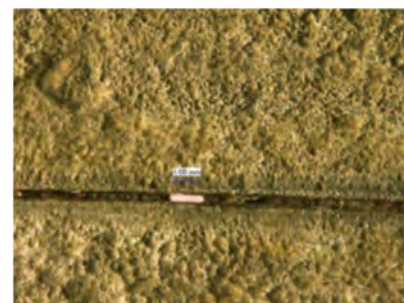
Weld Seam Corrosion Leak

Based on the history of leaks occurring in the facility, Engineered Corrosion Solutions was contracted to identify the root cause of the corrosion and develop a corrosion control strategy to prevent future leaks. The conclusion was that trapped air in the high points of the mains and branch lines resulted in oxygen corrosion of the piping. Oxygen corrosion resulted in the formation of iron oxide deposits in the system piping, further accelerating the metal loss and resulting in additional leaks. The recommended method of preventing additional metal loss and leaks was to remove oxygen from the sprinkler system by using nitrogen gas to inert the piping.

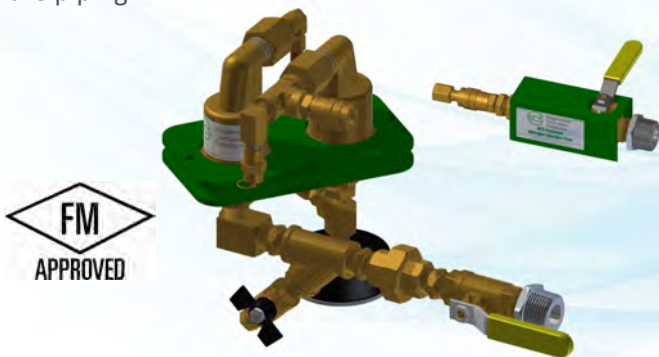
ECS Nitrogen Inerting Vent

- No significant pipe replacement was performed, existing leaks were addressed
- Installation of ECS Protector Nitrogen Inerting Vents on each of the 36 wet pipe systems
- Installation of ECS Protector Nitrogen Injection Ports on each of the 36 wet pipe risers
- Performed WPNI on all of the fire sprinkler systems using the ECS nitrogen inerting protocol for wet pipe fire sprinkler systems
- Maintained inert state during subsequent drains and refills of the systems following specific ECS protocols

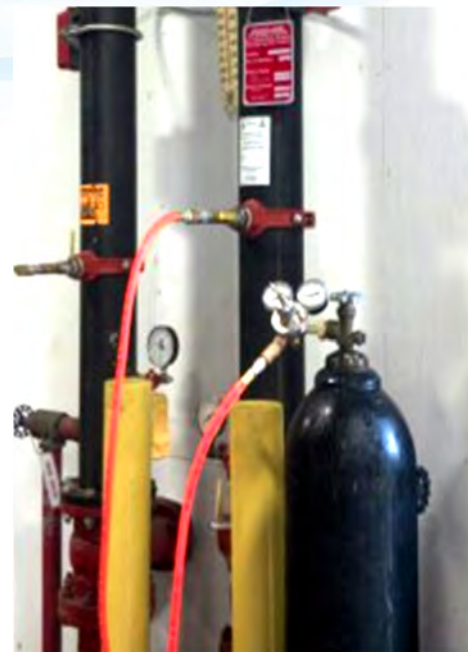
Pressurized Cylinders Provide Nitrogen Gas
