**CORROSION IN AUTOMATIC SPRINKLER SYSTEMS**

This data sheet provides recommendations that are intended to address the prevention and control of corrosion in automatic sprinkler system piping.

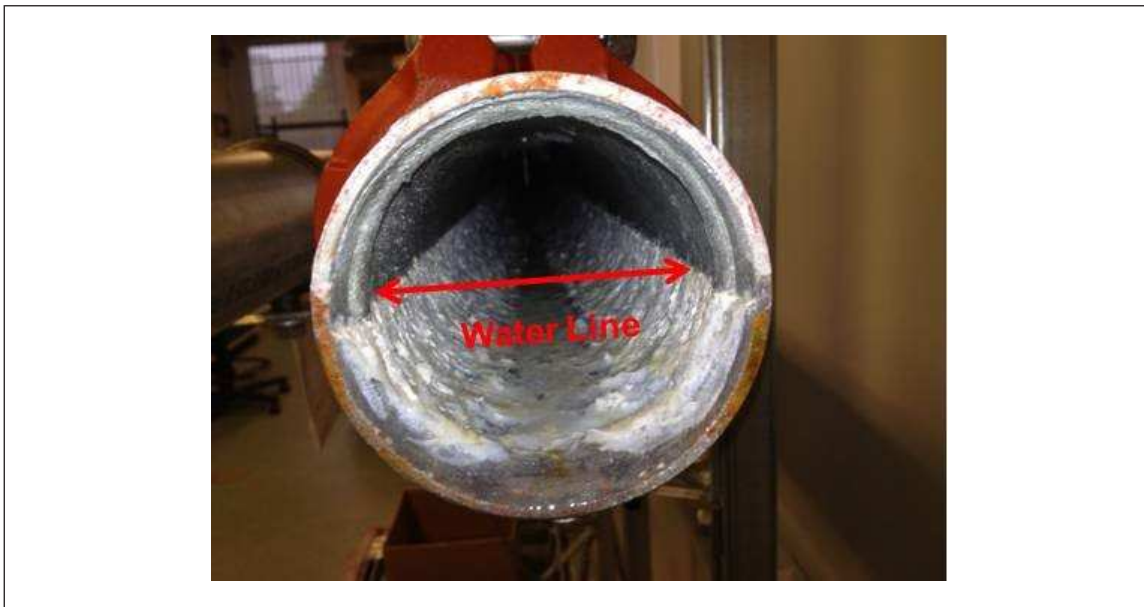
Figures 4a and 4b are photographs of galvanized steel pipe half-filled with tap water in house air (4a) and in compressed nitrogen (4b) after nearly six weeks' exposure. Whitish zinc corrosion products covered the bottom half of the house air-filled pipe in Figure 4a, but only limited zinc corrosion products covered the bottom half of the compressed nitrogen-filled pipe (Figure 4b). This result indicates that compressed nitrogen can reduce corrosion of galvanized steel pipe containing trapped water.

Fig. 4a. Galvanized steel pipe half-filled with tap water in house air after nearly six weeks' exposure

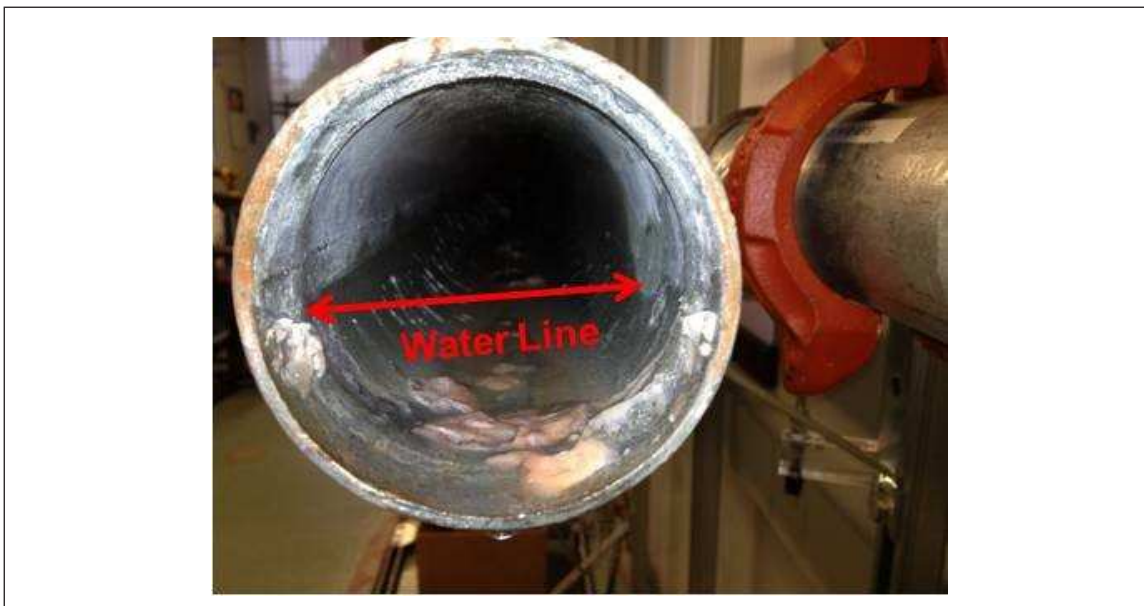
Fig. 4b. Galvanized steel pipe half-filled with compressed nitrogen after nearly six weeks' exposure

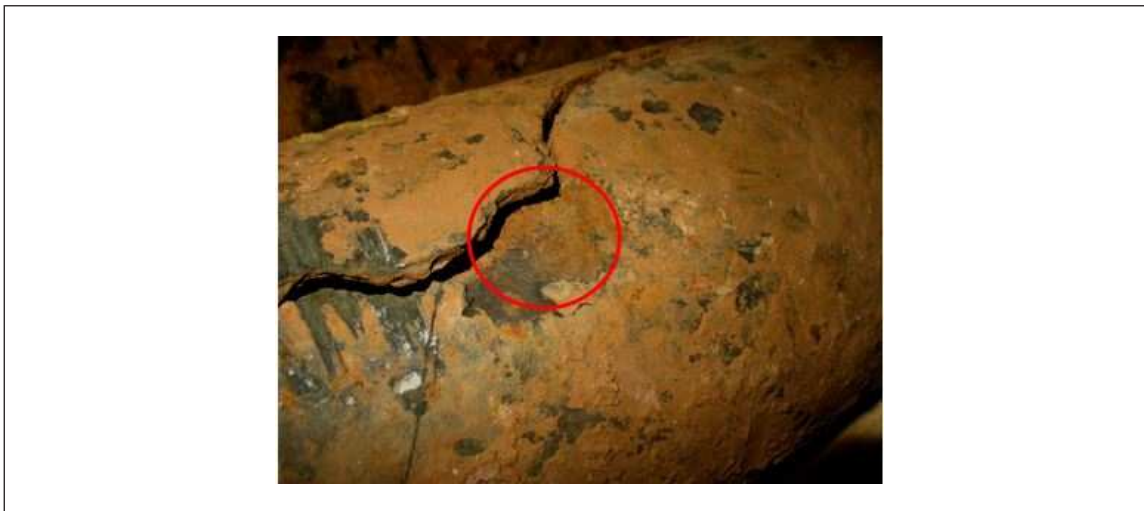
Figure 7 shows a ruptured underground water main (identified as gray cast iron, 8 in. [20.3 cm] diameter) with cement lining on its inside diameter. The circled area in Figure 7 shows graphitic corrosion on the outside

surface of the main due to its exposure to mildly aggressive groundwater and soils. Generally, high moisture content in the surrounding soil is required for graphitic corrosion to occur.

Fig. 7. Ruptured underground water main (identified as gray cast iron, 8 in. [20.3 cm] diameter) with cement lining on its inside diameter

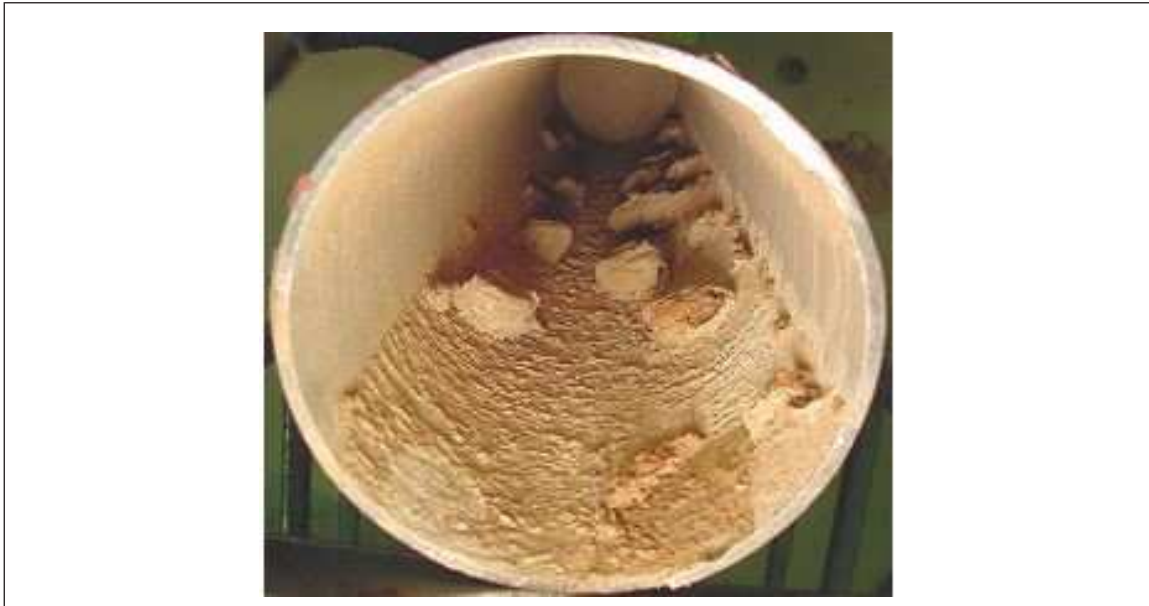
Figure 9a shows tubercles and and Figure 9b shows pinhole leakage (circled) in galvanized steel sprinkler pipe from dry-pipe systems.

Fig. 9a. Tubercles that formed inside a galvanized steel sprinkler pipe (4 in. [10 cm] diameter)

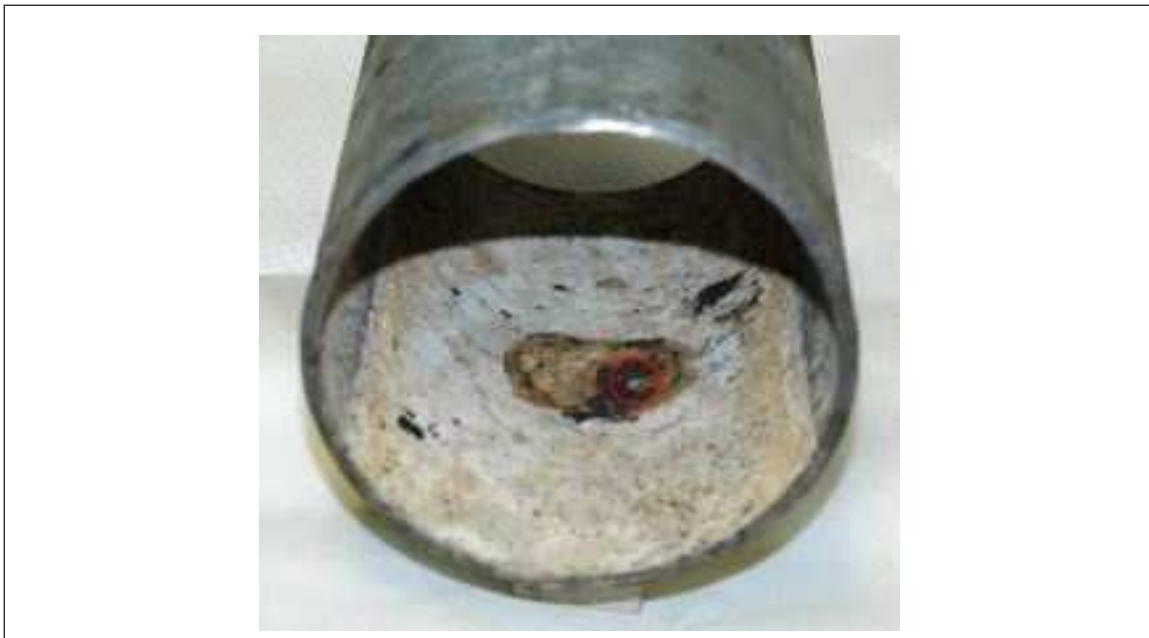
Fig. 9b. Corrosion at the base of a tubercle, which ultimately led to through-wall leakage

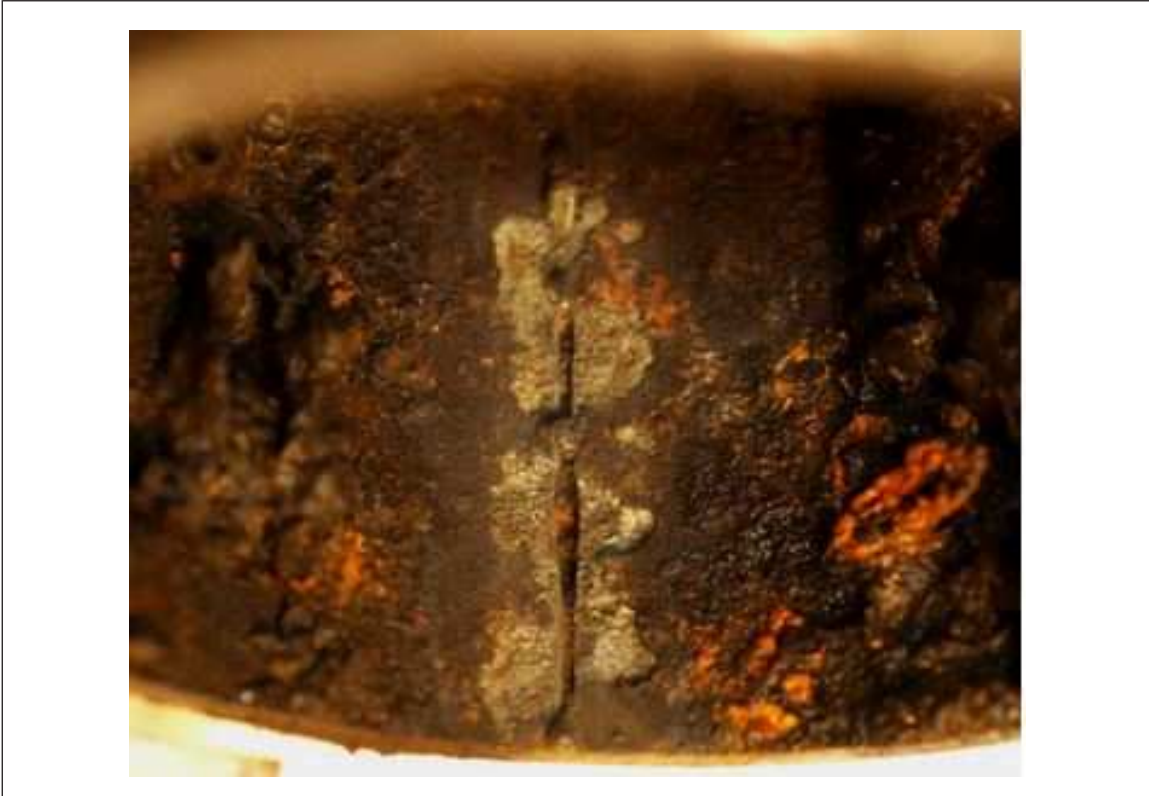
Figure 11b shows the waterside of the pipe in the region corresponding to the leakage site, after removal of corrosion products. Preferential attack surrounding the weld seam is severe.

Fig. 11b. Leakage on an NPS 2½ steel sprinkler pipe in a wet pipe system after removal of corrosion products; preferential attack surrounding the weld seam is severe

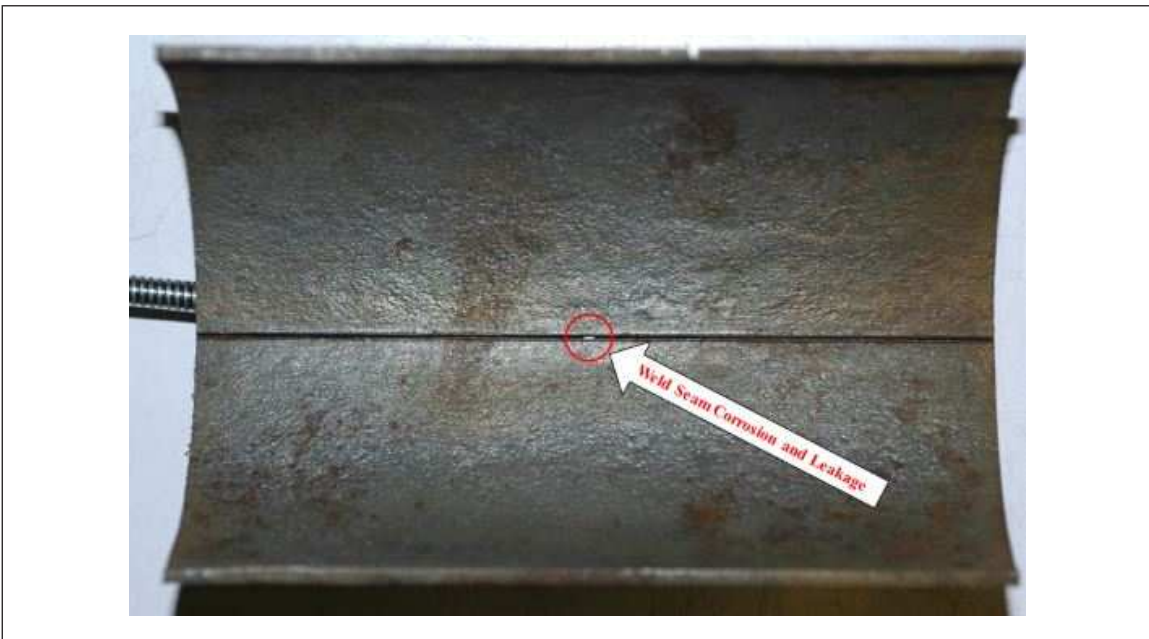
Figure 12 shows an example of preferential grooving corrosion on a pipe weld seam with a .04 in. (1 mm) pinhole leak in a wet-pipe system, after removing corrosion products inside an NPS 3 pipe.

Fig. 12. Preferential grooving corrosion on a pipe weld seam with a .04 in. (1 mm) pinhole leak in a wet pipe system, after removing corrosion products inside an NPS 3 pipe

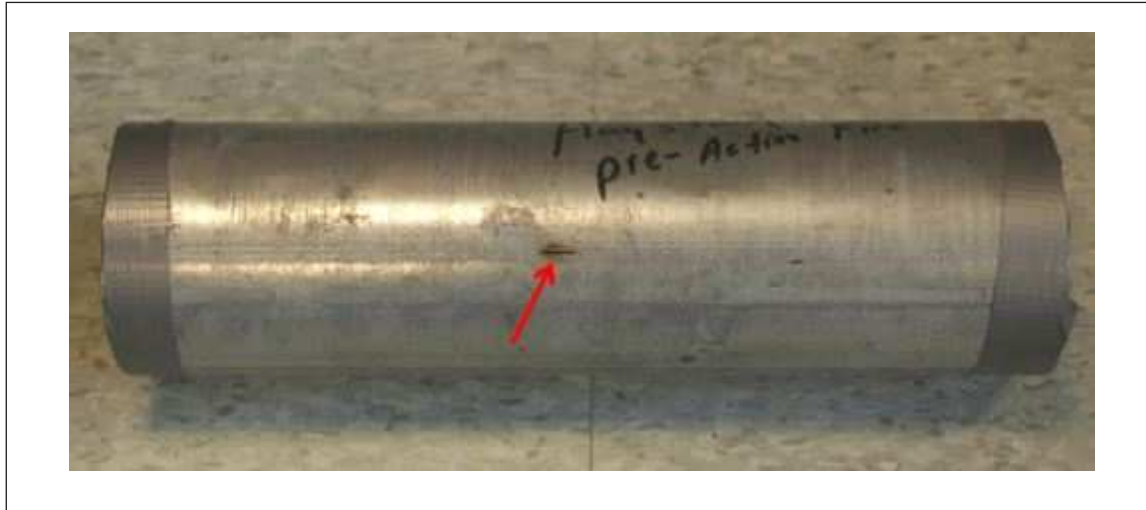
Figure 13 shows grooving corrosion of a longitudinal through-wall leakage in a galvanized steel pipe along its weld seam in a preaction system. The leak occurred beneath a large tubercle along the pipe's approximate 6 o'clock installed position. The arrow points a longitudinal through-wall leakage site on the pipe.

Fig. 13. Grooving corrosion of a longitudinal through-wall leakage in a galvanized steel pipe along its weld seam in a preaction

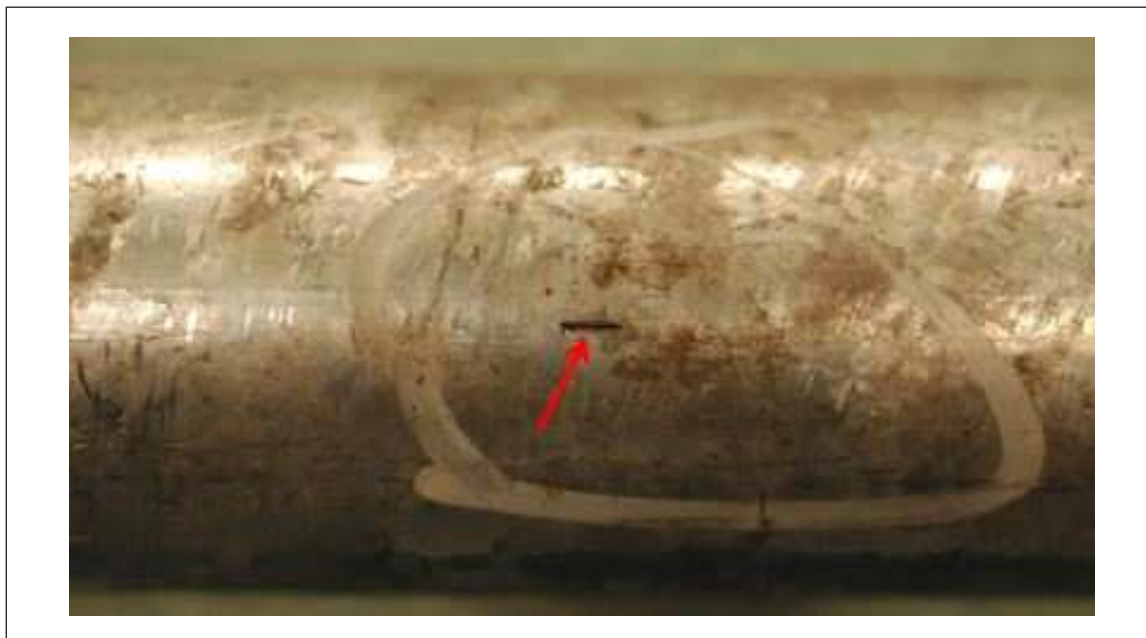
Figure 14 shows another preferential grooving corrosion attack surrounding the weld seam area for a preaction system, near the pipe's 6 o'clock (bottom) installed position.

Fig. 14. Preferential grooving corrosion attack surrounding the weld seam area for a preaction system, near the pipe's 6 o'clock (bottom) installed position

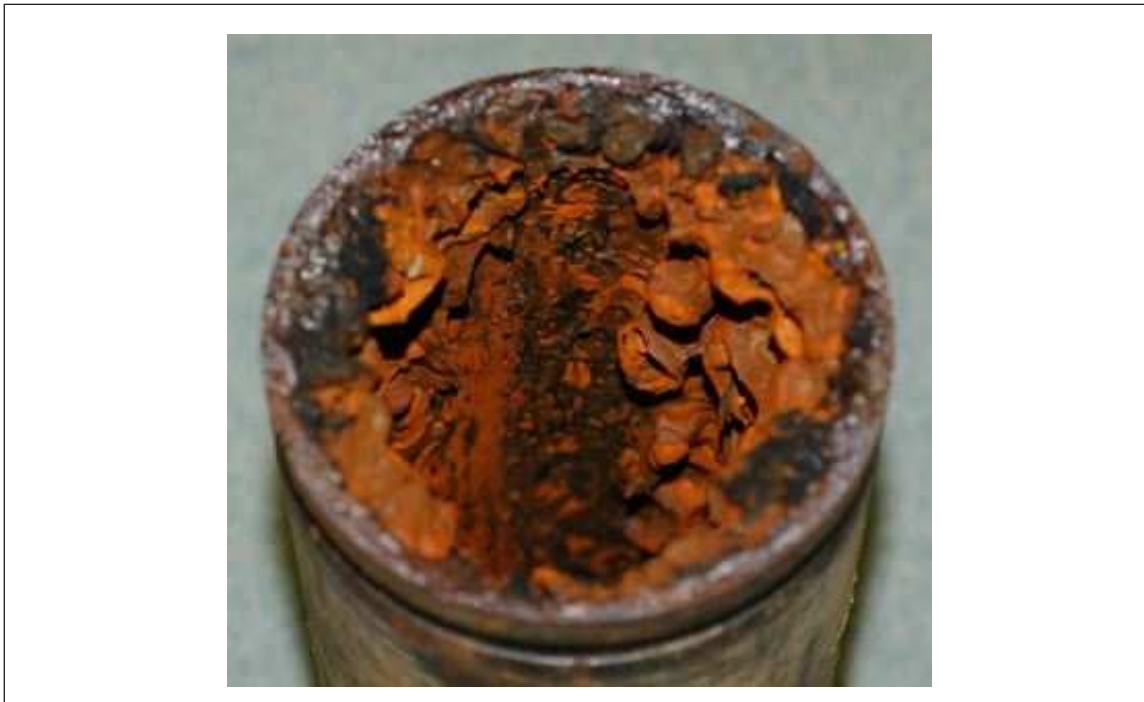
Figure 15 is an example of a 4 in. (10 cm) diameter corroded/leaking steel pipe with many tubercles formed inside the pipe. MIC caused by SRB was identified to be a likely contributing factor to the corrosion based on testing results of SRB immunoassay, lead acetate sulfide tests, water chemistry analyses, and corrosion/metallurgical evidence.

*Fig. 15. Corroded steel pipe with many tubercles inside*
