White Paper

Fire Sprinkler Riser Corrosion (May 2014)

By Jeffrey T. Kochelek

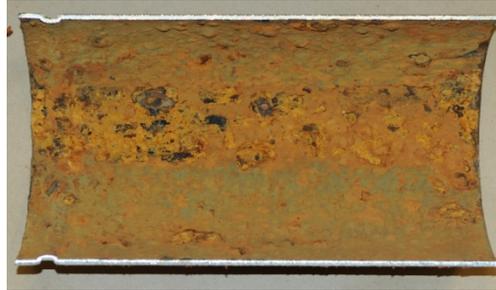
Oxygen Corrosion of Black Steel Piping in the Supply Main

Oxygen corrosion is very common in the piping on the discharge side of the fire pumps. Although the exact location and mechanism for oxygen ingress has not as yet been determined, failed pipe analysis of the fire water delivery piping downstream of the fire pump discharge provides conclusive evidence that oxygen gas is entering the fire water supply lines. Examples of oxygen corrosion have been found in the fire water piping downstream of the pump, in the riser piping below the control valve and in the piping between the control valve and the riser check.

Underground fire water loops that employ ductile iron cement coated piping do not exhibit oxygen corrosion on the internal surfaces of the piping. The cement lining generally prevents oxygen attack of the underlying black steel. Failures in ductile iron cement coated underground piping are most commonly due to external corrosion. When standard black steel piping is employed as part of the fire water delivery system, oxygen corrosion on the interior surfaces is very common.

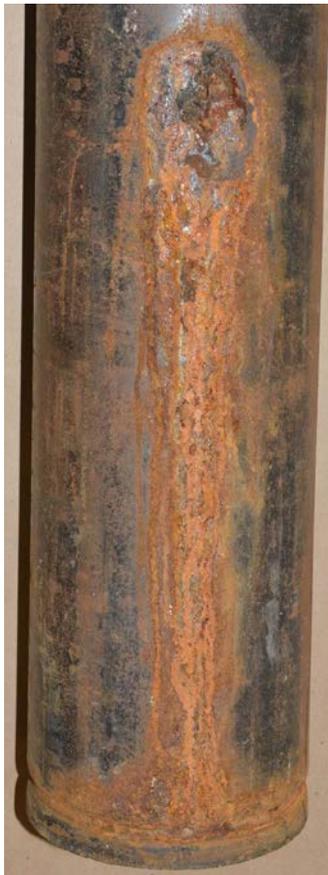
Oxygen Corrosion of Riser Piping (external view at pinhole leak)

4. **Under-Deposit Oxygen Acceleration** – as the corrosion by-product builds on the vertical walls of the pipe the corrosion rate accelerates. The net effect is a continuous build-up of corrosion debris on the sidewalls of the pipe until a pinhole leak occurs.
5. **Weld Seam Corrosion** – the weld seam in the vertical piping is vulnerable to oxygen corrosion attack. Piping that is used in fire sprinkler systems is not heat annealed and as such is subject to weld seam attack as evidenced in the pictures of the metal loss on the piping.

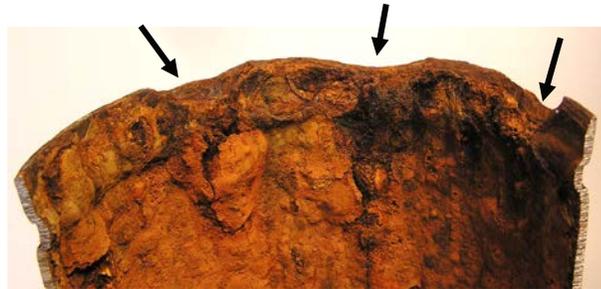
Oxygen Depleted Zone at Rolled Groove of Riser Piping

3. **Oxygen Depletion Corrosion** – the oxygen depleted zone in the small gap at the middle of the rolled groove connection shows evidence of oxygen corrosion. When the pipe ends become anodic, they become “hot spots” for rapid acceleration of the metal loss.

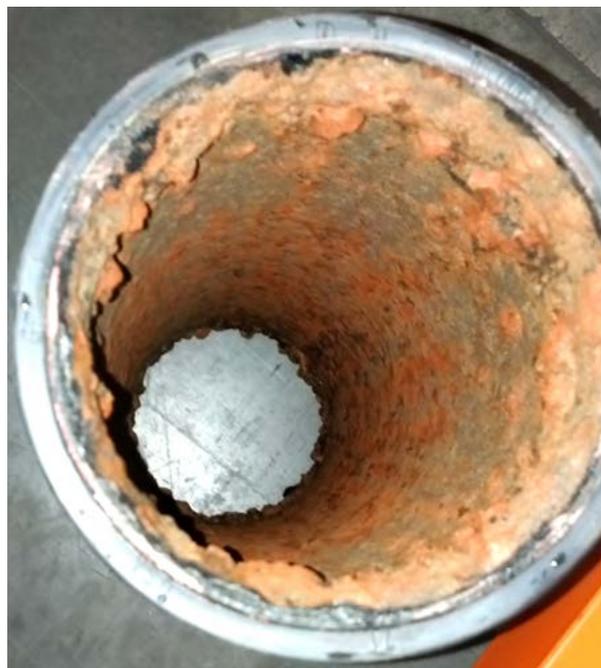
Oxygen Corrosion of Riser Piping

1. **Corrosion is Oriented Vertically** – the pattern associated with the corrosion by-product deposits and the actual metal loss indicate that the entire piece of pipe is filled with trapped air. If there were an air/water interface within the pipe section the corrosion would appear as a “ring” of corrosion at the air water interface. The physical evidence from the pipe samples indicates that the corrosion is longitudinal along the vertical axis of the pipe.

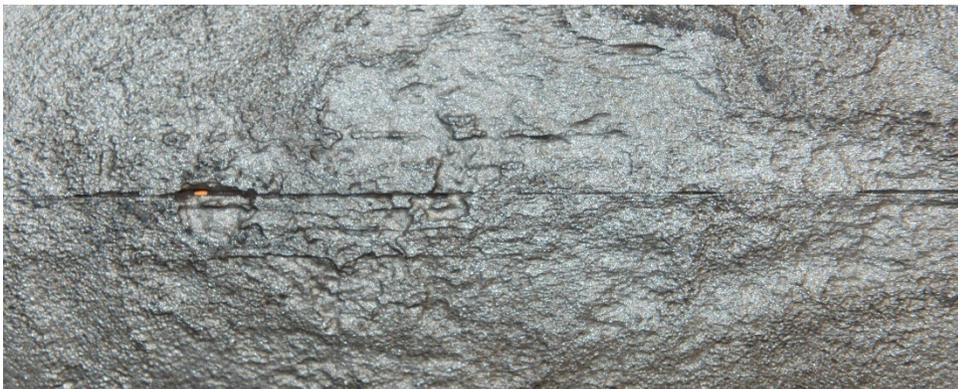
Oxygen Corrosion of Riser Piping with pinhole leak at weld seam (external view)

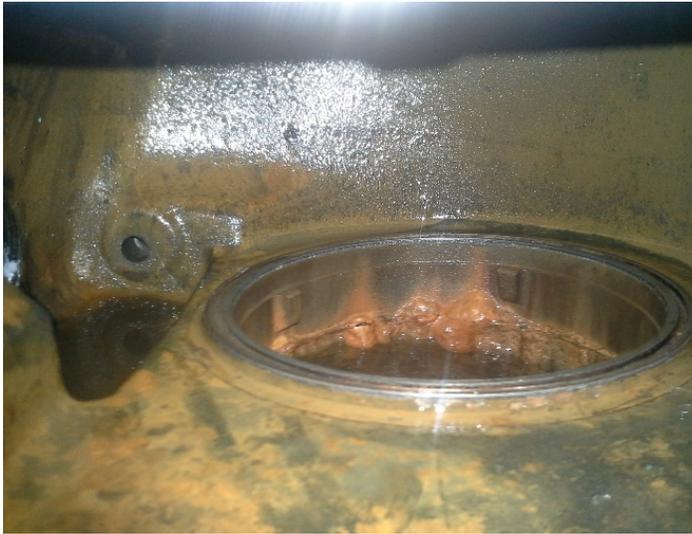
Riser Check Valve Housing
Note Corrosion Below Clapper

The pictures below show two aspects of oxygen corrosion in the riser assembly. First it is evident that the check valve housing does not exhibit evidence of oxygen corrosion attack. This is because there is not trapped air on the top side of the check valve. The check valve housing and the piping above the check valve are fluid packed. Second, it is clear that oxygen corrosion tubercles have formed at the top point of the piping just below the riser check valve. If the check valve stays closed, the air accumulates just below the riser check where it can continuously provide oxygen for the corrosion process.

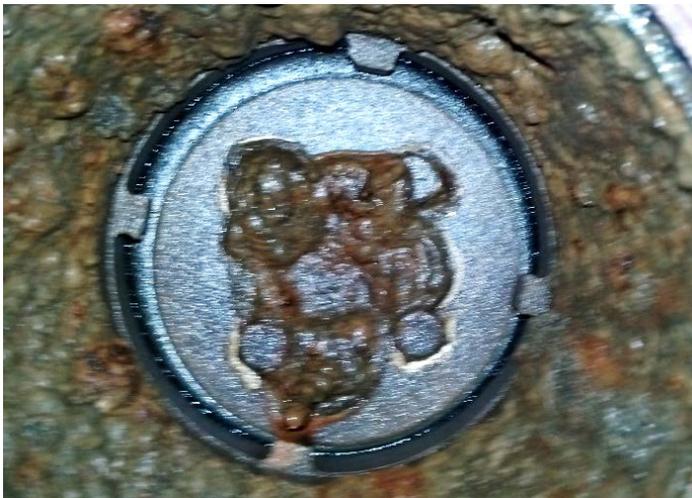
Condensate Corrosion on Underside of Clapper

2. **Evidence of Evaporation/Condensation** – the underside of the check valve indicates that water is condensing and “dripping” off of the clapper (see picture). In this process water evaporates from the pool at the bottom of the pipe and rises up to re-condense at the top of the pipe and on the underside of the closed check valve clapper. Water drips off of the clapper and runs down the sides of the pipe. As the liquid condensate water runs down the pipe dissolved oxygen from the trapped air reacts with the sidewalls of the pipe.
