# White Paper

Weld Seam Corrosion of Fire Sprinkler Piping  
(February 2015)

By Gerard J. van Moorsel

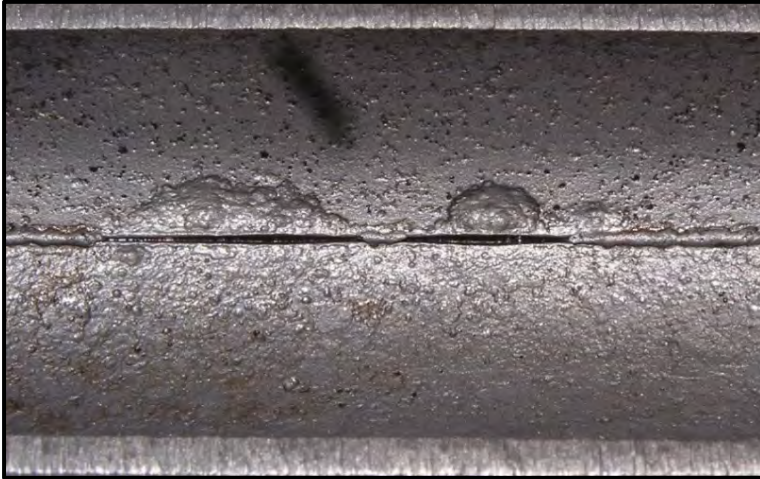
**Figure 3. Knife-Cut Corrosion of 1" Black Steel Branch Line**

In the case of *Figure 3*, the weld metal was completely removed resulting in a pin-hole leak, with additional significant metal loss in the adjacent HAZ.

Weld seam corrosion will occur in any location where non-heat treated pipe is exposed to a corrosive environment. Examples are plentiful in all type systems, including wet, dry, preaction, and deluge. Further, evidence of weld seam corrosion is found in every area of these systems including the bulk supply lines, the system risers, feed mains, and branch lines. In every case the preferential corrosion of the metal at the weld seam and HAZ resulted in the characteristic metal loss typical of weld seam corrosion.

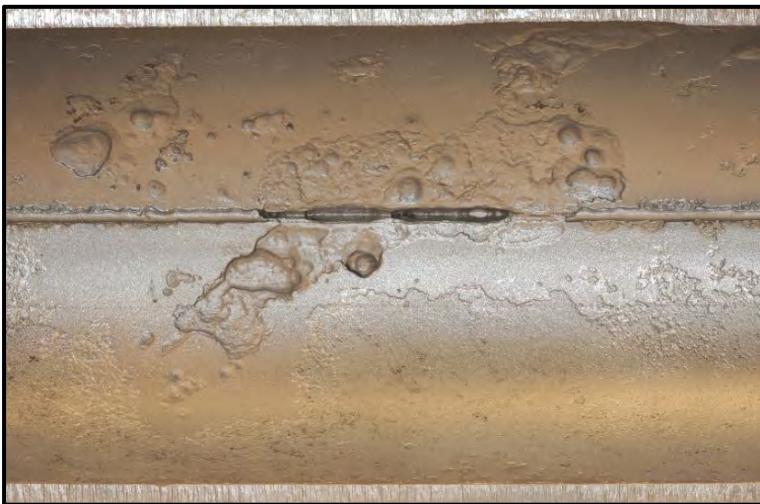
**Figure 4. Weld Seam Corrosion of 4" Galvanized Main**

As seen in *Figure 4*, weld seam corrosion is not isolated to black steel pipe. Once the zinc layer of galvanized pipe is removed, aggressive metal loss occurs at the weld seam.

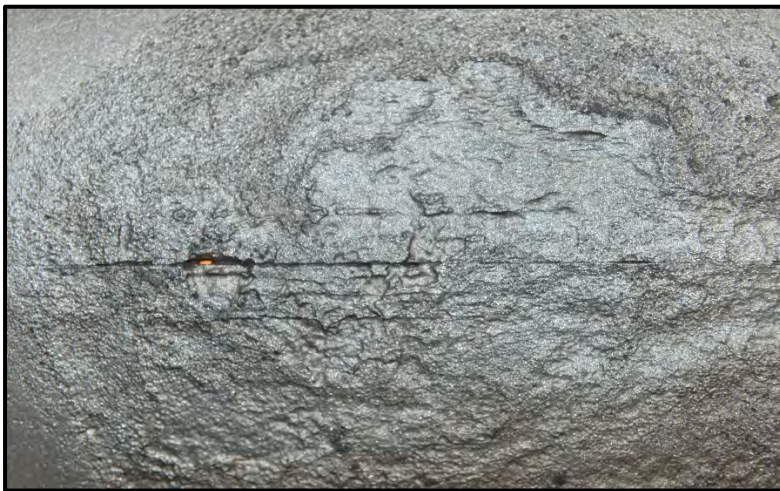
The water released from the leak wetted the external surface of the pipe which led to additional metal loss on the exterior of the pipe wall, including knife cut corrosion at the weld seam.

**Figure 6. External Corrosion Resulting from Leak, with additional Metal Loss at Weld**

Preferential loss of the weld metal can occur from both internal and external corrosion. As seen in *Figure 5* and *Figure 6*, internal corrosion at the weld seam resulted in a leak which in turn caused significant corrosion to occur on the external surface of the pipe.

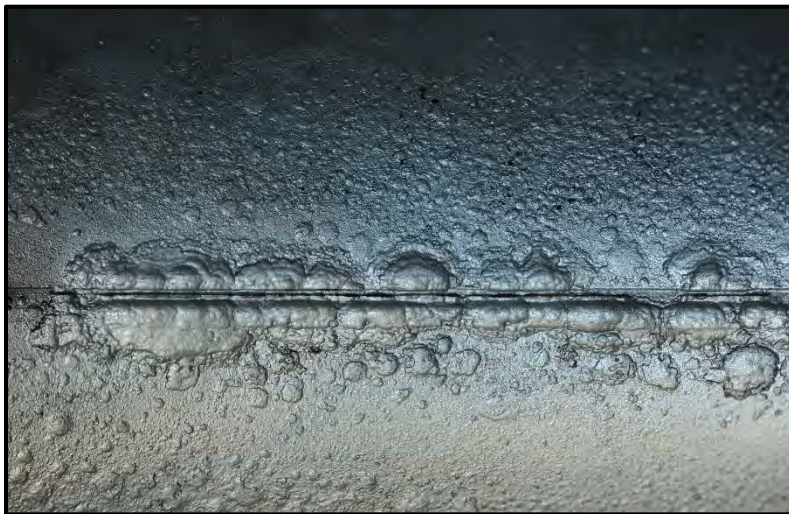
***Figure 7. Severe Metal Loss in the HAZ resulting from Under-Deposit Corrosion (Vertical Riser Pipe)***

Oxygen corrosion can be further accelerated when any adherent deposits are present, including accumulations of iron oxide by-product solids from the corrosion process itself and biofilms formed by bacteria in the system. Under-deposit corrosion occurs when the water beneath a deposit becomes oxygen deficient with respect to the bulk water in the pipe, resulting in the formation of an oxygen concentration cell. The metal beneath the deposit becomes anodic and will corrode preferentially. If the weld seam and HAZ are located beneath the deposits, the potential for corrosion is even greater.<sup>[4]</sup>
