# **CASE STUDY:**

# **Steel Manufacturing**

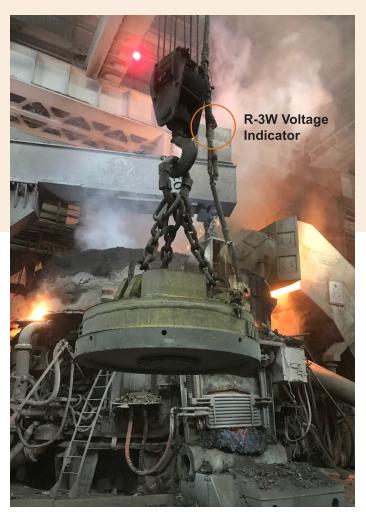
The root cause of these incidents was the failure to recognize that the magnet cables were energized. The cranes have indicator lights on the bridge indicating power to the magnet. However, due to circumstances; could be hard to see or the employee just forgets to check.

The U.S. Department of Labor reported an average of 2,370 non-fatal electrical injuries per year due to electric shock and or electrical burns. Grace PESDs® help to identify all possible sources of electrical supply to specific equipment, such as the magnetic crane shown above.

The addition of Voltage Indication at the connection point of the cables will give an added level of safety awareness. Adding a Permanent Electrical Safety Device (PESD), such as the model R-3W Voltage Indicator; a couple of feet above the connectors will provide a visual indicator at eye level. The R-3W LEDs will blink when energized and none when off.
