Everything but the Kitchen Sink: Use of Multiple Foundation Types to Allow for Construction on a Boston Hillside

Michael J. Weaver, P.E.

Haley & Aldrich, Inc.,
465 Medford Street, Suite 2200,
Boston, MA 02129
mweaver@haleyaldrich.com

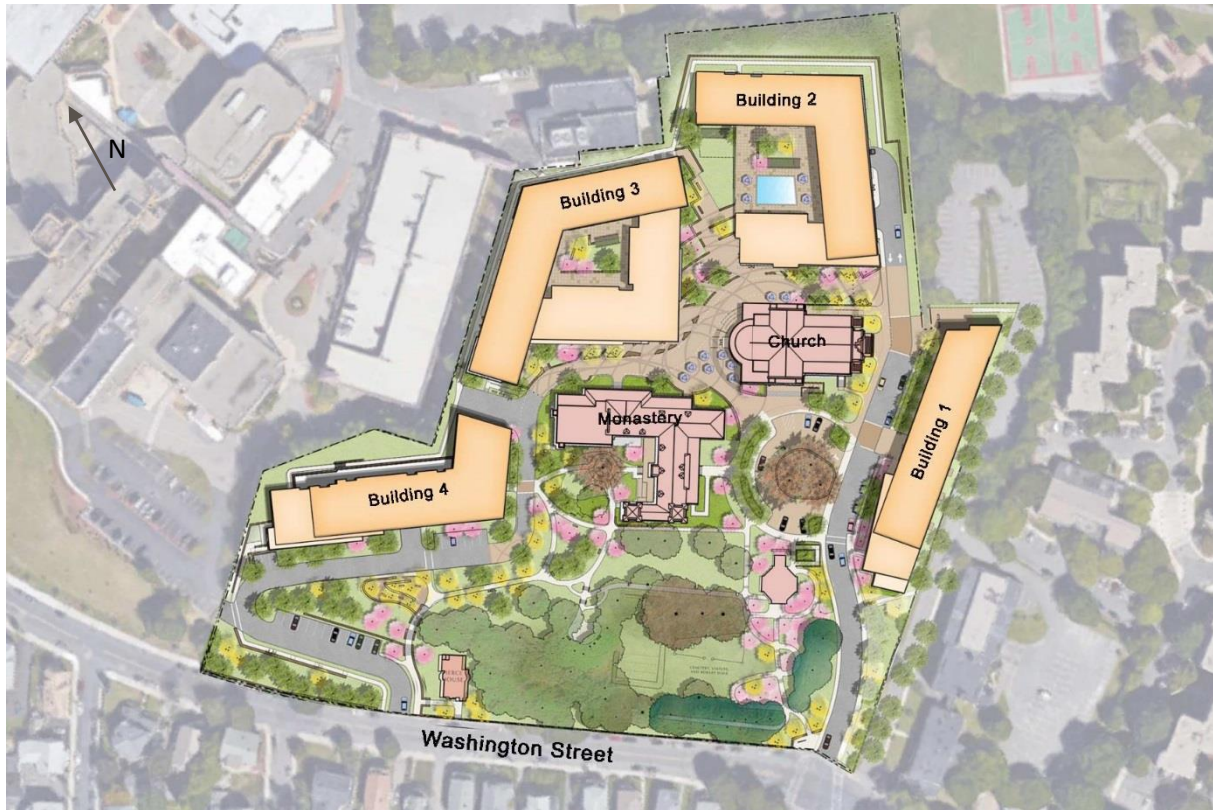
Figure 1. Conceptual Site Plan (courtesy of Cabot, Cabot & Forbes)

The proposed site layout, along with the location of the former St. Gabriel's church and monastery which is to remain, is shown in Figure 1 below. Due to the variability of the subsurface conditions and the presence of Asbestos Containing Materials (ACM) in portions of the existing fill soils, a hybrid foundation system consisting of a mix of deep and shallow foundations was recommended to facilitate construction of the new buildings. A significant retaining wall was required to level the northern portion of the site to achieve the planned finished site grades.

The proposed development consists of the construction of four new residential buildings, ranging in height between five and six stories, that will surround the existing St. Gabriel's Church and Monastery (Figure 1). As previously stated, this paper focuses on the areas of Buildings 2 and 3, and thus information on Buildings 1 and 4 will not be presented.

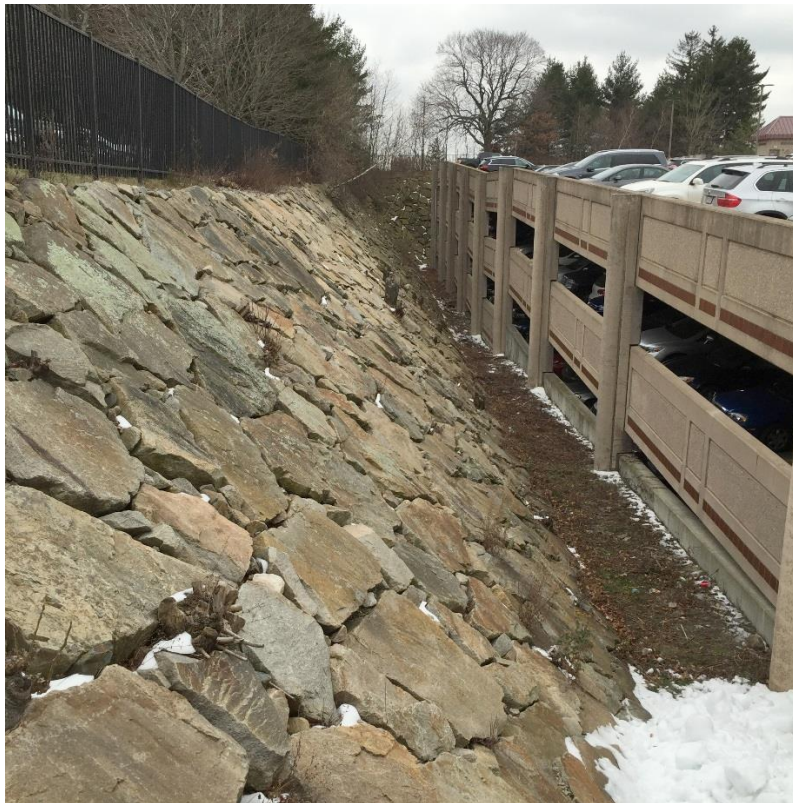
Figure 3. Existing slope along northwest side of site (looking south)

The site, located along Washington Street in the Brighton neighborhood of Boston (Figure 2), is located on a hilltop (historic glacial drumlin). The site grades vary by almost 15.2 m (50 ft) ranging from El+43.6 (El +143 ft) near Washington Street and up to El+58.2 (El +191 ft) near the existing Church. Steep slopes exist on the north (approximately 2H:1V) and northwest (approximately 1H:1V) portions of the site and grade from approximately El +56.4 (El +185 ft) down to approximately El +45.7 (El +150 ft) on the adjacent properties. A reinforced concrete parking garage associated with the adjacent hospital is located to the west of the site, and a public high school and a heating and cooling plant building associated with the hospital are located along the northern edge of the site. The eastern side of the site is bordered by a mix of residential and commercial buildings. Figures 3 and 4 show the existing slopes to the northwest and north of the project site, respectively.

The adjacent parking garage (pictured in Figure 3) was constructed in 1991, along with the engineered slope. The parking garage is believed to be founded on shallow foundations bearing on the natural glacial soils or on compacted granular fill placed following the removal of the then existing fill.

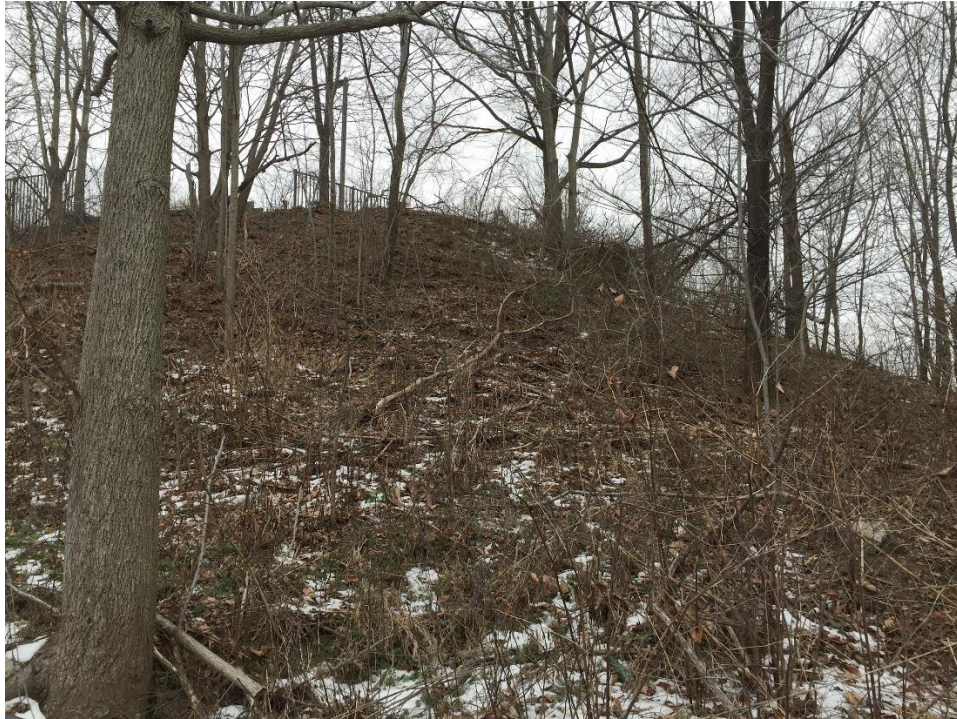
Figure 4. Existing slope along the north side of site (looking west)

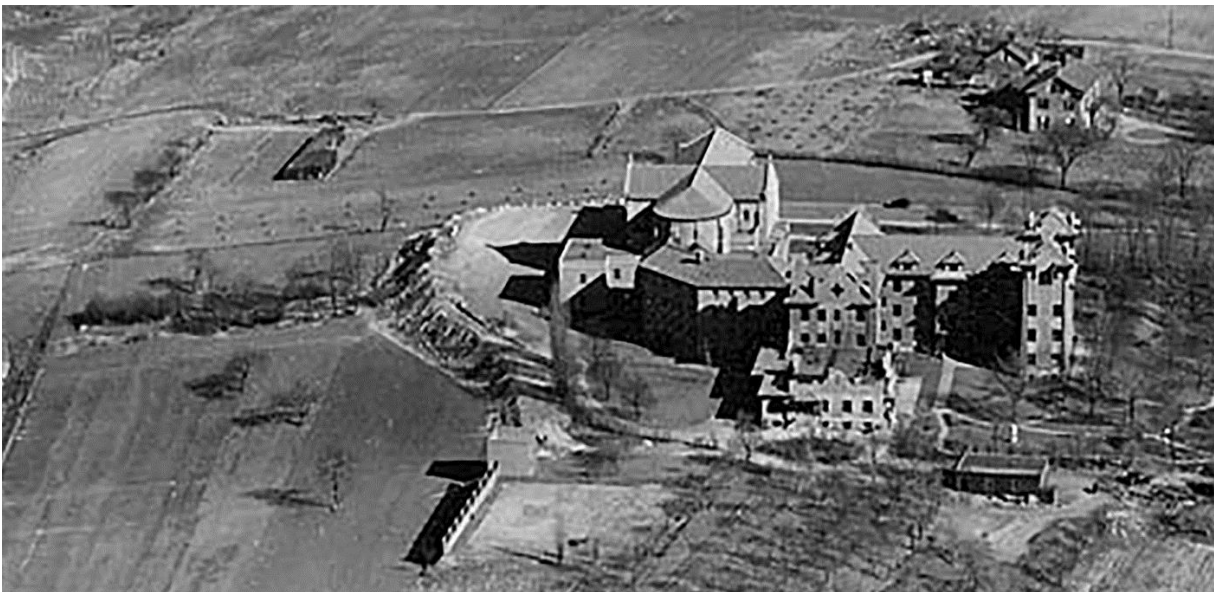
Figure 5. Historic Photograph (undated, courtesy of Cabot, Cabot & Forbes)

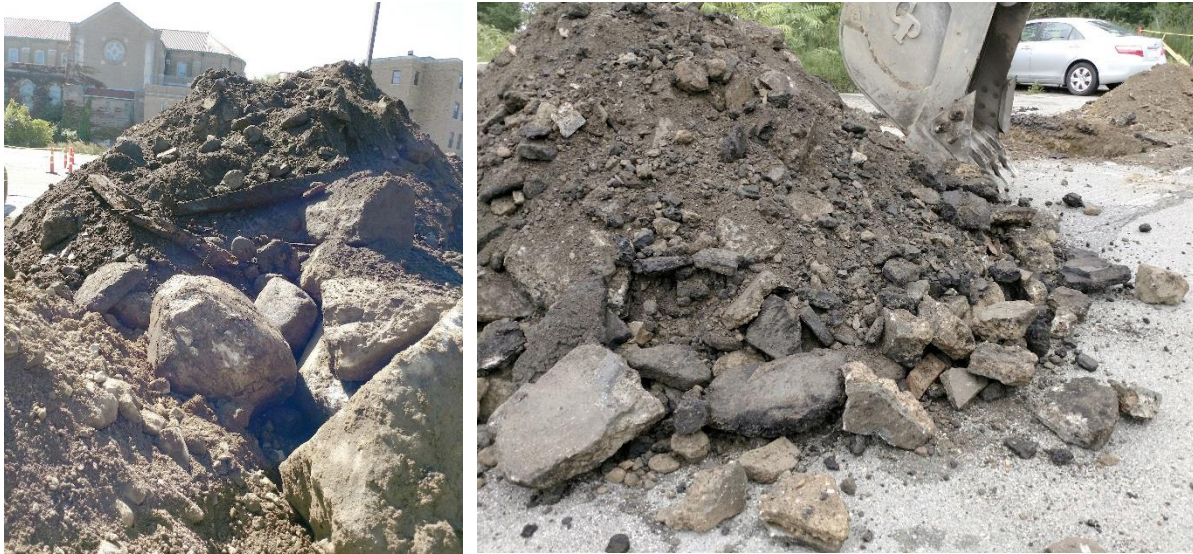
Figure 6. Fill encountered within Building 2 and 3 north of the 1955 fill line.

Figure 6 below shows pictures of the fill and debris encountered within the test pits conducted within the footprint of Buildings 2 and 3 to the north of the 1955 fill line. Buried construction debris within the test pits was noted to consist of large pieces of concrete, some exceeding 1.2 m (4 ft) in dimension.

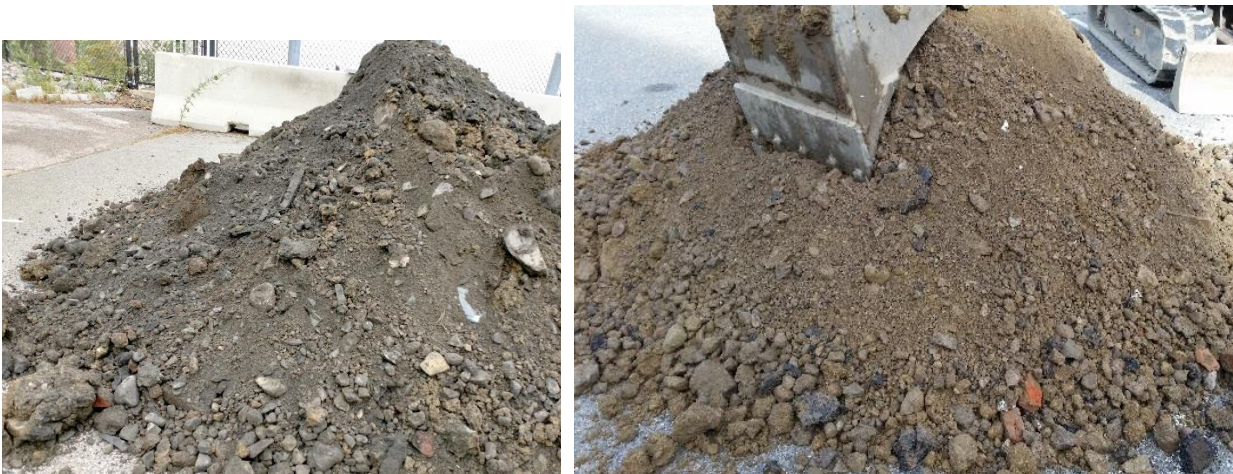
Figure 7. Fill encountered within footprints of Buildings 2 and 3 between 1938 and 1955 fill line.

Figure 7 shows pictures of the fill and debris encountered within the test pits conducted within the footprint of Buildings 2 and 3 in areas that were filled between 1938 and 1955.
