Replacement of the Brooklyn Queens Expressway (BQE) Connector for the Kosciuszko Bridge in New York

Matthew D. Riegel, P.E., D.GE. (HNTB),
Paul B. Pizzimenti, P.E. (H&A), Britain Materek, P.E. (HNTB),
Edward M. Zamiskie, P.E. (H&A)

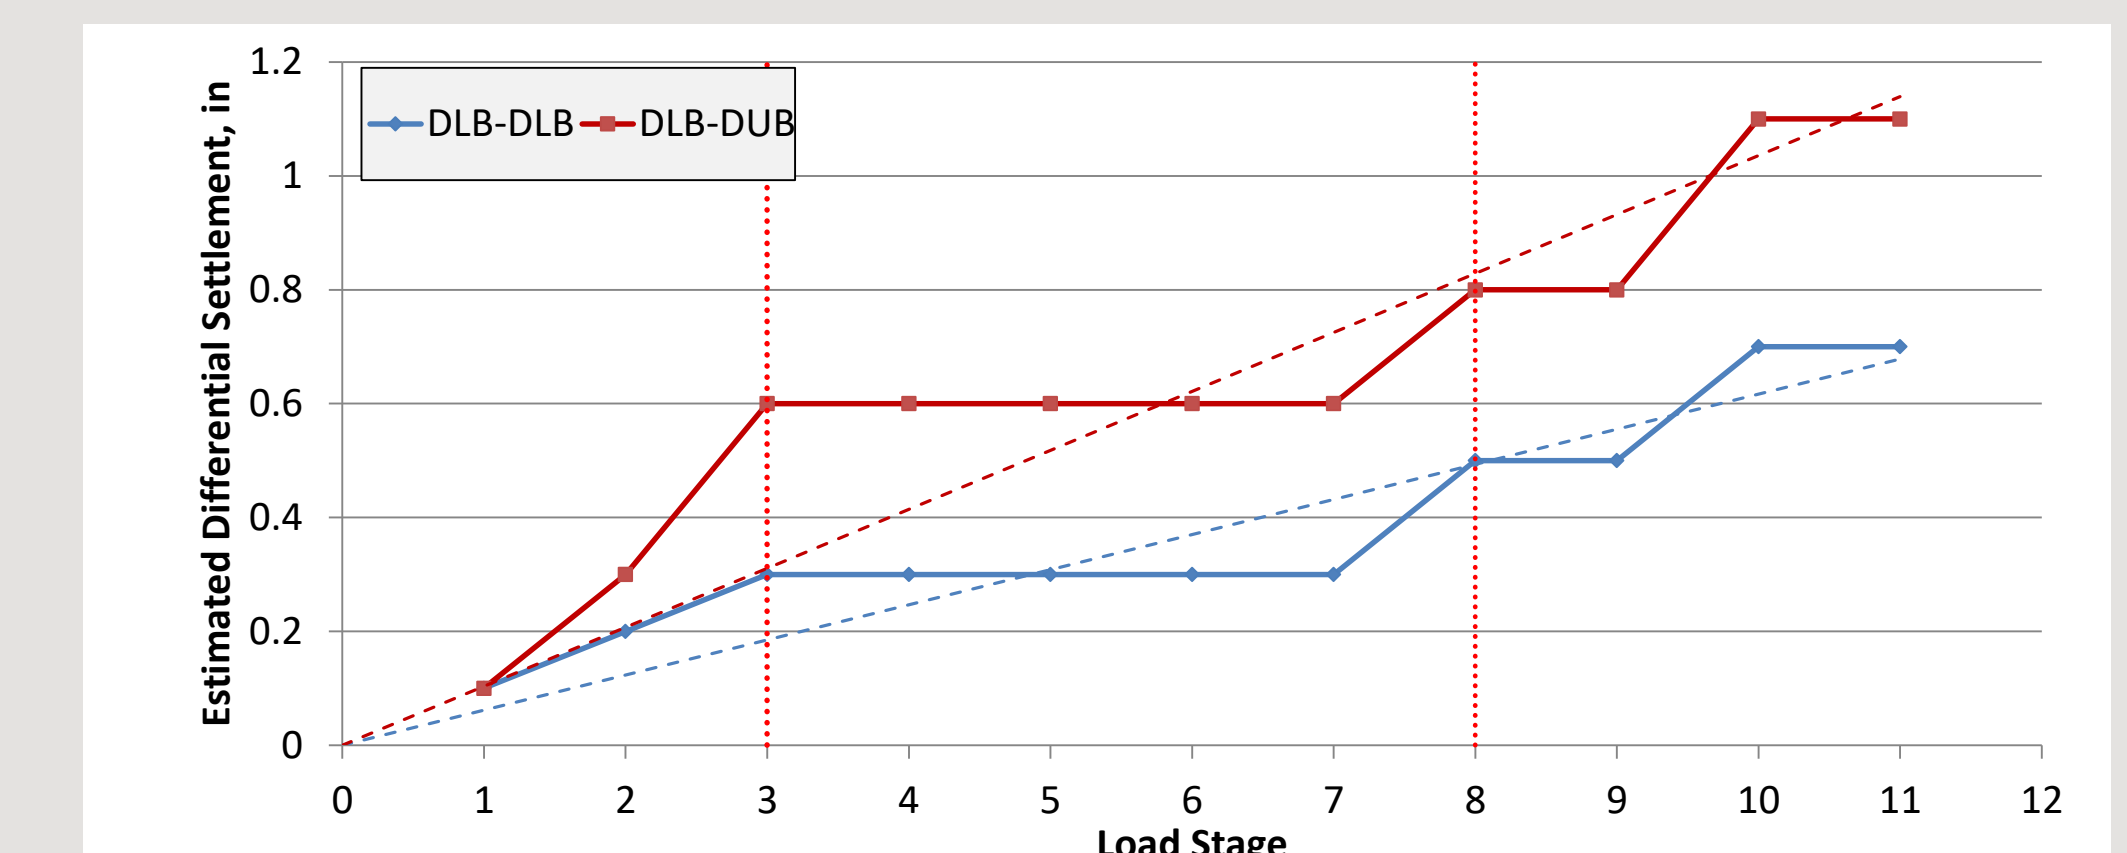
- Plots of anticipated differential settlements based on construction load stages were developed for every column pair.

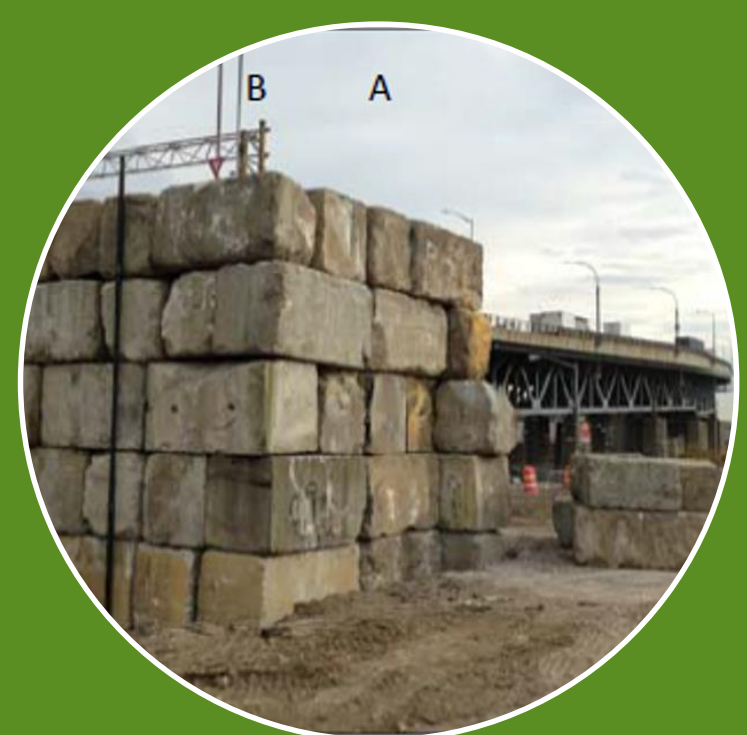
Full scale field load tests were performed to calibrate soil properties against field and laboratory measurements.

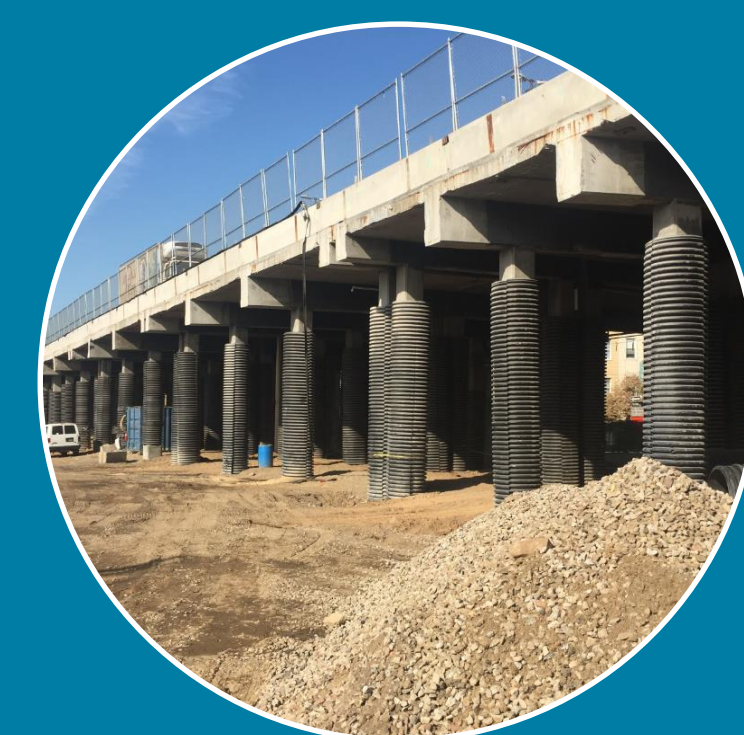
Fill was carefully placed underneath the existing Connector while it remained open to traffic.

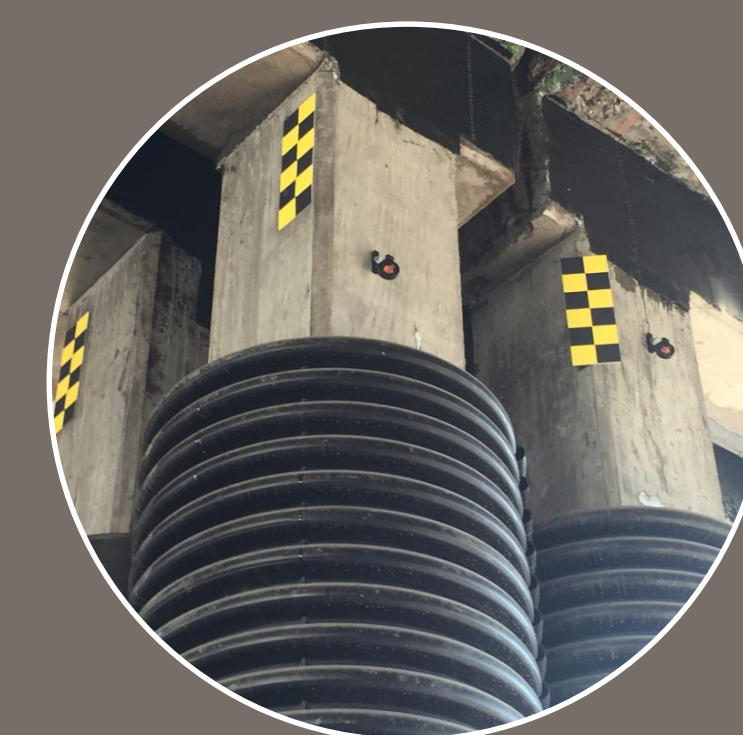
An extensive, redundant instrumentation program was initiated to confirm predictions and protect the public.

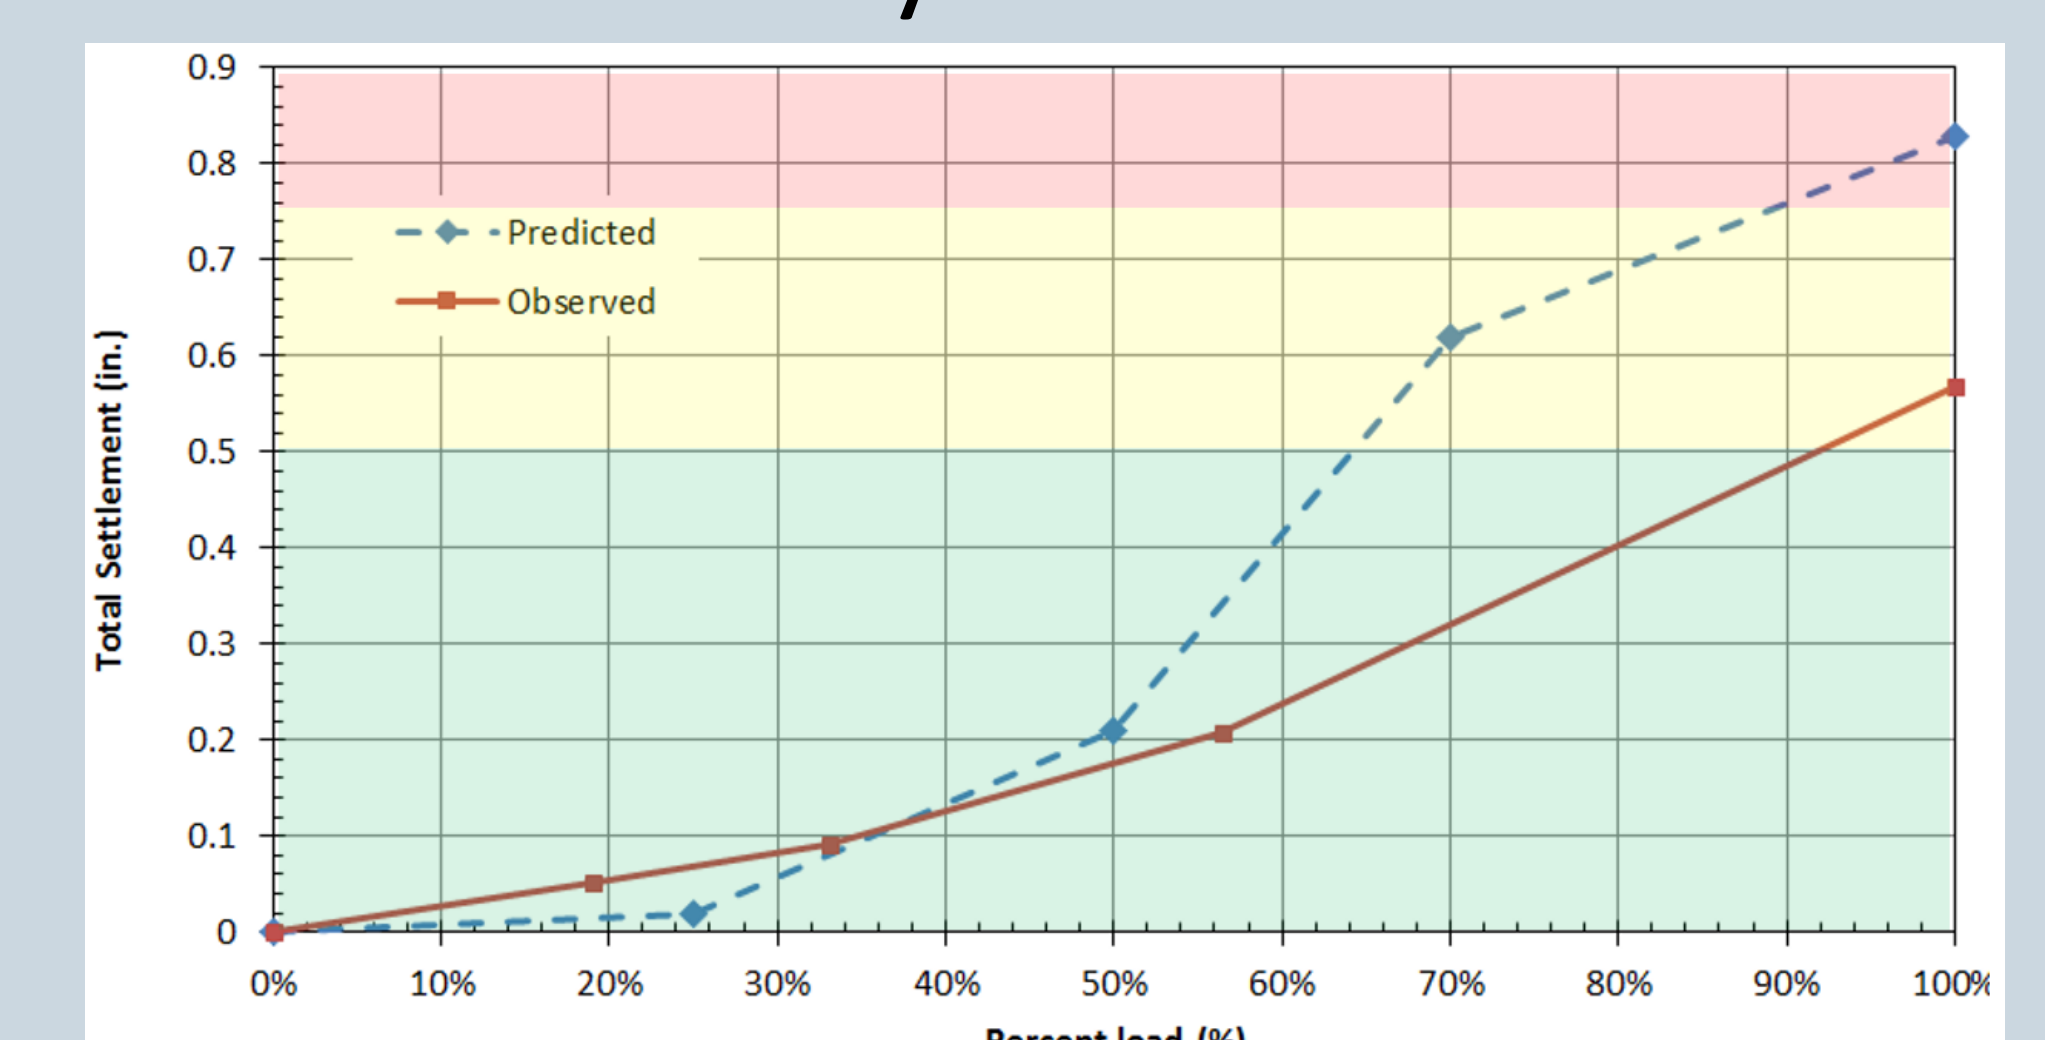
- By observing actual deformations versus predicted settlements, we were able to demonstrate to the Owner that traffic could be safely maintained.
