# Rock slope remediation at the Penobscot Narrows Bridge

Bryan Steinert, P.E.  
Laura Krusinski, P.E.  
Amber B. Granger, P.G.  
Wayne A. Chadbourne, P.E.

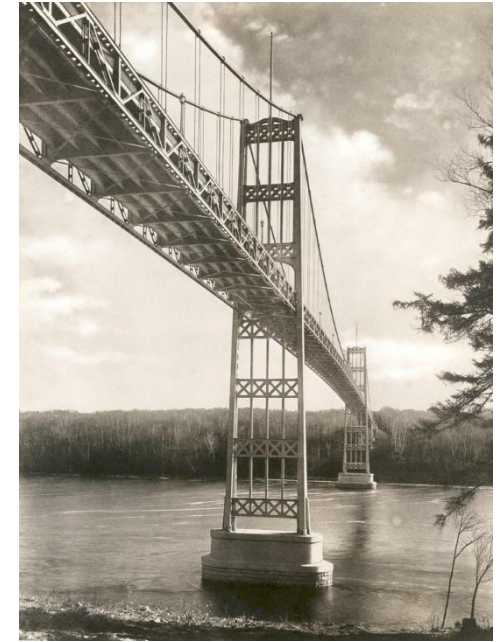
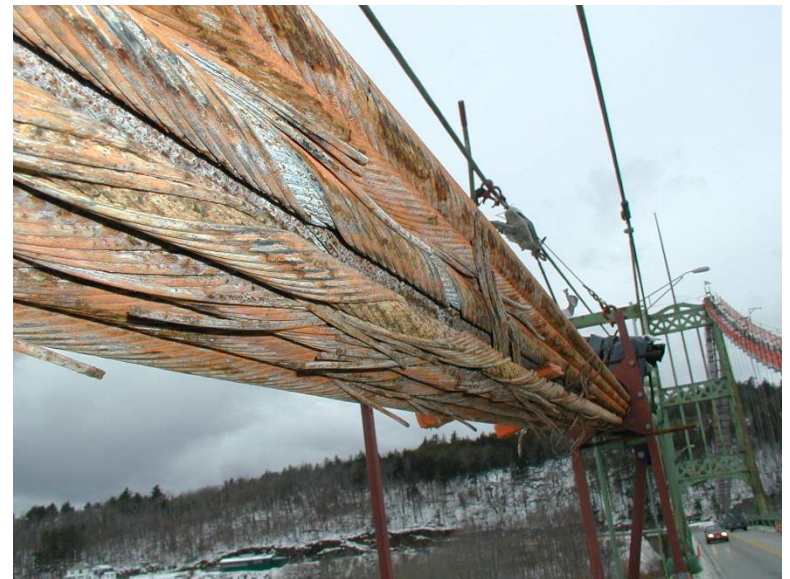
- Waldo-Hancock Suspension Bridge constructed in 1931
- Main-span cable inspection completed in 2003
- Substantial deterioration
- Strengthen main-span cables and replace bridge

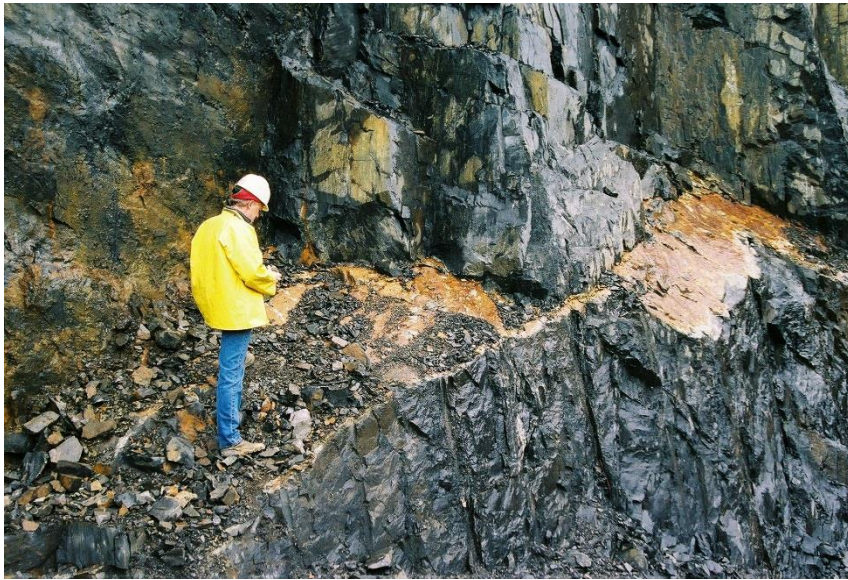
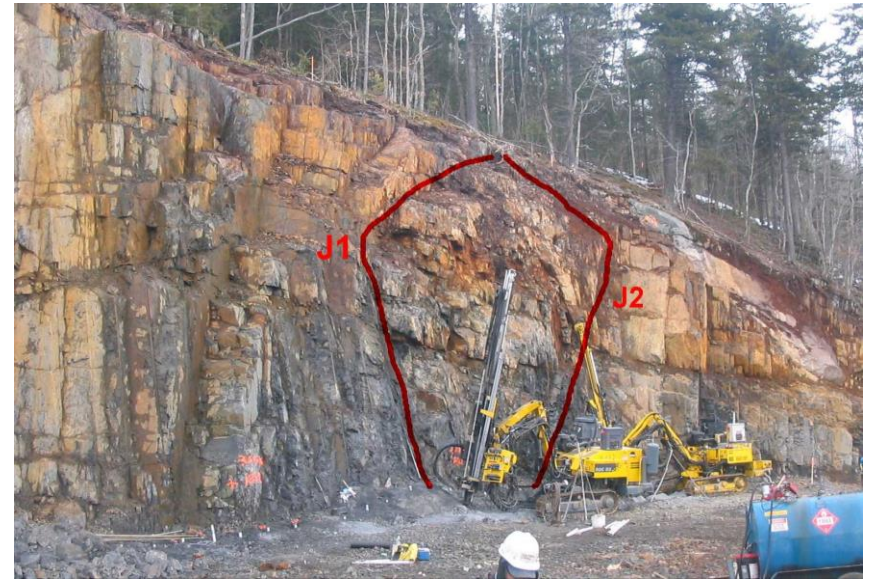
- Began in late 2004/early 2005
- Multiple inspections and areas identified where stabilization/remediation was recommended; sketches, details and specifications prepared
- MaineDOT elected to not stabilize/remediate identified areas during construction
- Substantially complete by June 2005

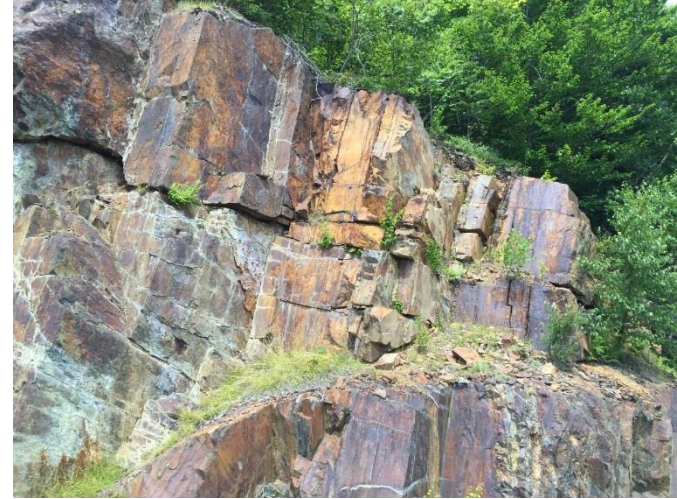
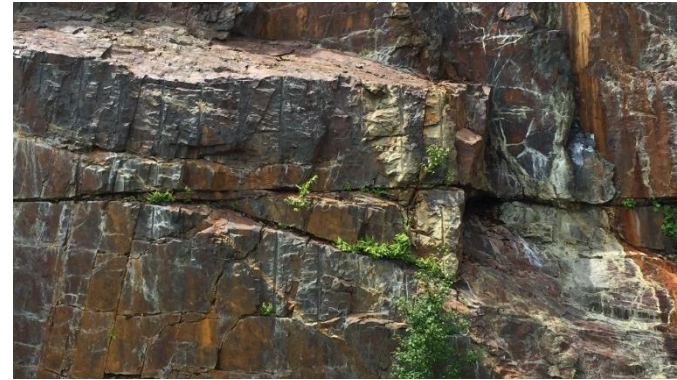
- Previously identified areas re-evaluated by Haley & Aldrich in 2009 and 2012
- Sketches, details and specifications prepared for bidding and inclusion in Waldo-Hancock Bridge demolition contract
- MaineDOT elected to not stabilize/remediate identified areas
- Long-term maintenance and monitoring program developed

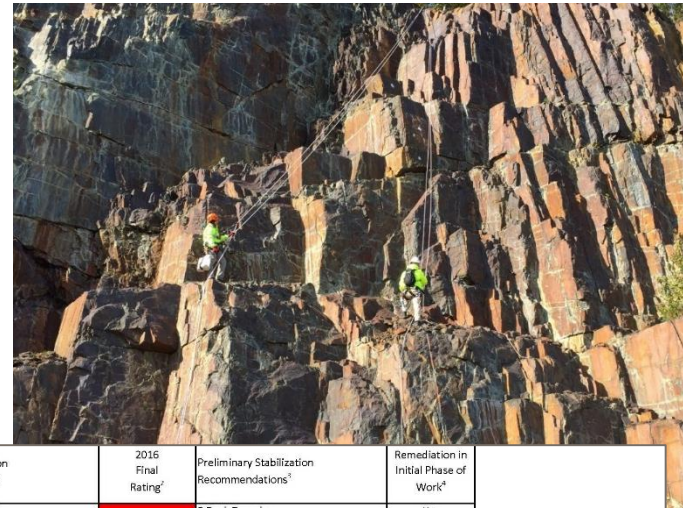
- July (ground) and October (ropes) 2015 site inspections
- 23 areas identified as needing stabilization/remediation – 6 “most critical” and 5 “moderately critical”
- Stabilization/remediation design recommendations refined for “most critical” and “moderately critical” areas and one “slightly critical” area
- Cost estimate confirmed that work could be completed with available funds.

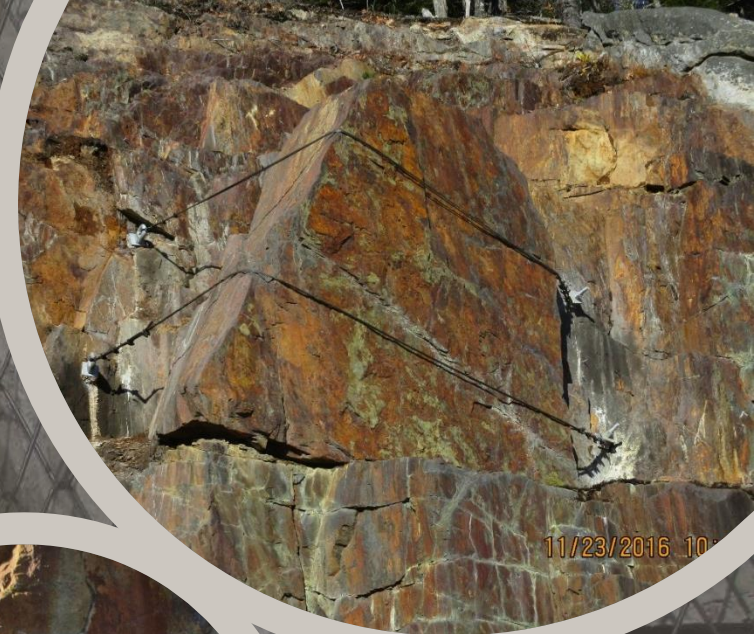
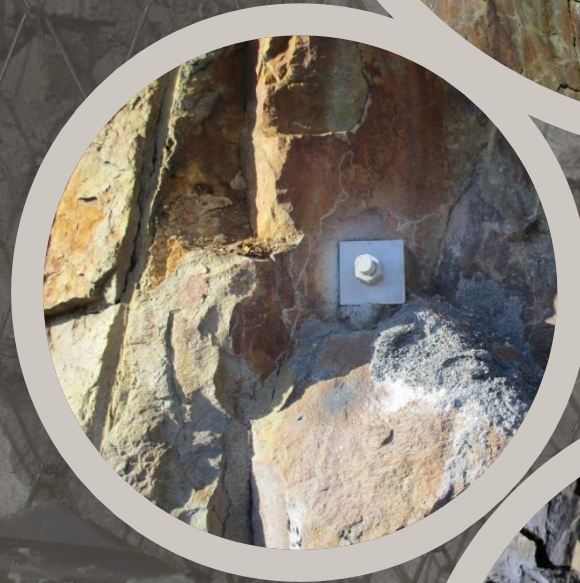
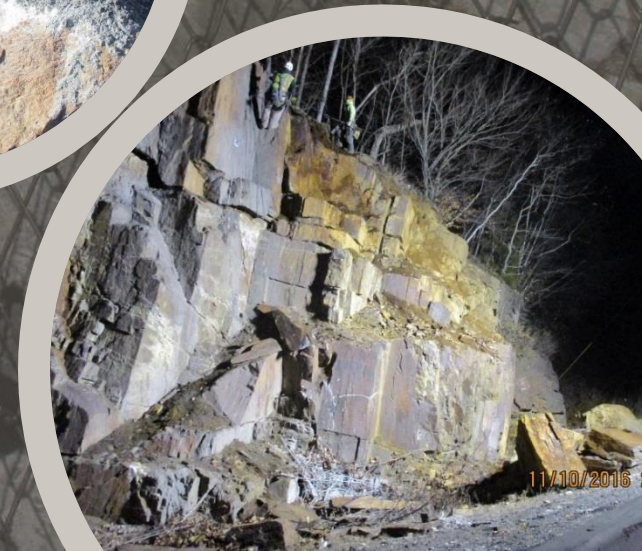
- Rock slope scaling and vegetation removal
- Passive rock dowels
- Anchored wire mesh netting
- Wire rope cable lashing

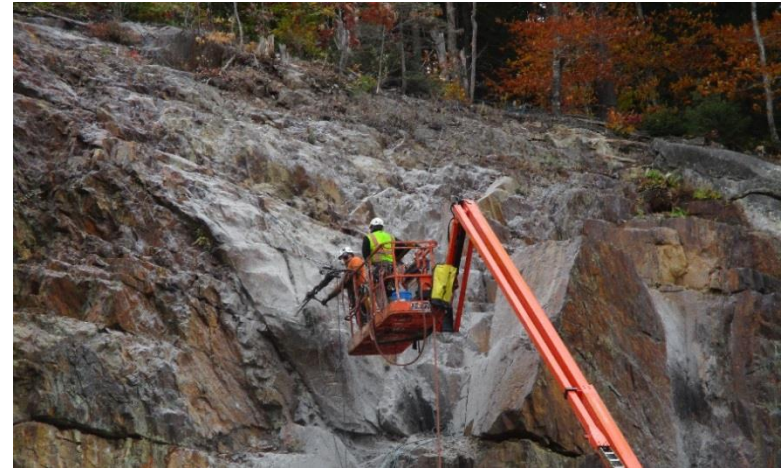
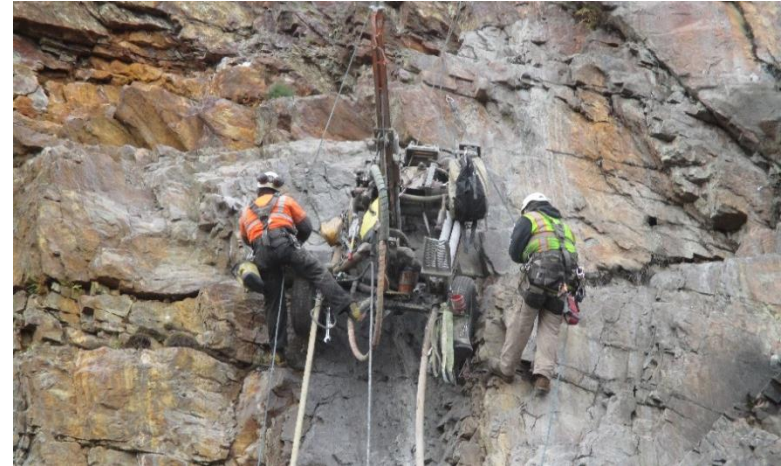
# Construction: Passive rock dowels

- 67 rock dowels installed in seven areas (1, 4, 5, 6, 9, 10, 16)
- Drilled using wagon drill or “plugger” drill
- Subhorizontal and vertical dowels
- 1-3/8” dia., Grade 150, galvanized bar
- Lengths varied from 5 to 20 ft
- 12 pull tests (1 ea. area)

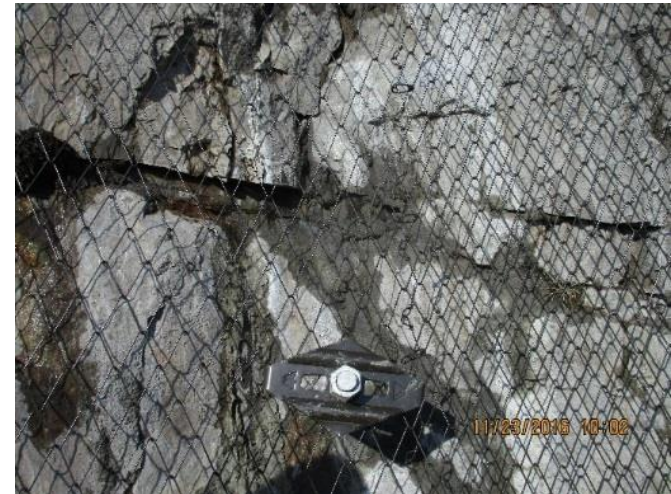
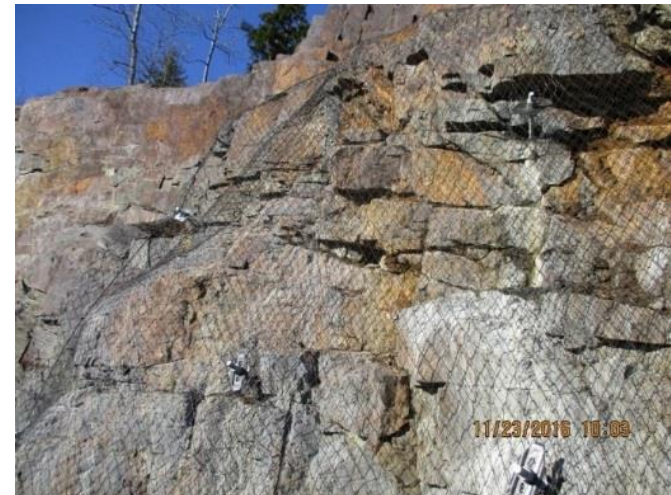
# Construction: Anchored wire mesh netting

- Geobrugg TECCO G65/3
- Mesh and spike plates powder coated black for aesthetics and have supercoating corrosion protection
- 10-ft long rock dowels
- 9-ft c-c spacing, triangular pattern

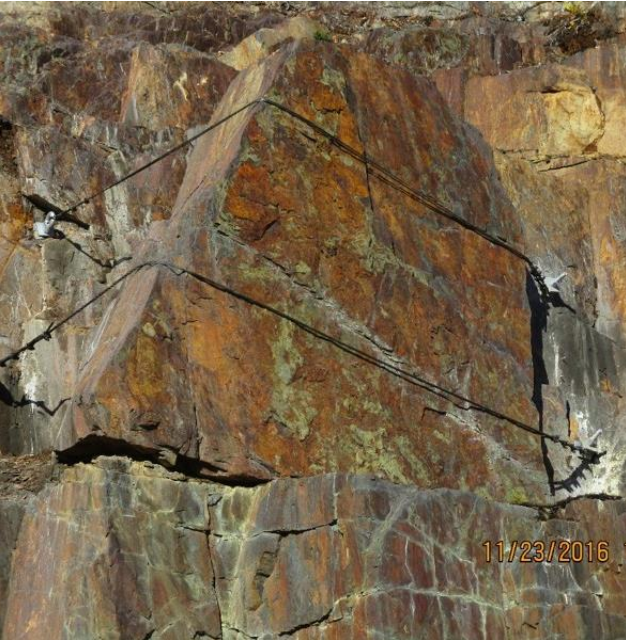
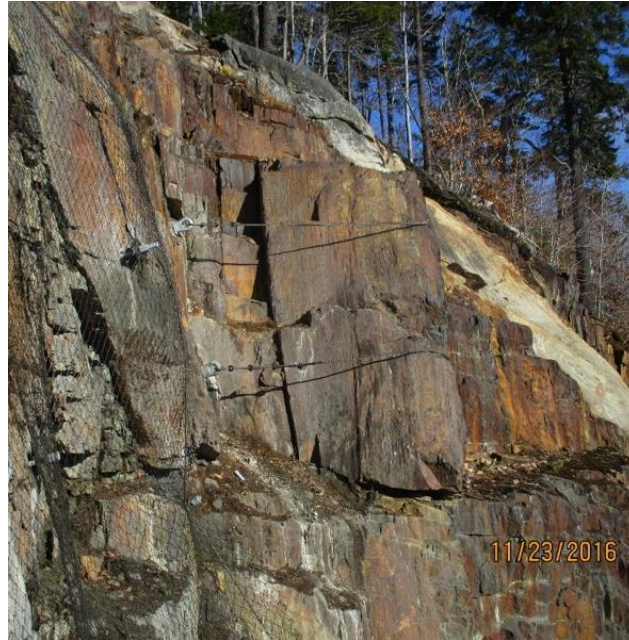
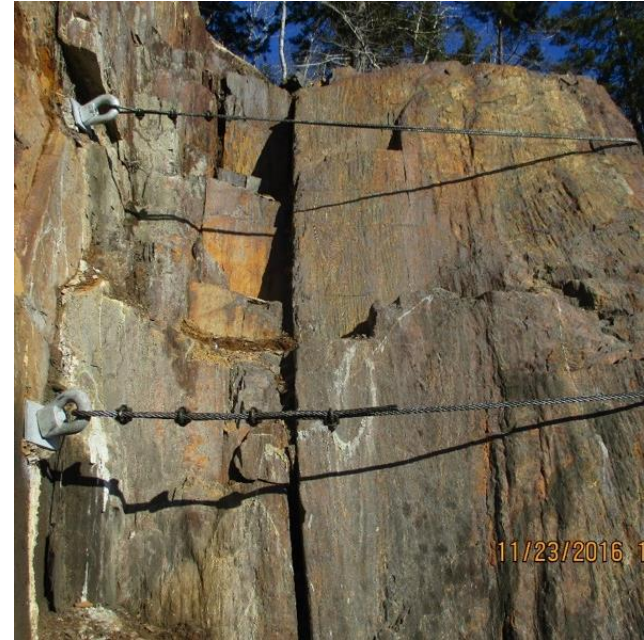
# Construction: Wire rope cable lashing

- Concerns about scaling and ability to safely install rock dowels
- Four, 5-ft long rock dowels
- $\frac{3}{4}$ -in. diameter galvanized wire rope
