Air Ingestion and Transport Testing in a Rotating Drum Raw Water Strainer

Ludwig Haber, Alden Research Laboratory
James Smith, McGuire Nuclear Station, Duke Energy

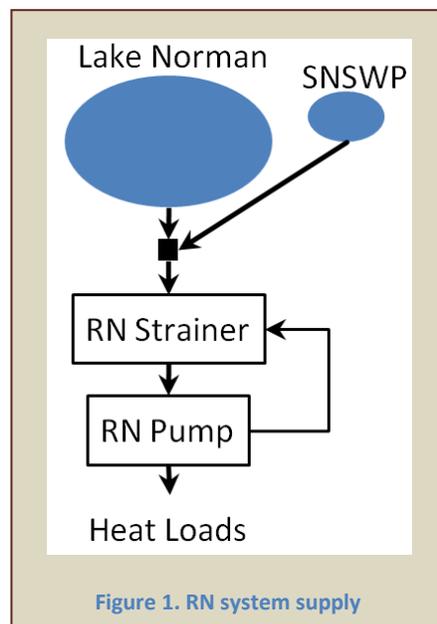
A simplified schematic of the relevant system is shown in Figure 1. The figure correctly shows the difference in piping length between sourcing the water from Lake Norman compared to from the Standby Nuclear Service Water Pond (SNSWP).

Under normal operating conditions, the installed elevation of the RN strainer results in a positive pressure of about 10 psig at the inlet to the strainer. Under emergency operating conditions, the long suction piping from the SNSWP, coupled with higher flow rates cause vacuum conditions at the strainer inlet.

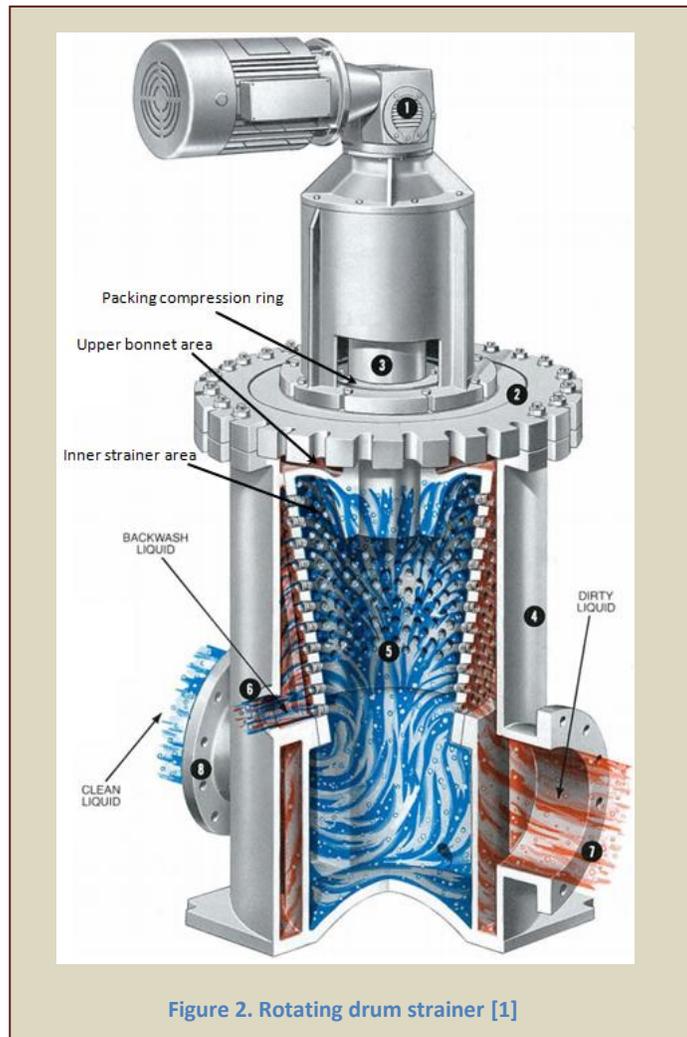
The RN strainer is a rotating drum type strainer, an example of which is shown in Figure 2. Dirty water enters the strainer and distributes up and around the rotating drum. The rotating drum is equipped with a large number of holes which contain filter media. In the case of MNS the filter media are made of perforated plate with 3/16" holes. A previous study examined the fluid mechanics and debris cleanout characteristics of the strainer [2].

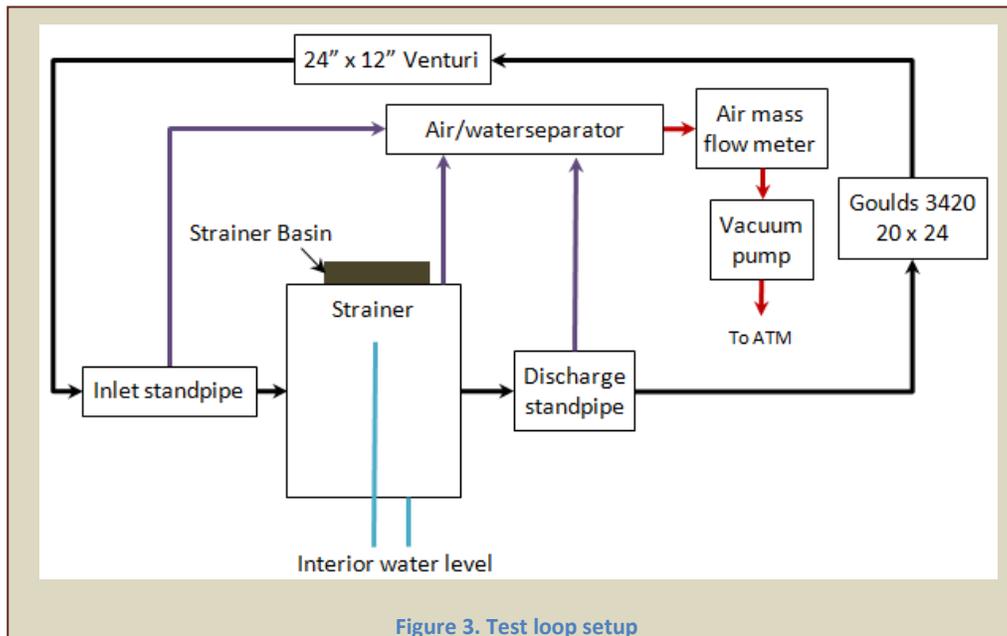
Figure 3. Test loop setup

Figure 3 shows a schematic representing the important parts of the test loop setup. Control and isolation valves have been omitted from the schematic for increased clarity. The test setup is made up of a closed loop around the test strainer. The test loop is equipped with a large centrifugal pump to drive the full range of operating flow rates through the strainer. Flow is measured with a venturi, designed and calibrated at Alden for this test. The loop has an inlet standpipe which consists of a six inch pipe extending vertically upward beyond the height of the strainer, to about 8 ft above the centerline of the pipe loop. A short length of the standpipe was transparent and a water level gauge was installed to monitor water level inside the standpipe. The transparent section allowed a visual inspection as to the quantity of air that might be getting trapped at the standpipe. For the sequence of tests described here, the standpipe was capped and connected to a vacuum pump for venting.

The strainer itself was modified slightly from its condition when it was removed from the plant. Windows were cut into the steel wall to allow visual observation. A basin was installed at the top of the strainer around the packing ring area to allow a water blanket to be maintained and prevent air intrusion from the packing.

On the interior, a water level gauge was installed to measure the interior strainer water level. A long copper tube was installed into the top of the upper bonnet area. A second copper tube was installed such that it was flush with the floor of the strainer near the center of the strainer. To measure the water level, the copper tube installed into the upper bonnet area was first filled with water. The two copper tubes are connected to the two sides of a differential pressure transducer. When the strainer is full and

Downstream of the strainer a 12" standpipe was installed to collect air that is entrained into the process flow. The standpipe was also equipped with a level sight gauge. The standpipe was capped and connected to an air mass flow meter and the venting vacuum pump.

An air water separator receptacle was used to isolate the air mass flow meter and vacuum pump from any potential water that may also be withdrawn from the test loop.

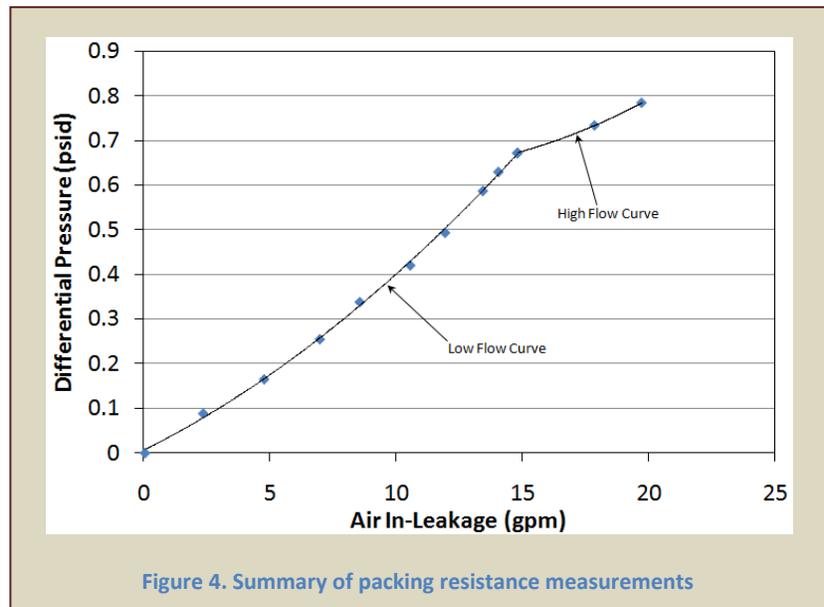
The packing leakage curve obtained from testing is shown in Figure 4. The air intrusion from the packing was very significant and the vacuum capacity was exceeded at only a 1 psi differential across the packing. Plant conditions could be much worse with differential pressures reaching up to 4 psid. Nevertheless the collected data is valuable. When extrapolated to plant conditions, 74 gpm (at downstream packing pressure, 75°F) is predicted to be entering from the drum packing in the present conditions. It should be noted that similar measurements were previously performed on another strainer without drum rotation and exhibited lower air intrusion. It is therefore conceivable that rotation generates a thin fluid film layer that allows a lower resistance path to form and allows air intrusion to increase. However, static measurements to confirm this behavior have not been conducted to date. The level of air intrusion observed with rotation here is still not a concern for pump operation since it represents less than 0.75% of the process flow (at 10,000 gpm) under these conditions.

Figure 4 shows that the results appear to fall along two separate curves, one for low differential pressures and another for higher differential pressures. The differences cannot be explained simply by distinguishing a turbulent from a laminar regime. Both flow curves are quadratic and therefore are likely to involve turbulent flow. The thin gas passages between the packing and drum shaft involve relative rotational motion and the dynamics of such a flow can be very intricate and complicated (e.g. Görtler vortices [3]).

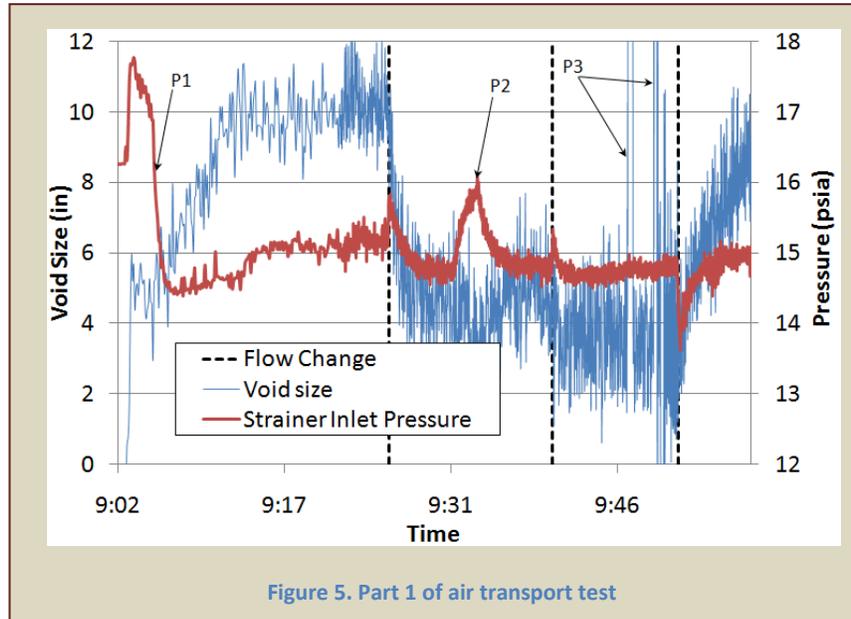
Figure 5 shows the first part of the test. The figure shows both the RN strainer inlet pressure and the void indicator described above. The figure also marks several points during testing which are labeled P1, P2 and P3. P3 identifies points where the void indicator sensing lines were bled. Changes in flow rate are indicated by black vertical dashed lines. It should be noted that at approximately 9:19, the visual void indication manometer board was isolated to prevent potential emptying of the high side of the sensing lines.

The RN strainer was initially bled out to be water solid. The main pump was then started with the well at the top of the RN strainer dry. The flow rate was close to 6000 gpm. P1 indicates the point at which vacuum operation was begun. The RN strainer pressure is seen to decrease. Immediately upon decrease of the RN strainer inlet pressure the void gauge began to register an increase which eventually built to a level difference of approximately 10 inches. No void was indicated on the inlet side of the drum by two different sight gauge lines. The void was therefore located within the drum. One likely reason no void was observed on the inlet side was the pressure differential across the drum (about 1.8 psid at 6000 gpm for this test). The flow resistance of the drum is high enough to require the entire inlet surface of the drum to wet on the upstream side. However, flow resistance downstream of the drum is low and velocities at the top of the drum are also low allowing the air to accumulate.

The air appears to travel through the packing and then is entrained by the flow surrounding the drum, being eventually pushed through the drum where the air can accumulate due to much slower velocities. The flow is likely bubbly. Once an initial void is formed, air is more and more easily separated from the water. The separation becomes easier because the existence of the void causes the water to be sprayed through the media making it easier for the bubbles to separate from the water, releasing the air from the flow stream. Void formation is limited by the ability of the flow inside the drum to entrain the air being pushed through. As the water level drops, velocities inside the drum increase allowing entrainment to increase. The void stops increasing in size when there is a balance between air ingestion and air entrainment inside the drum.

Note that during the formation of the void, the RN strainer inlet pressure initially increased. The increase in pressure can only be explained by a short term decrease in the flow resistance of the drum packing. These changes depend on the cleanliness of the water in the well and the area around the packing. While every effort was made to begin the overall test program with a clean well, grease and other crud from the RN strainer continued to be produced causing the material to be available for entrainment into the packing under vacuum conditions. When the material eventually gets expelled or fully absorbed, the resistance of the drum packing decreases once again.

The void size monitor signal was relatively noisy. The RMS observed was not due to sensor noise but is an indication of the dynamic water surface inside the drum. It was also not possible to determine whether the void is symmetric but drum rotation and the low mean velocities at the top of the inside of the drum can be expected to generate a nearly symmetric void. Drum rotation also contributes to the water level dynamics within the drum and the high RMS void size reading. Even while the signal itself was noisy, it is clear that the void presence is stable. Once the water initially displaced by the void was removed from the downstream stand pipe, the steady state condition withdrew only air. There does not appear to be any long term drift in the size of the void. There is no indication that the void has the potential to collapse suddenly under steady operating conditions.

The first indicated flow rate change marks an increase in flow from 6000 gpm to 8000 gpm. Void size is seen to decrease very suddenly. During testing a correspondingly fast drop in the downstream stand pipe water level was observed. The drop occurred over the time required for the main pump to spool up to the higher speed, i.e. 1-2 seconds. The test demonstrates that a large pocket of air did exist within the drum and was swept downstream with the increase in flow. The void level continued to evolve over several minutes stabilizing at approximately 5 inches.

Point P2 indicates a short time during which vacuum pump operation was ceased and loop pressure was allowed to increase. During this time, the rate at which air is ingested by the RN strainer decreases while the velocity inside the drum remains the same. The difference between the rate of supplied air and the rate of entrained air therefore causes the void to deplete. When vacuum operation is restored, the void reforms to the original size. While the vacuum operation was secured, the air being removed from the RN strainer void could be observed in the form of a dropping downstream standpipe level.

The second dashed black line indicates a change in flow rate from 8000 to 9500 gpm. As in the previous increase in flow, the void size again decreased quickly and the downstream standpipe level was seen to decrease simultaneously. An equilibrium void size of 3 inches was reached relatively quickly. The final flow change shown in Figure 5 returned the flow rate to 6000 gpm. The void size began increasing immediately back towards the previously observed steady state condition of 10 inches.

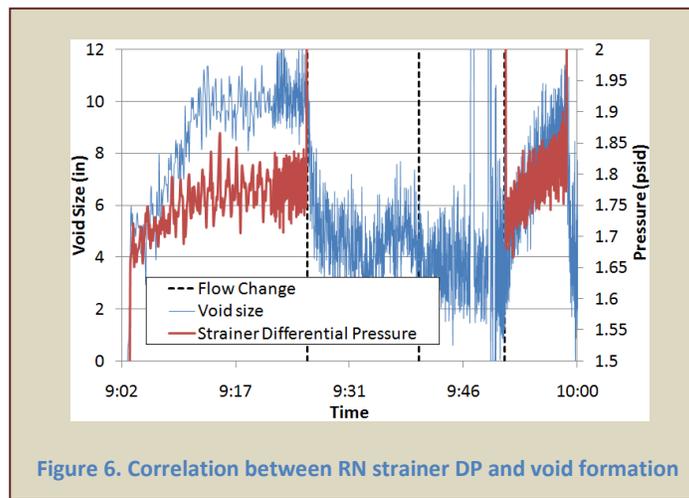
Figure 6. Correlation between RN strainer DP and void formation

The development of the void and loss of water column pressure on the downstream side of the rotating drum should cause an increase in RN strainer differential pressure. The correlation is most obvious when examining the differential pressure history of the formation of the largest void. Figure 6 isolates a time period similar to that shown above. While the initial increase in differential pressure could be caused by pass-through debris slowly being caught by the drum (due to residual debris in the loop from previous debris testing), the differential pressure increase observed upon decrease of process flow later cannot be explained in the same way. The differential pressure increase is clearly a direct consequence of the formation of the void within the RN strainer drum.

Note though that the RN strainer differential pressure change was not measured to be equal to the void size but significantly smaller. (The strainer differential pressure is greater than 2 psid between the two low flow periods shown and therefore does not appear on the plot of Figure 6).

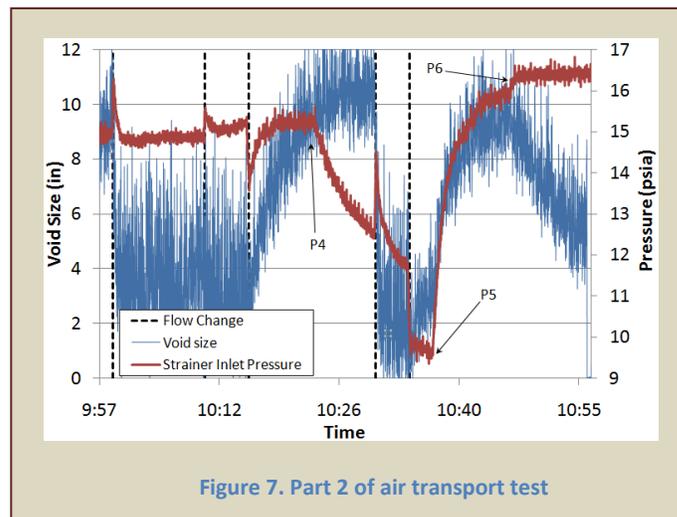
Figure 7. Part 2 of air transport test

Figure 7 shows the second portion of the same RN strainer air intrusion test. The void that had reformed, nearly to full size, by moving flow back to 6000 gpm is quickly removed by an increase of flow rate to 8000 gpm. The void size formed was similar to the size developed previously. A further increase in flow to 9500 gpm caused a slight further reduction in void size, as expected. Flow was then reduced again to 6000 gpm causing void formation to begin very quickly. At the time marked P4, the RN strainer well was filled with water. The result of eliminating air introduction via the drum packing is that the vacuum pump is able to dramatically decrease the RN strainer inlet pressure. However, the void was maintained. At these much lower pressures a new balance was set up between air in-leakage into the system (dominated by the main pump packing) and the withdrawal at the downstream stand-pipe. The transport of air from the drum by entrainment was replenished by the air transported to the RN strainer from the main pump.

Flow was then increased from 6000 gpm to 9000 gpm. The air in the RN strainer void was immediately transported downstream with a small void remaining, somewhat smaller than observed previously at nearly the same flow rate. It is possible that the higher flow rate does not allow as much air transported into the RN strainer through process flow to be trapped at the top of the drum. In contrast to air being introduced through the packing, air coming in with process flow is likely better distributed in the flow and not concentrated near the top of the drum.

Flow was then reduced again to 6000 gpm and the fluid in the RN strainer well was no longer replenished. Even while the well still contained water, the void begins to grow again, fed by loop air in-leakage. However, at point P5, the well runs dry and both inlet pressure and void increased very quickly as the air supply was dwarfed by the flow's ability to entrain the air rushing in. The void quickly formed to nearly full size again. At point P6, vacuum operation was stopped to allow the loop to come to equilibrium with the top of the drum acting as the pressure controlling point. The pressure increased slightly upon securing vacuum pump operation. At the same time, the void began to shrink as the air supply was now removed from both the loop and drum packing sources. The slow decrease in the void fraction demonstrates the relatively slow rate of air entrainment that exists at the relatively low flow rate of 6000 gpm.
