**SUBJECT:** TRUBLUE Carabiner Safety Notice

## Inspection Notice on the ISC KH260 Twister Karabiner

February 8, 2018

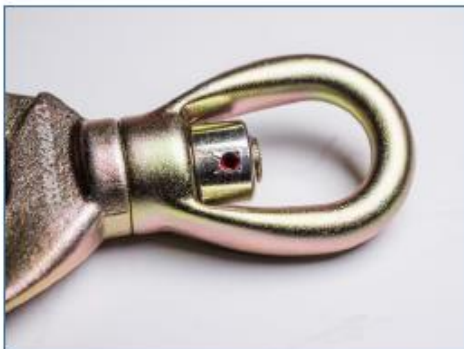
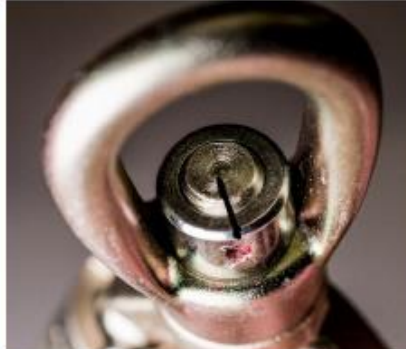
Step 3: Inspect the nut at the top of the KH260 Twister Karabiner. You should notice a hole in the nut where the retaining pin is inserted at the factory. Look for the red indicator paint which should be in the hole.

- 1) Verify presence of the red paint
- 2) Customer should permanently mark the top of the stem and nut as shown below. During daily inspection verify that the mark is aligned between the stem and nut and does not rotate.

If you do not see the red paint, or if the nut rotates, remove the karabiner from service immediately.

Please send all affected units back to ISC quoting RMA#763 on all paperwork and boxes. If the KH260 is installed on another manufacturer's device, please contact that manufacturer. We apologize for any inconvenience because of this issue.
