Creep corrosion of electronic assemblies in harsh environments

Petri Savolainen* and Randy Schueller

DfR Solutions

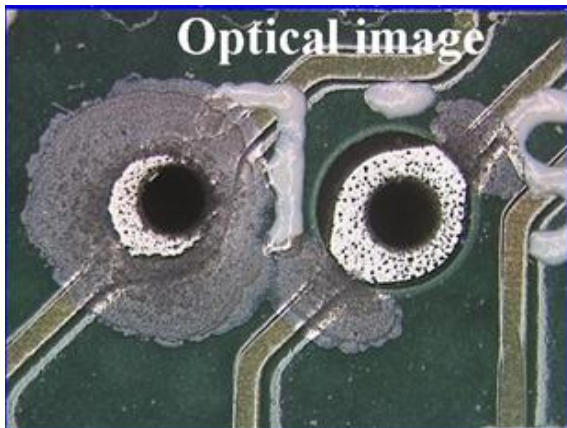
A typical creep corrosion failure is shown in Figure 1 and Figure 2 provides an EDX spectrum of the corrosion product. It is primarily copper sulfide (Cu_2S) with a small amount of silver sulfide (Ag_2S). Studies have shown that high amounts of Cu_2S typically indicate the presence of active sulfur compounds such as elemental sulfur, hydrogen sulfide (H_2S), or organic sulfur compounds [5]. Creep appears to begin by growth of dendrites. However, this is not electro-chemical migration (voltage potential driven) dendritic growth, since creep takes place equally in all directions and does not require the board to be powered. Rather it appears that Cu_2S is being formed in a layer of moisture on the surface and precipitates out of solution as it forms (since Cu_2S is insoluble in water).

Figure 1: Creep corrosion on pad

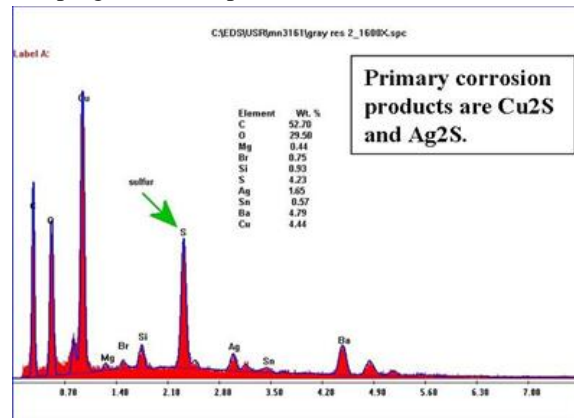
Figure 2: EDX spectrum of creep corrosion product

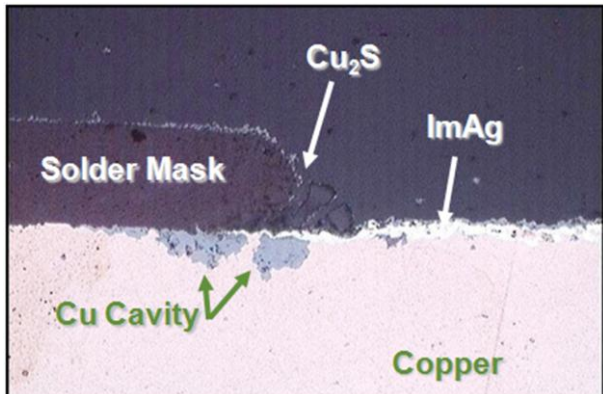
Data show that this same type of behavior (exposed Cu at edge of soldermask) is the primary reason most creep corrosion seems to emanate from soldermask defined features. Cross sections of heavily creep corroded vias are shown in Figure 3. A large amount of copper is etched from beneath the soldermask and converted to Cu_2S. The full area of silver coverage (cathode) is much larger than the small exposed copper region (anode), thus helping to

drive this aggressive galvanic corrosion in the presence of sulfur and moisture. Any pinholes in the Immersion silver film would also result in a similarly etched Cu region.

Figure 3: Cu cavity at the edge of solder mask

Improve Coverage of the Silver: If the silver film was not compromised to allow access to the underlying copper, the creep corrosion would not occur. Naturally the silver would still tarnish and form an Ag_2S film on the surface, but failure would not take place. The challenge is to achieve coverage under the edge of the soldermask. Preventing ingress of moisture beneath the mask would require improved adhesion of solder mask to copper. This is a challenge for the PCB shops and the soldermask manufacturers.

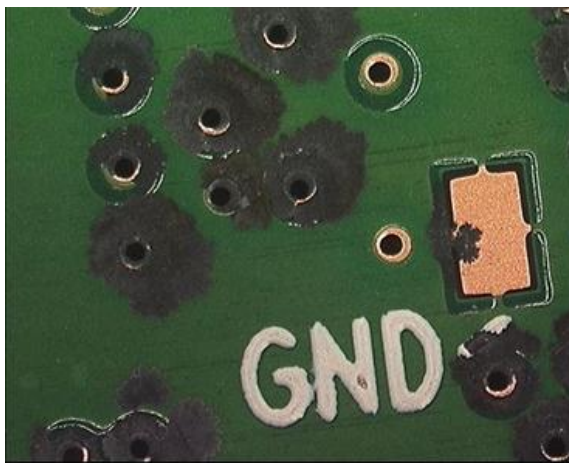
This does not to imply, however, that bare copper cannot creep corrode on its own (without an Immersion silver coating). PCB cards with OSP finish have been known to fail from creep corrosion when used in severe sulfur environments with high humidity (ink stripping room in a paper mill). An example is shown in Figure 5. In this case, copper was exposed through the residual OSP coating and was attacked. Cross sections show this attack does not occur under the solder mask edge (as with Immersion silver) but is more uniform. In extreme cases it consumed the full thickness of copper.

Figure 4: Corroded Cu with OSP finish
