LCD Failure Modes – It's All About Quality

Edward Wyrwas

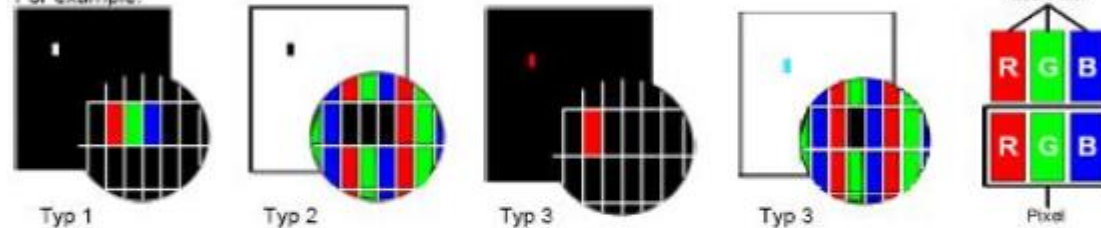
Pixel fault Typ 1: constantly bright pixel

Pixel fault Typ 2: constantly dark pixel

Pixel fault Typ 3: defect subpixel, either constantly bright (red, green, blue or constantly dark)

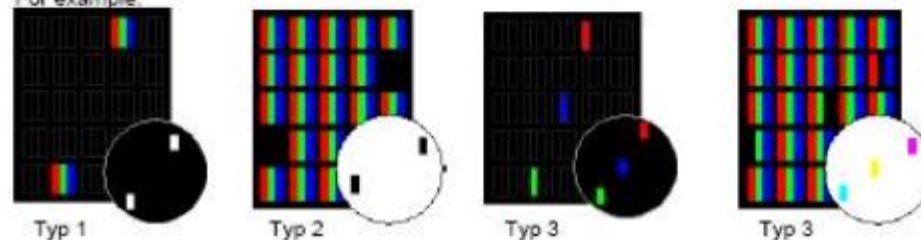
A cluster is an area of 5 x 5 pixel

Cluster pixel fault Typ 1 and Typ 2: constantly bright or dark pixels within the clusters

Cluster pixel fault Typ 3: defect subpixel, either constantly bright red, green, blue or constantly dark within the cluster.

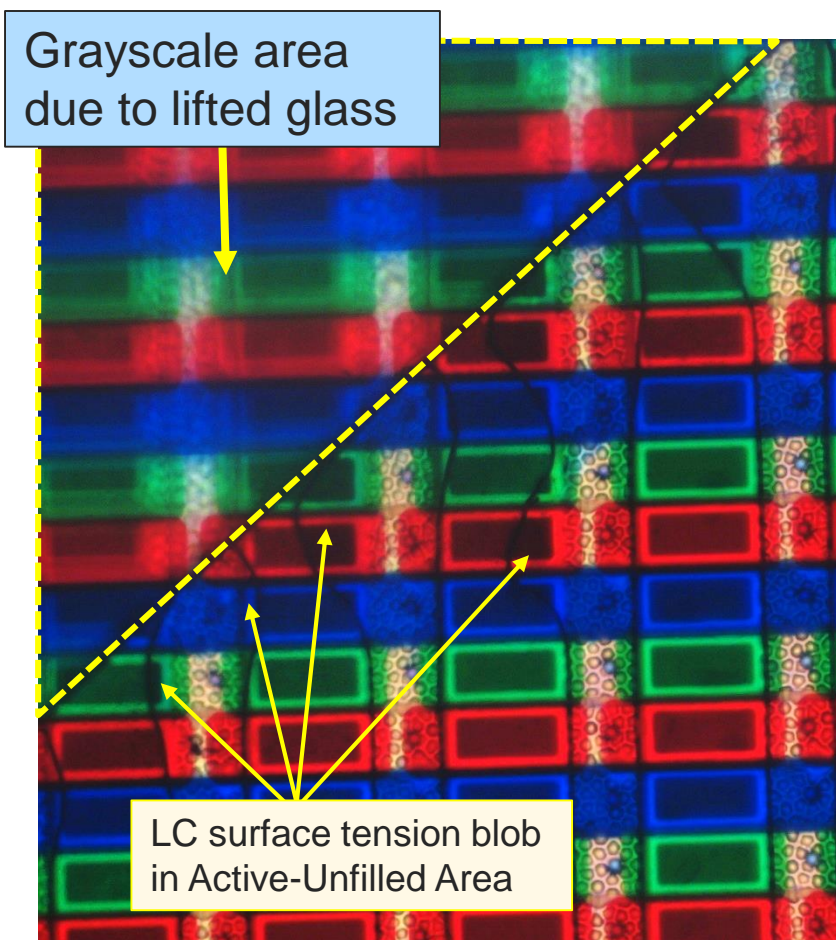
Working LCD Comparison

- The LCD referenced here was intentionally cracked.
- The screen was examined using a *dark-field* filter to determine the effects of the surface tension of the liquid crystal within the TFT cell array.
- It was observed that liquid crystal (LC) would become movable within the array and appear to be voided. Upon illumination of the screen, a gray scale appearance was *not* noted, except in the area that the glass sandwich was less than parallel.

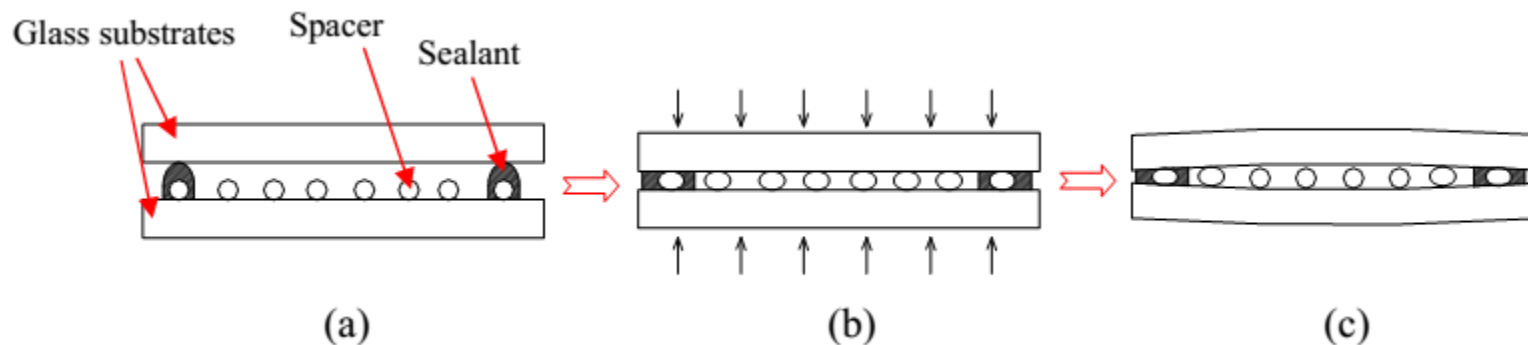
Fig. 2. (a) Before hot press; (b) During hot press; (c) After hot press.

- The bulge problem originates from the elastic deformation of spacers rather than from the shrinkage of the sealant during temperature changes or curing process.

- During the hot bar process, the spacers are deformed into ellipsoid due to external pressure on the glass.
 - After hot bar process is completed, the external pressure exerted is released. The spacers in the cell center resume their former shape, but the spacers towards the cell periphery are prevented from resuming their original shape. The perimeter sealant keeps these areas more rigid which keeps the spacers in a compressed state.

- This results in a cell gap in the perimeter smaller than the spacer diameter, and the cell gap in the cell center is larger than the cell diameter. The characteristics resemble both gravity-gap and active-unfilled area pixel behaviors.

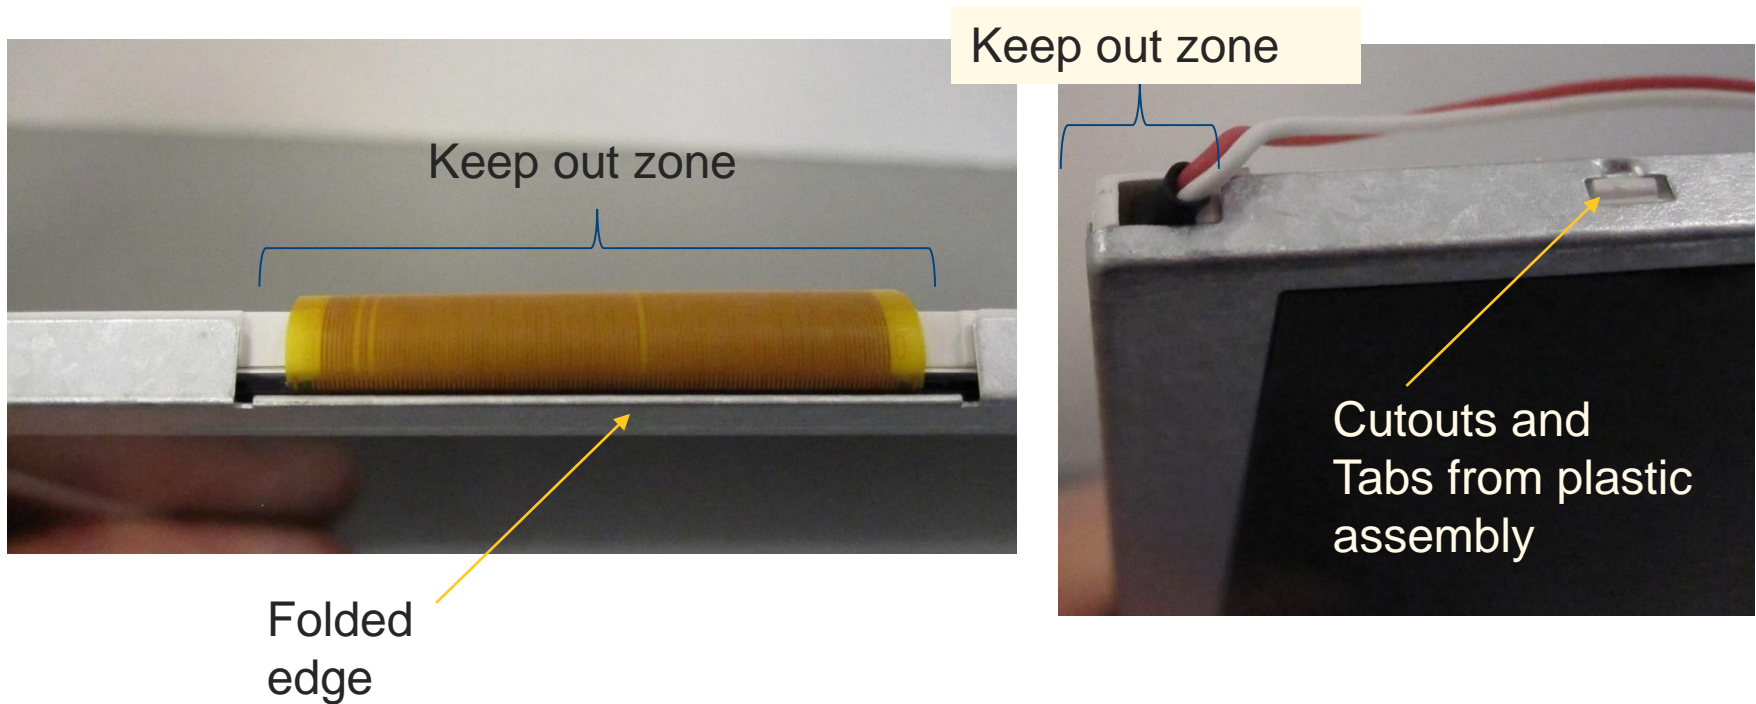
- Key item in a good assembly is a sufficient gap in the housing for the flex and LED power cables
 - There are no sharp edges or pinch points in the vicinity

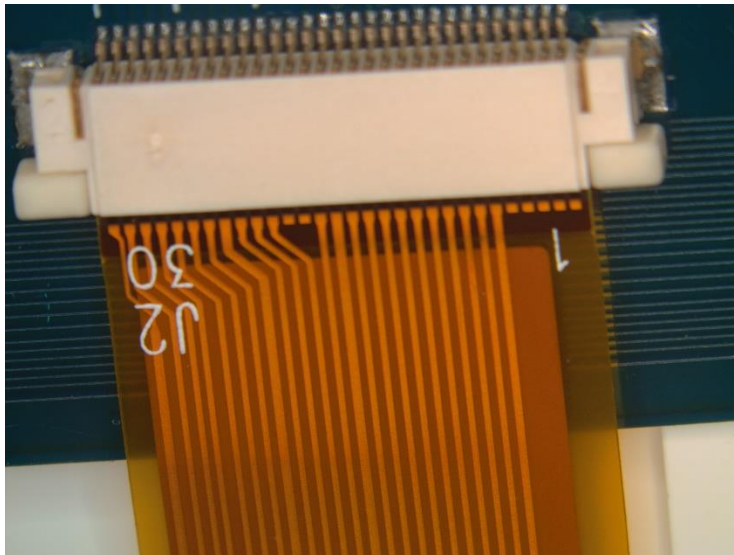
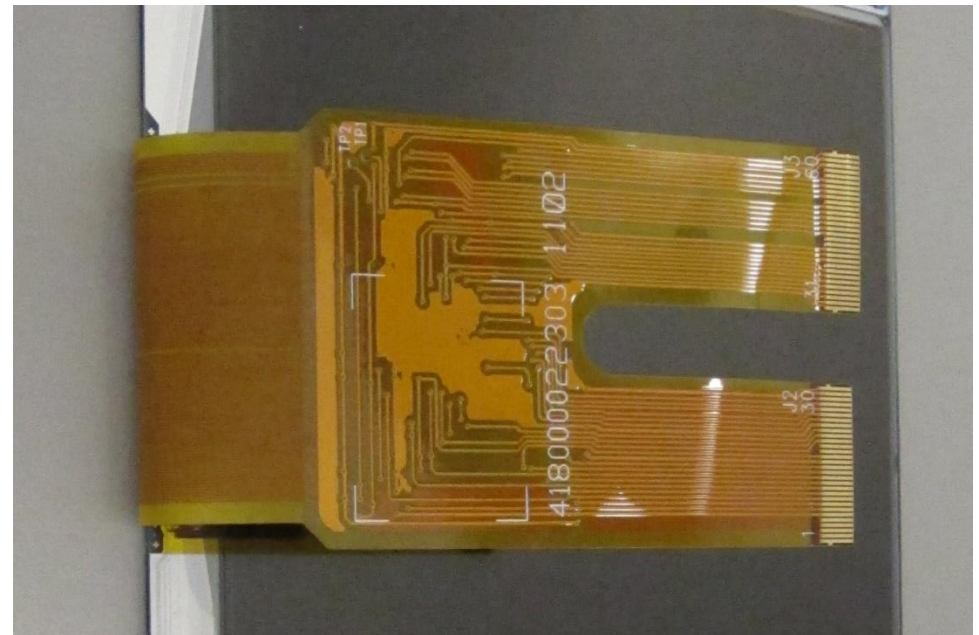
- The flex cables are a good design
 - Corse and thin conductor lines are separated
 - Solid shielding plane does not impair flexibility
 - Single piece of flex with sufficient margin around periphery, tapered angles with no 90° cutouts

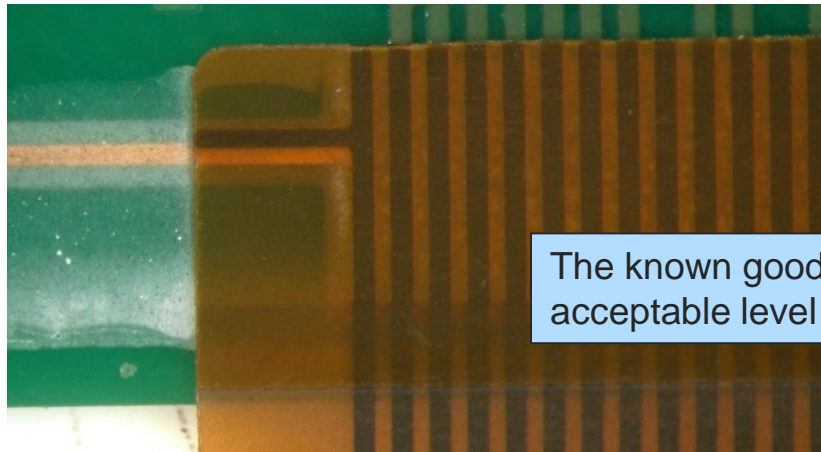
The known good unit has an acceptable level of misalignment

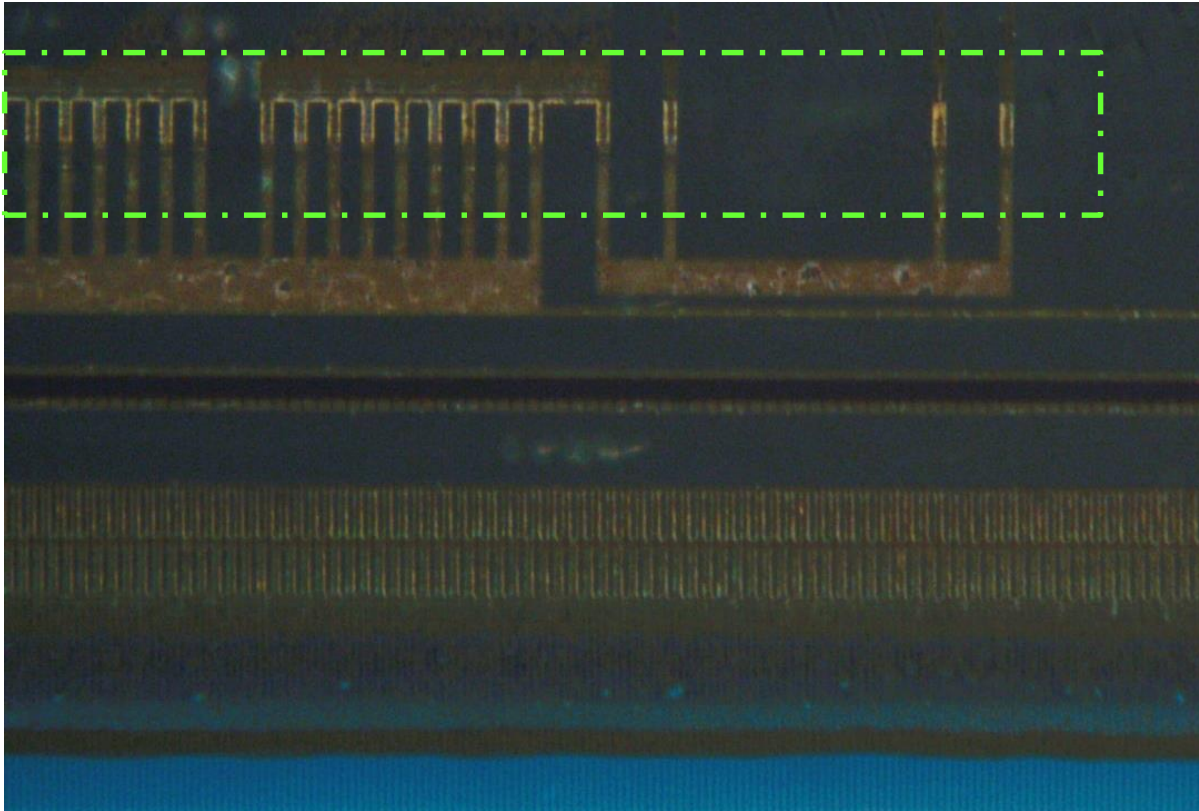
- The chips on glass are concentrically aligned to the bond pads
 - Note the gold-like appearance around each 'black' conductor

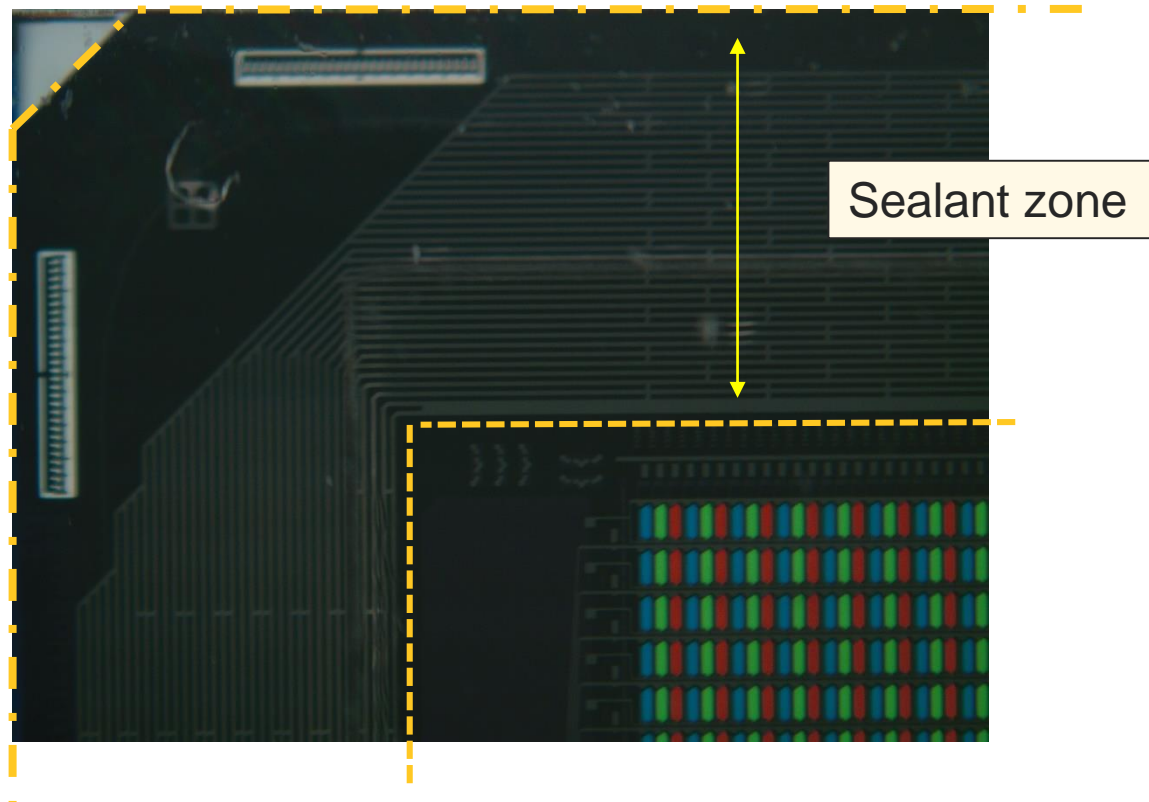
- The perimeter of the glass sandwich is adequately sealed
 - It is worth noting that the particulate matter seen in this image is on the surface of the glass

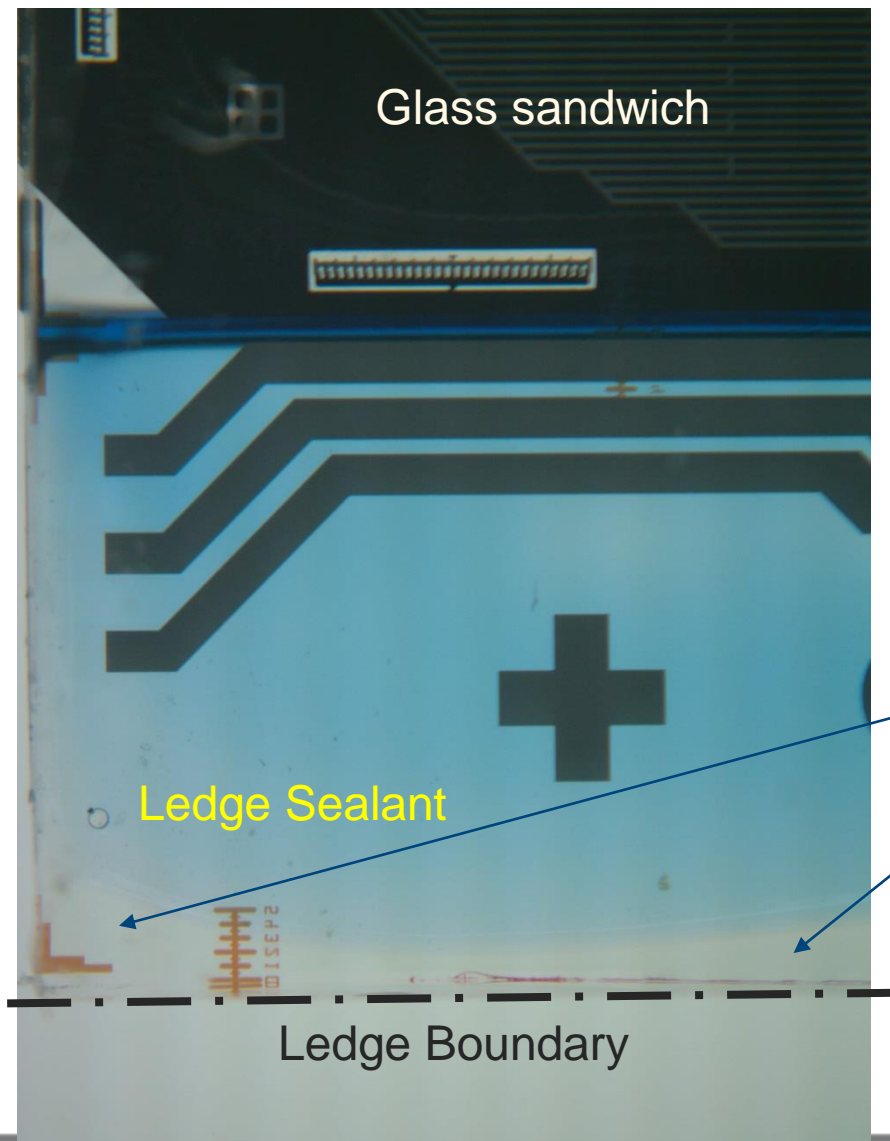
- Another view of the ledge sealant

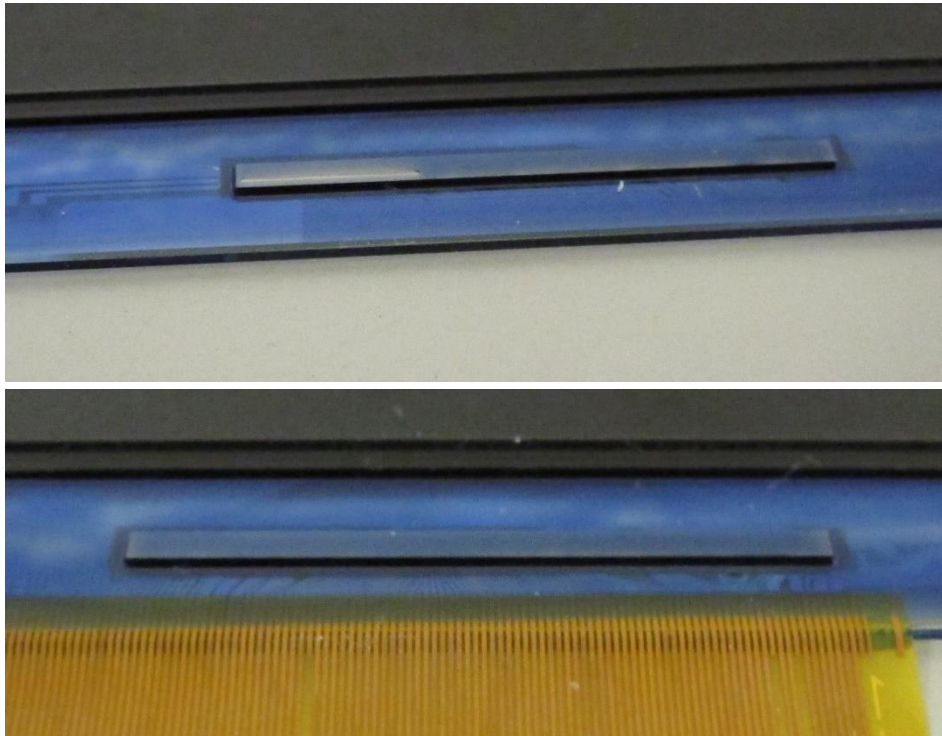
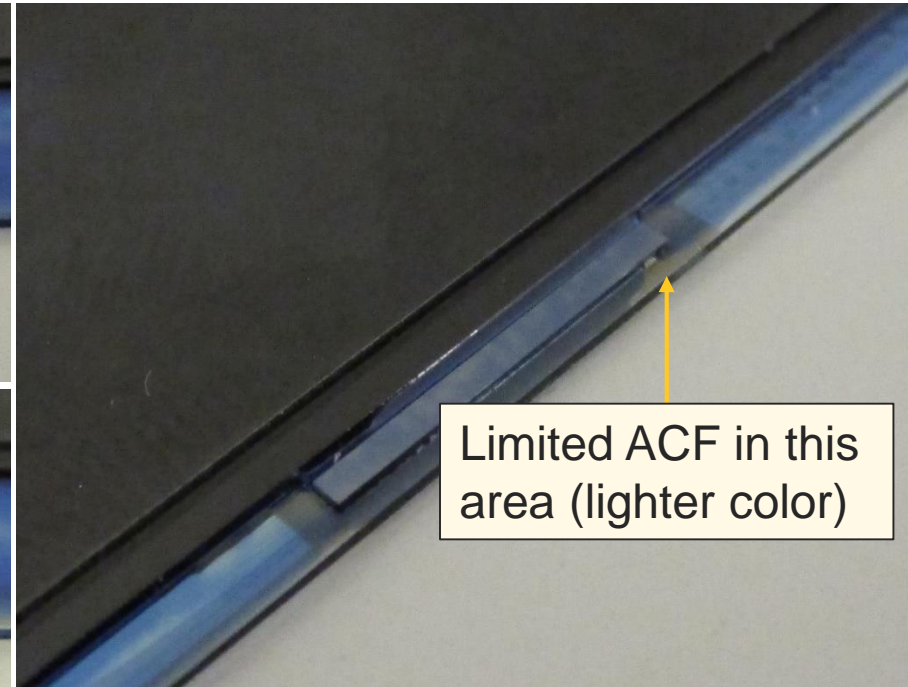
- Three driver chips were identified and shown attached to the ledge at the bottom and right sides
- A squeegeed ACA may have been used based on appearance

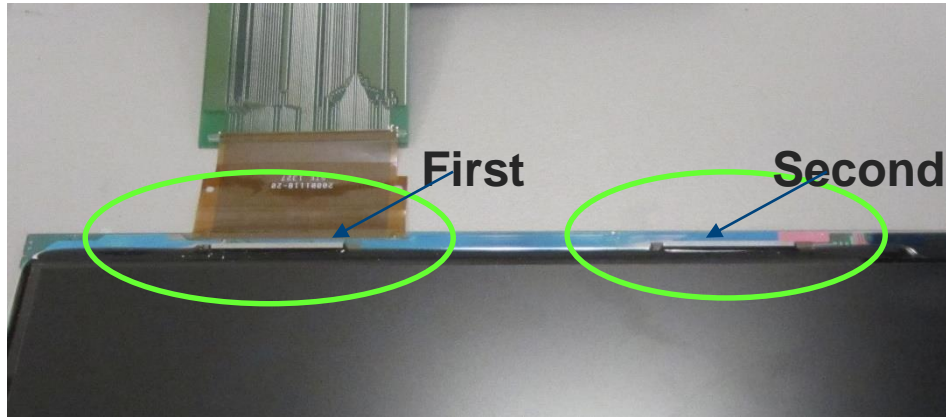
- Driver ICs are connected to glass ledge using hot bar process
 - One IC is adhered to the glass at a time, which creates a stress gradient across the glass ledge
- Elevated bonding force coupled with excessive temperature exposure (long dwells, fast ramp rates) will exacerbate the localized warpage stresses created by the thermal mismatch between the glass, conductive film and the silicon chip.
 - A schmoo plot is shown to depict the warpage associated with controllable process parameters

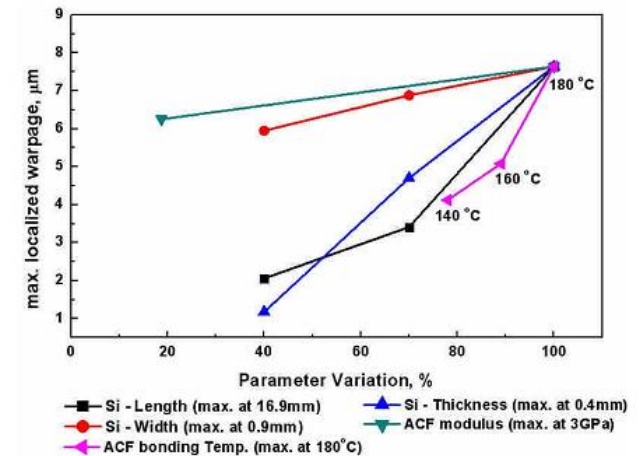
FIGURE 12 —The maximum localized warpage as a function of different parameters: ACF modulus, ACF bonding temperature, and Si dimension (length, width, and thickness) relative to a reference case of 0.3 mm-thick glass and ACF bonding temperature of 180 °C.
