Katrina - Revisited

WHITE PAPER • OCTOBER 2015

by Jerry Beall Technical & Product Specialist for FiberTite Roofing Systems

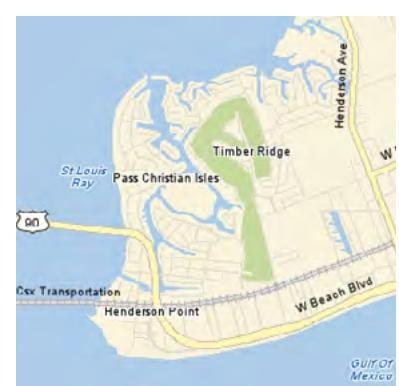
Our first target turned out to be a private school, located right on the point at Henderson Point.

The school was a three story, cast in place, structural concrete building that unfortunately resembled a parking garage when we got there. The lower two floors were cleaned out by the storm surge. Members of a US Geological Society survey team put the surge (28' 2 inches) just over the second story ceiling. The bedrooms on the third floor were basically intact, windows and all. But the bedrooms appeared to be isolated in time amidst the destruction they were clean and neat with bath towels laid out and beds with sheets and covers thrown back.

The roofing system was an aggregate surfaced built up roof. Apart from some general wind scour, and displacement of some of the roof top HVAC, there was no evidence that the 140 mph winds even knew the roof was there. The roof system lacked even the smallest hole that would allow us to see below the built up roof and confirm how the roof was assembled. And we weren't about to cut one into a perfectly good roof. We did know that the deck was virtually air tight and this worked in conjunction with the three foot parapet walls to help the roofing system resist the pressures that had to have been projected upon it.

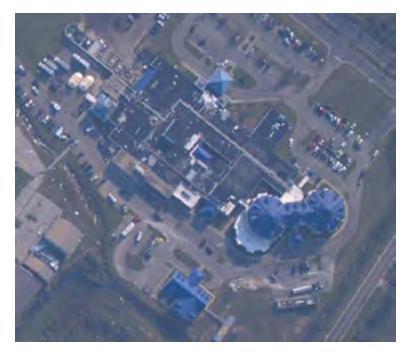
Here we investigated a hospital with a 20 year old mechanically fastened EPDM roofing system and some newer areas that used a mechanically fastened vinyl membrane. The deck was steel with lightweight insulating concrete creating a monolithic substrate. The membrane was attached with metal battens, secured through the membrane with fasteners spaced 12 inches on center at 5 foot intervals. The battens were sealed with a cover strip. There was some damage to the blue standing seam metal roof on one of the cupolas at the south east corner of the hospital but the EPDM roof and the smaller vinyl roof areas were intact with almost no damage except for some built up roofing debris that came from a small shopping center across the way.

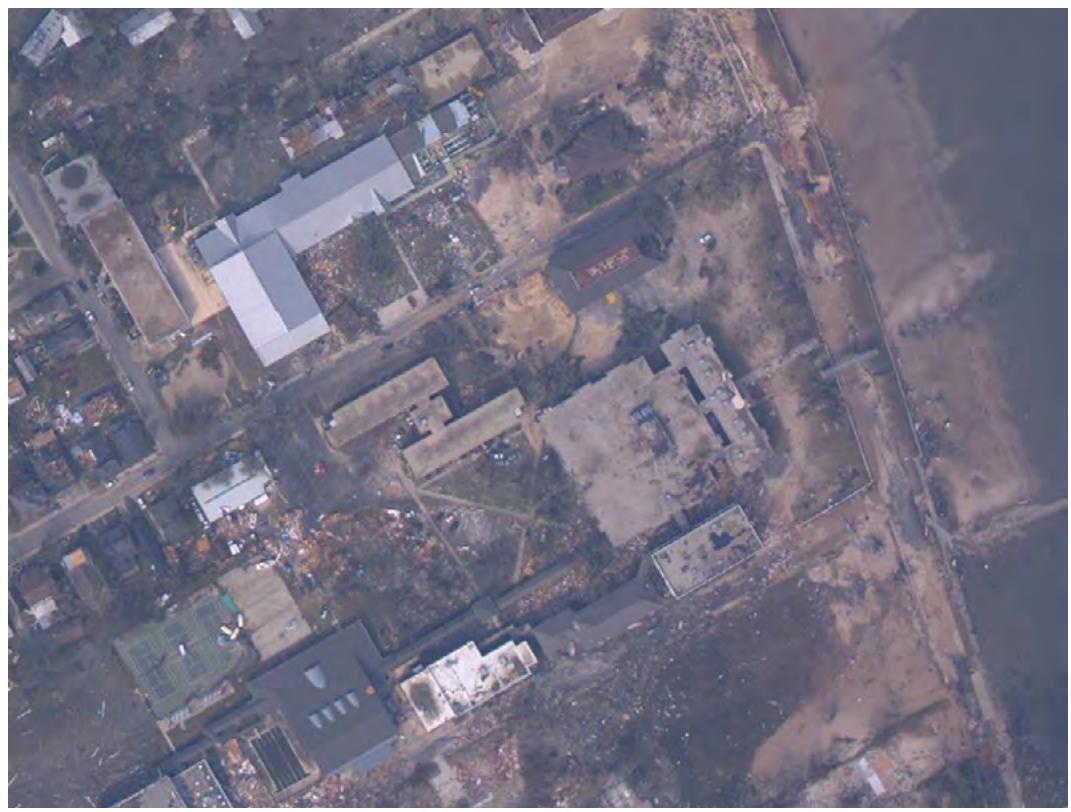
Another private school also on the bay...

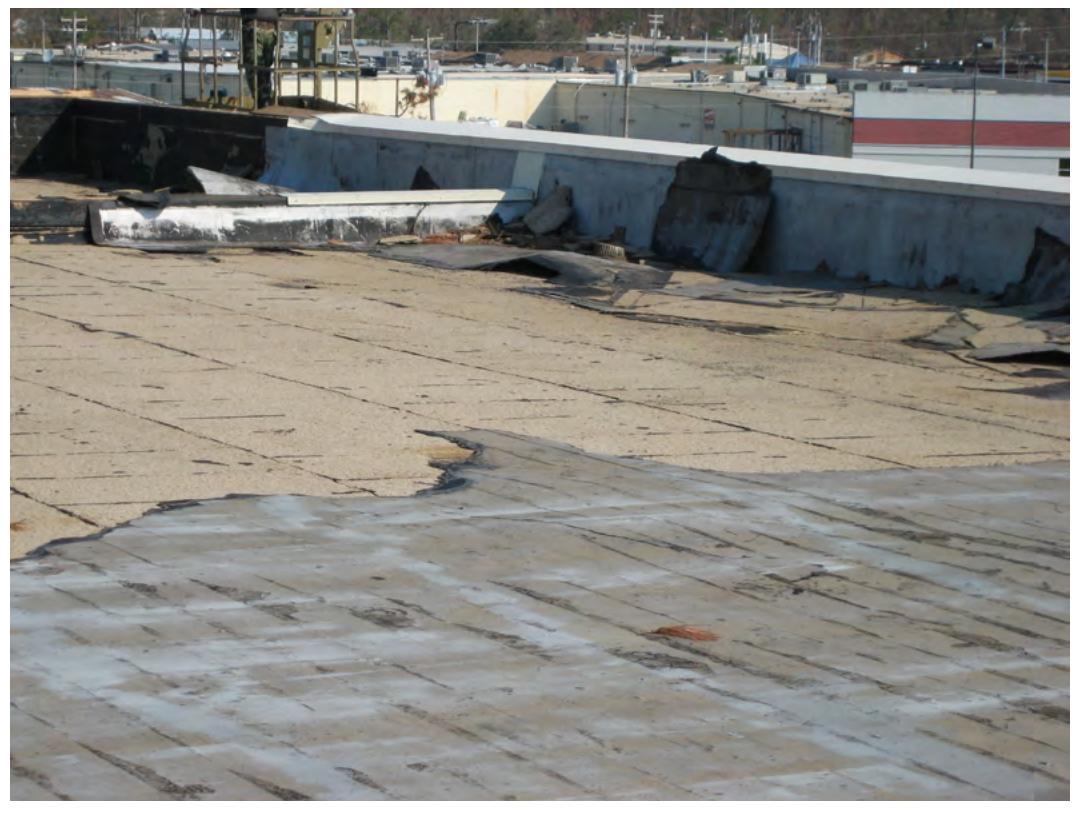
With this type of dramatic pressurization, the entire roof cover can blow off but in this case it created its own peel stop, although a bit too late. The membrane eventually tore apart as the weight of the air borne portion increased.
