Plastic Injection Molding Fluid Cleanliness

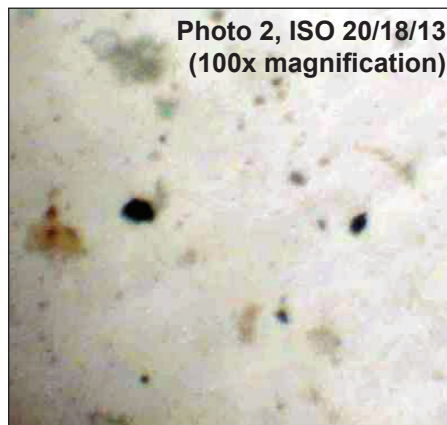
A PM-1 particle monitor was used to identify the most contaminated system. This system contained approximately 110 gallons of hydraulic fluid with an ISO cleanliness code of 21/19/14 (photo 1).

The cart with the competitors elements was allowed to run on the system for 1.5 hours. In this time the ISO cleanliness code of the system dropped from 21/19/14 to 20/18/13. Subsequently Hy-Pro HP709L20-1MB elements were installed in place of the rolled paper elements. Hy-Pro's full-flow design including pleated media and radial flow-path allow the diverter/bypass valves to be closed. Thus, 100% of the flow going through the filter cart was also passing through the filter elements. After 13 minutes of flushing with the Hy-Pro element the ISO code had dropped to 18/15/11 and after 30 minutes the ISO code reached 16/14/10 which is an acceptable cleanliness code for systems operating with servo valves. After one hour the ISO code was 14/12/10 (see photo 3). After 3 hours of flushing the ISO code plummeted to 10/9/1.
