Uses of Abaqus/Standard in Failure Analysis

Matthew T. Kenner, P.E., John A. Wilkinson, P.E.,

Engineering Systems Inc.

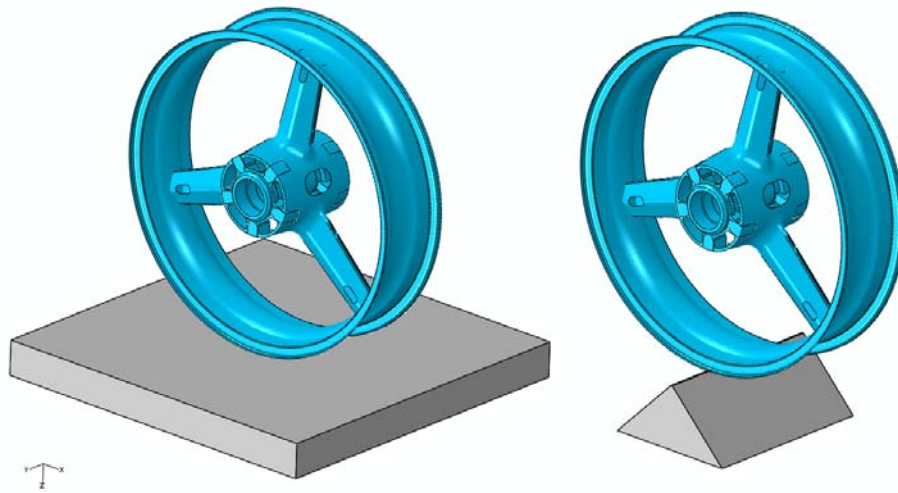
Figure 2. Model of the motorcycle wheel with a flat load block (left) and an edge load block (right).

In order to assist in resolving this question, Abaqus was used to compare the behavior of the wheel when loaded by a flat surface (i.e. coming down hard on the road) to that of the wheel when loaded by a 90° edge (i.e. the top corner of a concrete block wall). The two models are shown in Figure 2. While the load-deflection response of the wheel was of interest, the physical signatures of the wheel as a result of the different loads were also very important to assist in the interpretation of the physical evidence.

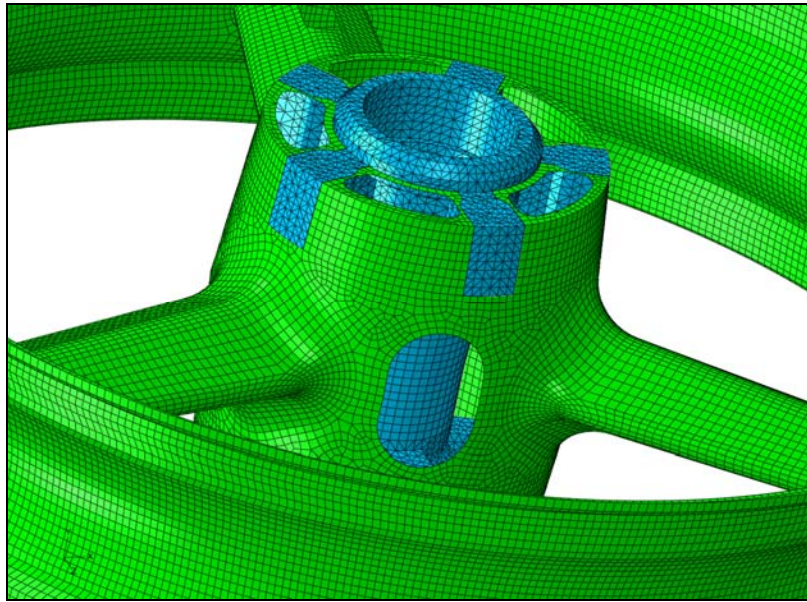
Figure 3. Details of the motorcycle wheel mesh.

Most of the wheel casting was modeled with shell elements, but material thicknesses in the vicinity of the axle dictated the use of solid elements (a combination of tetrahedron and hexagonal elements joined by ***TIE** constraints). The transition between the solid and shell elements utilized ***shell to solid coupling** to properly transfer forces and moments across the transition. Details of the mesh are shown in Figure 3. The loading blocks were modeled with analytical rigid surfaces. Display bodies were added to the model to simplify visualization of the rigid surfaces during post processing. Each model had roughly 500,000 degrees of freedom and the analyses were run on a PC with two processors.

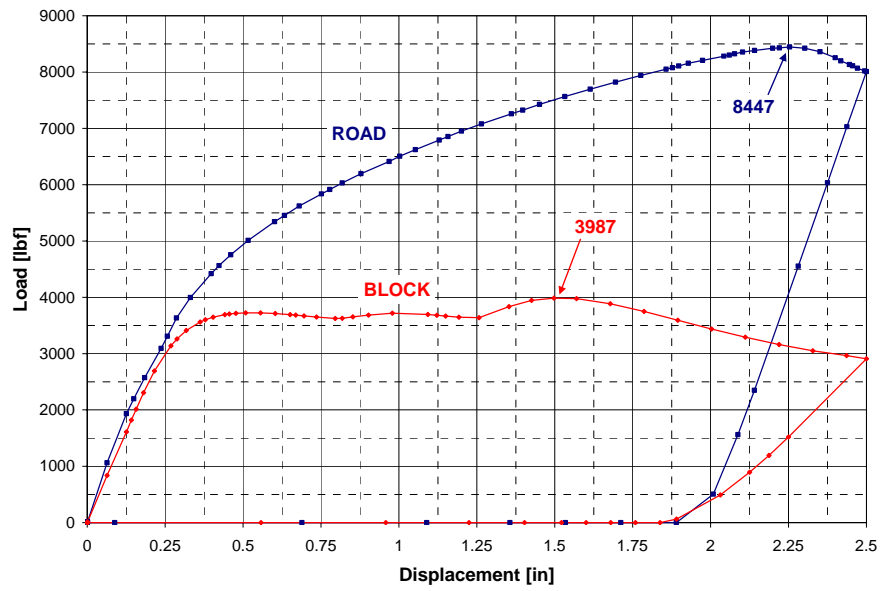
Figure 4. Motorcycle wheel load-deflection curves.

The load-deflection curves for the analyses are shown in Figure 4. The von Mises stress results under full load block displacement are shown in Figure 5 and Figure 6. The load-deflection curves show that the maximum displacement requires more than twice the load for the flat load block. Also, the load curve flattens much more quickly with the edge load block. In both cases, the load on the wheel is severe; with stresses at, or near, the ultimate true stress of 51,000 psi. This is to be expected, given the significant impingement by the load block and the fact that the subject wheel fractured in numerous locations (Figure 1). In both cases, the area of loading experiences some of the highest stresses. Additional areas of high stress are the intersections of the spokes with the hub and the rim. All these areas were fractured in the subject wheel. Note, though, that the results from the flat load block show high stresses in areas that did not fracture on the subject wheel, indicating that contact with a flat surface may not have been the most probable scenario.

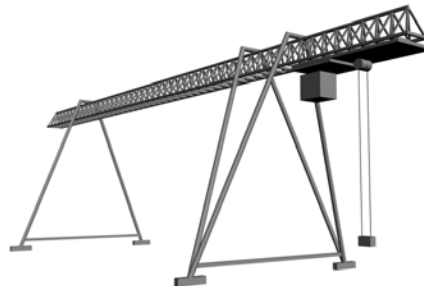
Figure 9. General arrangement of the subject portal crane.

The subject crane was a portal crane used at a lumber yard. Portal cranes come in many configurations, but this particular crane used a structural arrangement similar to the generic portal crane shown in Figure 9.

During the subject accident, the portal crane failed as the cab, hoist and load approached the extreme end of its travel on the outboard side of the larger vertical supporting member, as indicated in Figure 9.

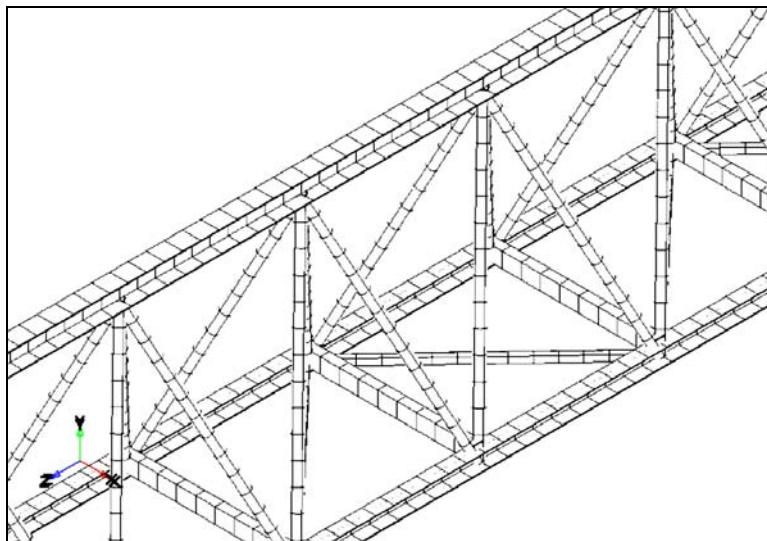
Figure 10. General arrangement of the space frame.

The main structural member of the portal crane was a long space frame with a triangular cross-section. It used one built-up beam as the top chord and two built-up beams, separated by intermediate and diagonal bracing, as the bottom chord. The operator's cab and hoist assembly was suspended from, and travelled along, the bottom chord of the space frame. A network of diagonal pipes was used to connect the top and bottom chords of the truss to create the final geometry of the space frame. Figure 10 illustrates the general arrangement of the space frame and the three beams used as chord members.

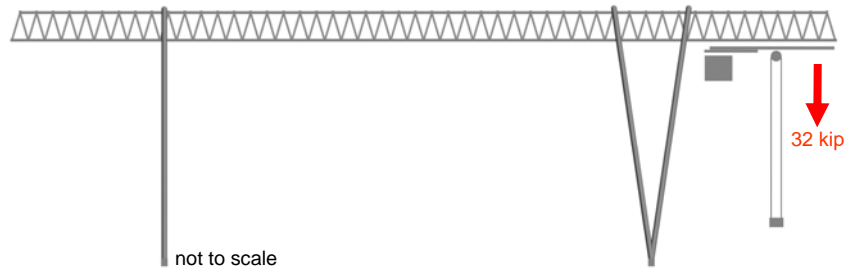
Figure 12. Vertical load case.

The space frame members were modeled using beam elements. Various loading scenarios were examined during the investigation, but in the end a single critical load case was identified as being the most likely cause of the failure: normal operation with the cab, hoist and load located at the extreme end of the space frame, outboard of the larger vertical support, as shown in Figure 12. This location results in a maximum 32,000 lbf downward vertical load being applied at the right-hand end of the space frame.

This downward vertical load produces tension in the top chord at the failure location, which is consistent with the fatigue cracking observed at the failure location, and the final sudden failure that occurred at the time of the accident. Therefore, the nodal displacements acting on either side of the failure location for this load case were extracted from the 3D global model and used to drive a refined local model. This detailed model was used to more precisely determine the local stresses that may have caused the fatigue cracking that led to the final failure.
