Issue

Spotlight: A Risk-Based Approach for Combustible Dust Hazard Mitigation

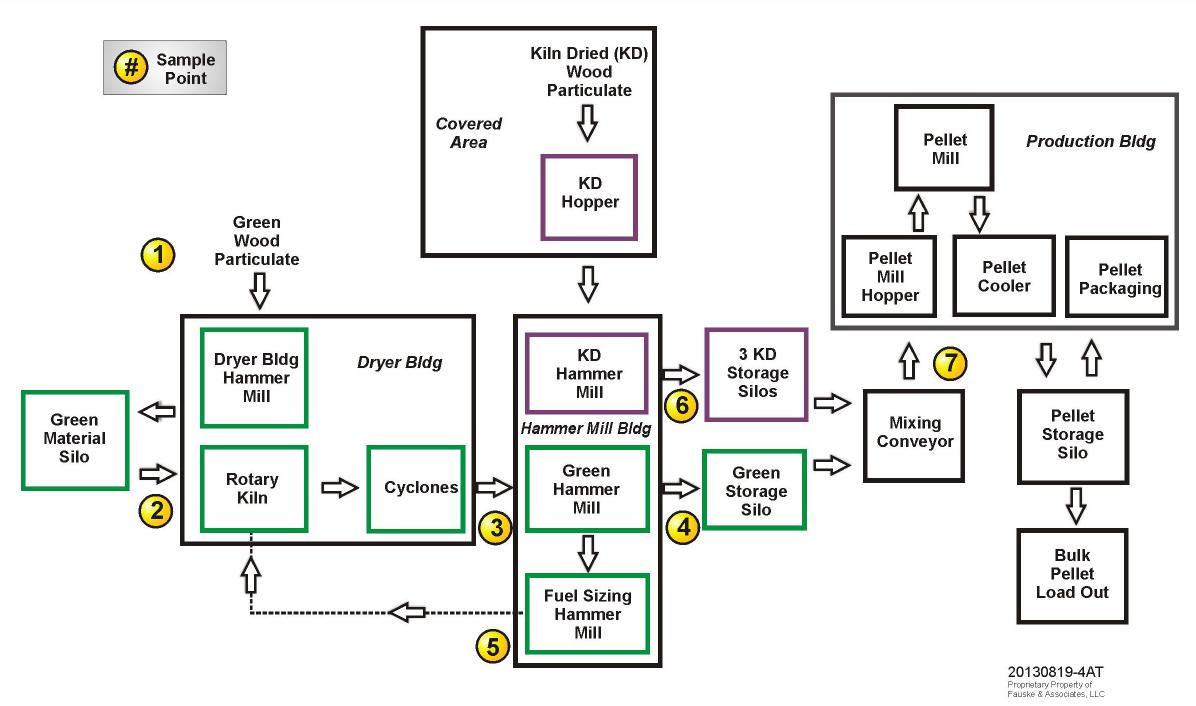
Figure 4. Process Flow Diagram

This plant receives both green and kiln-dried (KD) wood particulate that it handles separately until storage prior to pellet making. Figure 4 provides a process flow diagram of the pellet making process and identifies both green and KD wood particulate sampling points identified in the sampling plan.
