Nuclear Materials and Energy 000 (2016) 1-17

Safety insights from forensics evaluations at Daiichi

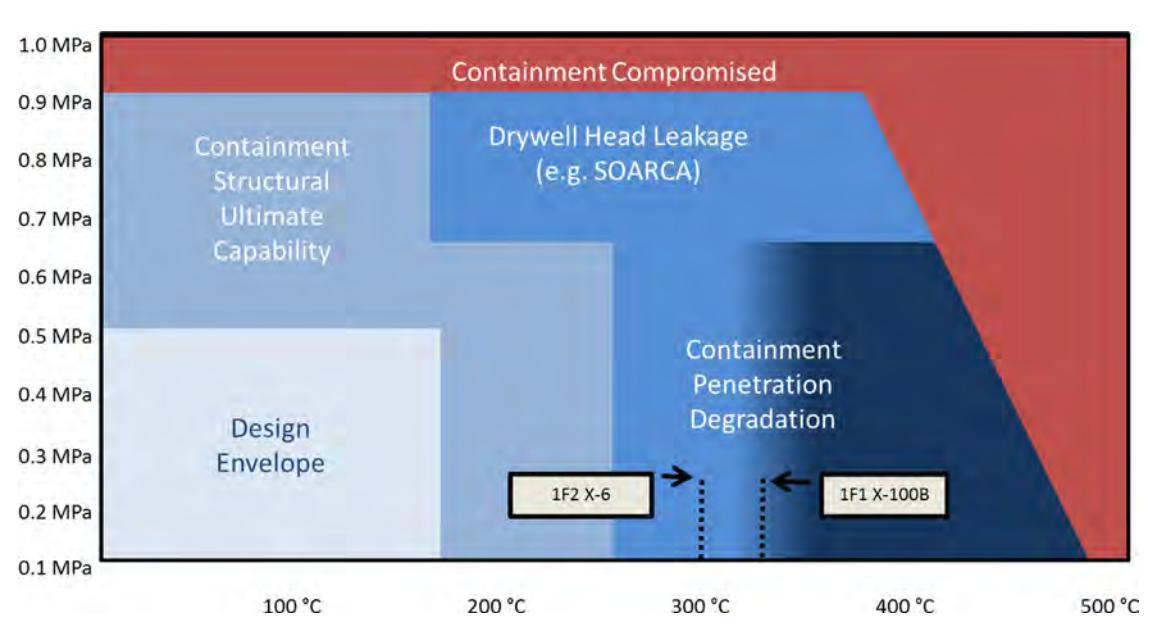
Fig. 4 shows available peak Daiichi information on a figure provided in NEI 13-02 industry guidance for venting[49]. The DW vent is assumed to have a design temperature of 285 °C/545 °F, and containment penetration degradation temperatures are based on engineering evaluations and testing information in the literature. Black lines in Fig. 4 correspond to peak temperatures inferred from currently-available 1F1 and 1F2 examination information. These values are consistent with the values assumed to cause degradation in NEI 13-02; thus, available Daiichi information support revised industry guidance recommending that operators maintain containments at low pressure.

Fig. 4. Containment pressure/temperature curve with available 1F1 and 1F2 information. (Graphic courtesy of NEI [49] as modified by Jensen Hughes).

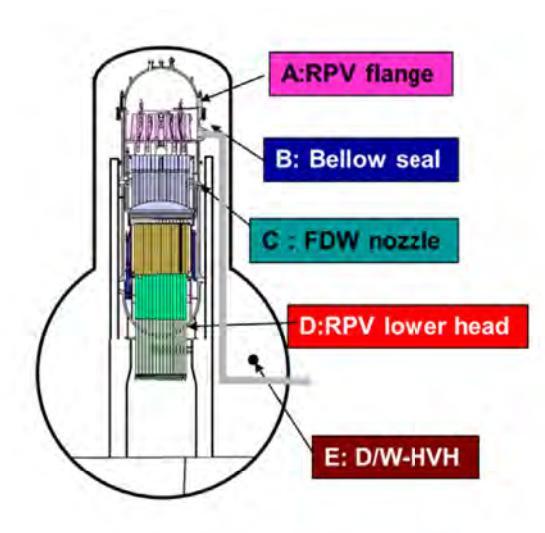
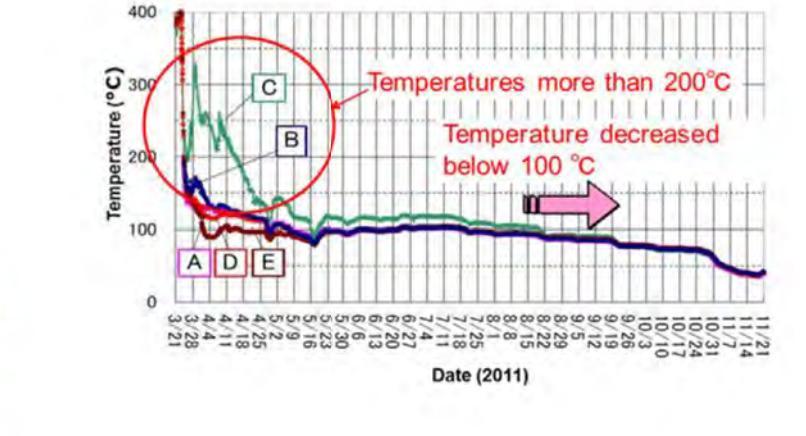
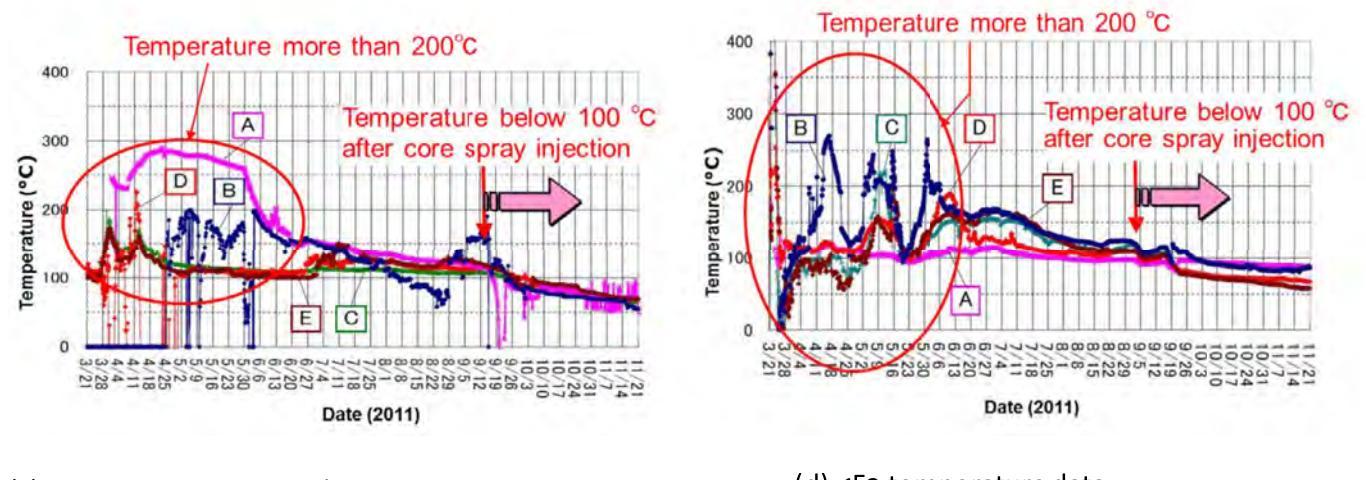
On this basis, TEPCO changed the water injection from the FDW system to the core spray (CS) system in the September 2011 timeframe for 1F2 and 1F3, while this change was made in late December 2011 for 1F1. This injection method directly introduces a water spray from above the core. As shown in Fig. 5c and d, this changed injection point caused the RPV temperatures for 1F2 and 1F3 to be reduced to coolant saturation temperature, which is the expected condition when core debris is covered with water. However, as shown in Fig. 5b, this change had little if any impact on 1F1; RPV temperatures had already fallen below saturation. This suggests that some fraction of fuel remained in the RPV for 1F2 and 1F3, but most of the core debris was likely exvessel for 1F1. This information does not rule out the possibility of ex-vessel core debris for 1F2 and 1F3; however, there is likely some fraction of core debris in-vessel that caused elevated temperatures to occur when water was introduced via the FDW system.

(a) Thermocouple position (RPV- reactor pressure vessel; FDW- Feedwater; D/W – Drywell; HVH
 -Heater Ventilating Handling)

(b) 1F1 temperature data

(c) 1F2 temperature data

(SAG) development. In particular, the data illustrate the benefit of injecting though core sprays for BWRs; this method optimizes the probability that core debris will be contacted by and cooled with the injected water, even if there are leaks in the pressure vessel.

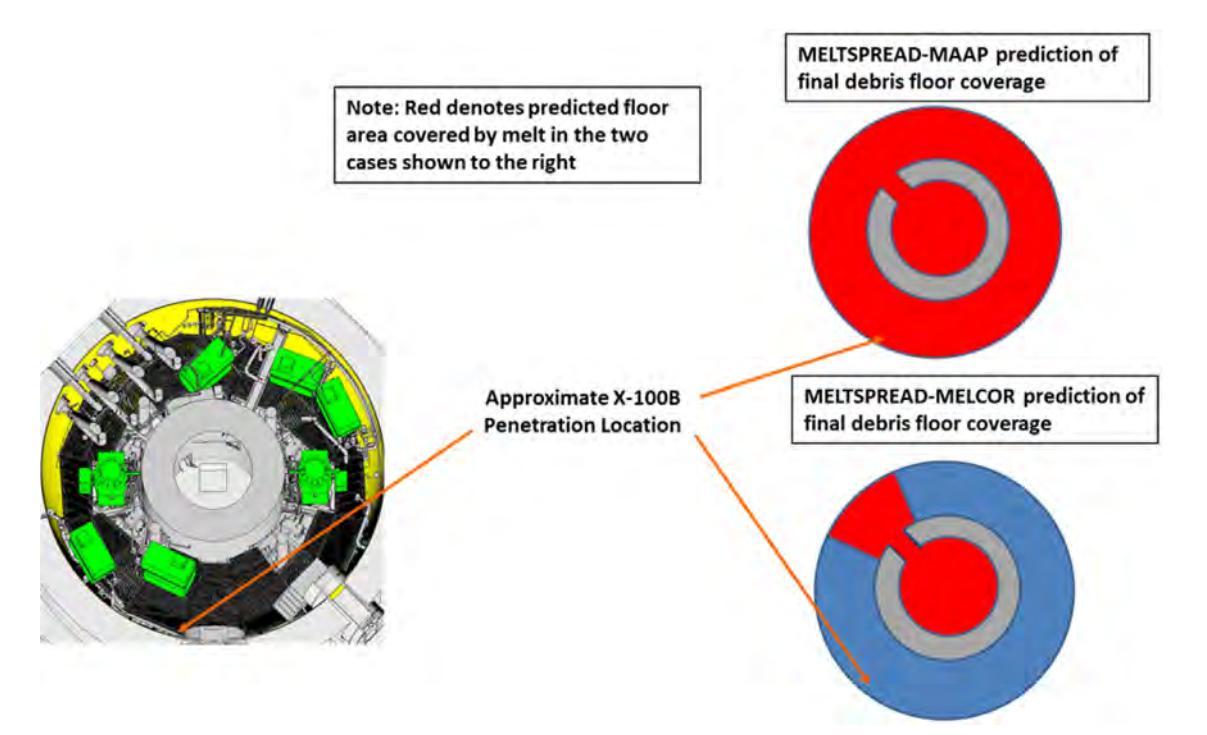
Upon gaining access through this penetration, TEPCO initially lowered a video camera through the catwalk to the drywell floor to measure water level, temperatures, and radiation levels inside the PCV. These inspections showed that there was no core debris on the drywell floor at this location, which is ${\sim}130^\circ$ from the pedestal doorway (Fig. 6). This finding was important as it provided a data point for assessing predictions of ex-vessel core melt spreading based on MAAP and MELCOR pour scenarios as calculated with MELTSPREAD [56]. As is evident from Fig. 7, the measurement indicates that the MELTSPREAD prediction of spreading distance based on MAAP pour conditions over-predicts the actual spreading distance. Conversely, this single data point is insufficient to gauge the accuracy of the MELTSPREAD-MELCOR prediction as the spreading prediction for that case is limited to the vicinity of the pedestal doorway. Nonetheless, this initial observation through this penetration has been useful in reducing the range of possibilities regarding the extent of melt spreading in 1F1.

Fig. 7. Approximate Location of X-100B penetration relative to predictions of core debris spreading in 1F1. (Courtesy of TEPCO and ORNL [55, 56]).

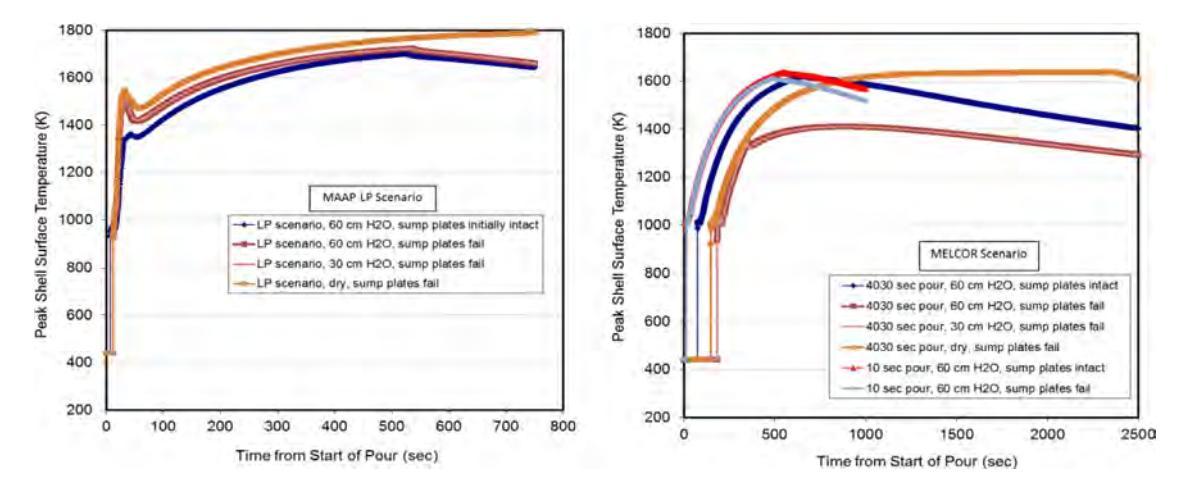
Another important finding regarding ex-vessel behavior is that the sand cushion drain line is leaking in 1F1[6]. This indicates that there is a leak through the PCV liner. Examinations did not detect water leakage from the bellows on the downcomer, but observations were limited. MELTSPREAD analyses [56] of liner heatup (Fig. 8) indicate that the liner would not have ablated based on either the MAAP low pressure (LP) or MELCOR pour scenarios [51,52]. However, analyses predict that the liner would have heated significantly, making it vulnerable to failure by creep rupture due to the elevated containment pressures (\sim in excess of 1.5 times the design pressure). Hence, liner failure is consistent with code predictions and with measured radiation levels in the 1F1 reactor building.

Fig. 8. MELTSPREAD predictions of liner heatup due to heat transfer from impinging melt for 1F1 based on a MAAP low pressure (LP) scenario (left) and MELCOR (right) melt pour conditions. (Courtesy ORNL, [56]).

from creep rupture of the PCV liner due to the elevated containment pressures (in excess of 1.5 times the design pressure) at the time of the accidents. Liner failure in 1F1 is consistent with MELTSPREAD code predictions and with measured radiation levels in the 1F1 reactor building.

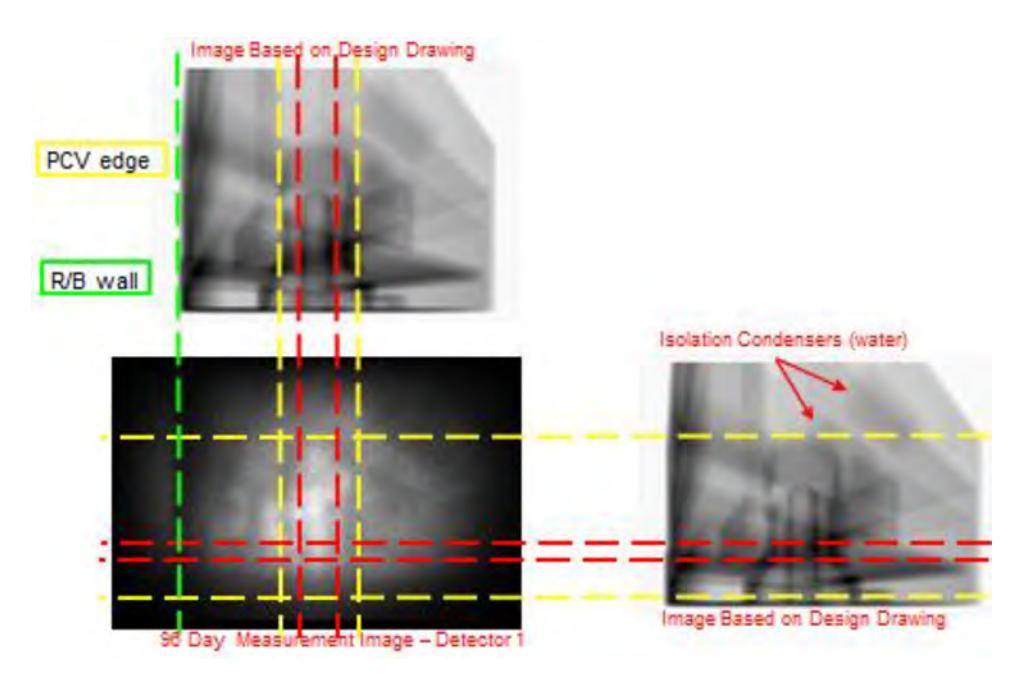
Muon tomography measurements using scintillation detectors are another information source that has been extremely valuable for evaluating debris end-state conditions for 1F1 (see Fig. 9) [10]. Using this approach, high density fuel should show up as dark regions in the images due to muon attenuation. As shown in Fig. 9, the core region appears to be essentially devoid of core material. The findings for 1F1 are consistent with previously described system-level code analyses. [51,52]

Fig. 9. Images of 1F1 obtained using muon tomography with scintillation detectors (the lower left image is measured; the other two images were calculated. Dashed lines are provided to show location of identified geometrical features). (Courtesy of TEPCO [10]).

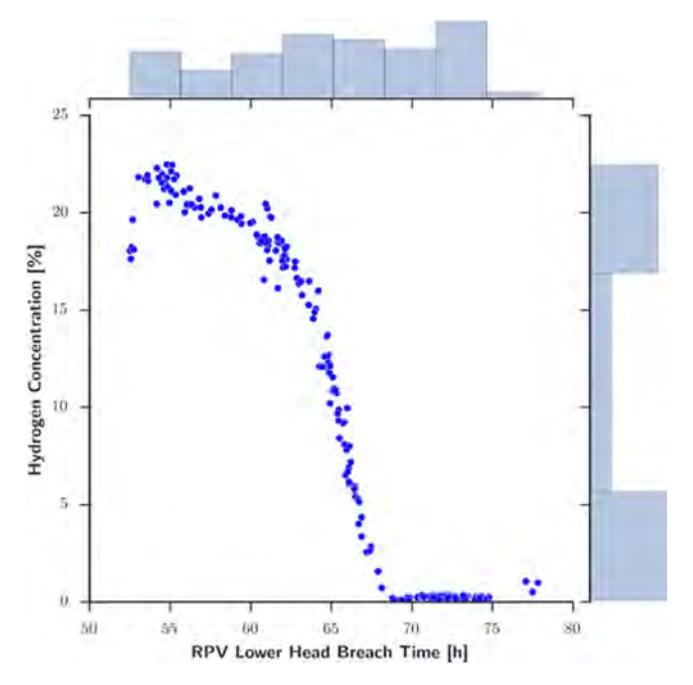
Fig. 16. MAAP 1F3 modeling uncertainty evaluation: refueling floor hydrogen buildup at time of 1F3 RB explosion. (Courtesy of EPRI [67]).

dictions for hydrogen production. Differences between code predictions stem from a lack of experimental data that would clarify appropriate modeling assumptions regarding in-core melt progression behavior. As a result, the two codes predict different amounts of in-core hydrogen generation, with MAAP5 typically predicting lesser amounts relative to MELCOR [54]. Evaluations with MAAP5 indicate that this modeling uncertainty has important consequences for predicting flammable conditions in the 1F1 and 1F3 reactor buildings. Figs. 16 and 17 compare results from a MAAP5 uncertainty evaluation of the 1F3 accident [67]. These figures show the predicted hydrogen concentrations on the refueling and fourth floors of the 1F3 reactor building, respectively, at the time of the actual 1F3 explosion (68.7 h after the earthquake), versus the timing of RPV lower head breach.

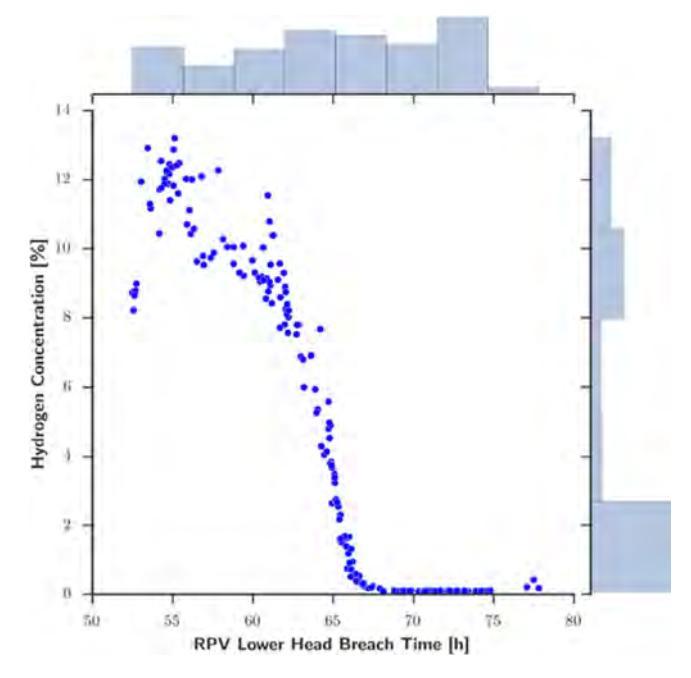
Fig. 17. MAAP 1F3 modeling uncertainty evaluation: fourth floor hydrogen build-up at time of 1F3 RB explosion (Courtesy of EPRI [67]).

in-vessel retention, at least up to the point of the actual 1F3 RB explosion, do not support the necessary conditions for combustion. This is due to relatively low amounts of in-core hydrogen generation being predicted. By contrast, MELCOR simulations can evolve enough hydrogen to reach the necessary conditions for flammable gas combustion in the RB[68].
