Service Letter

NUMBER: 20-103

SUBJECT: Modification of Instrument Panel & Manifold Pressure System

MODELS AFFECTED: M20C, Serial Numbers 1852, 1940 through 2575
M20D, Serial Numbers 1, 101 through 190

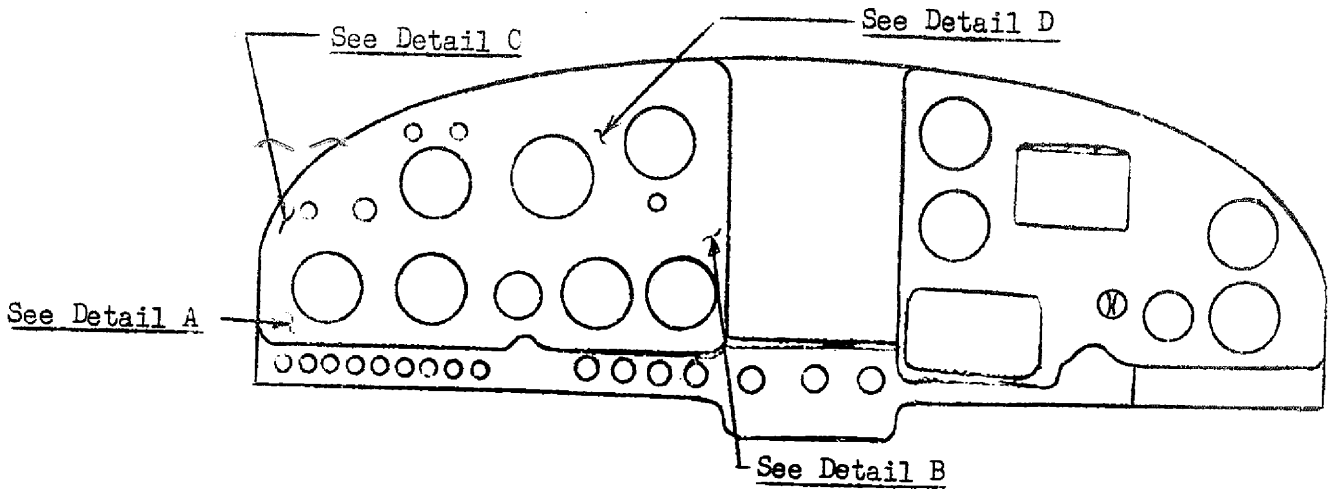
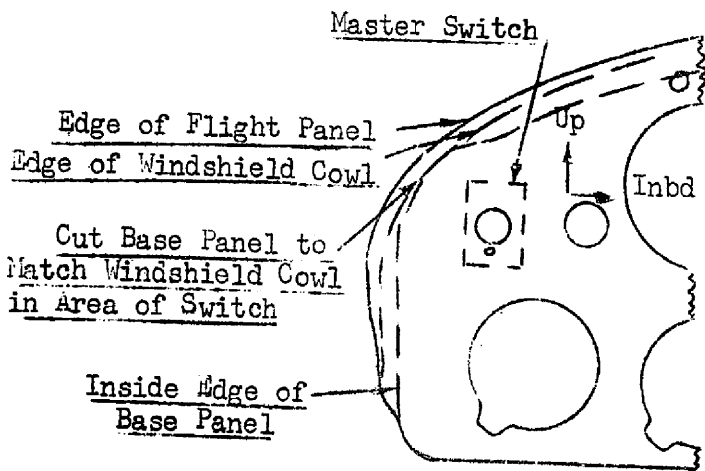
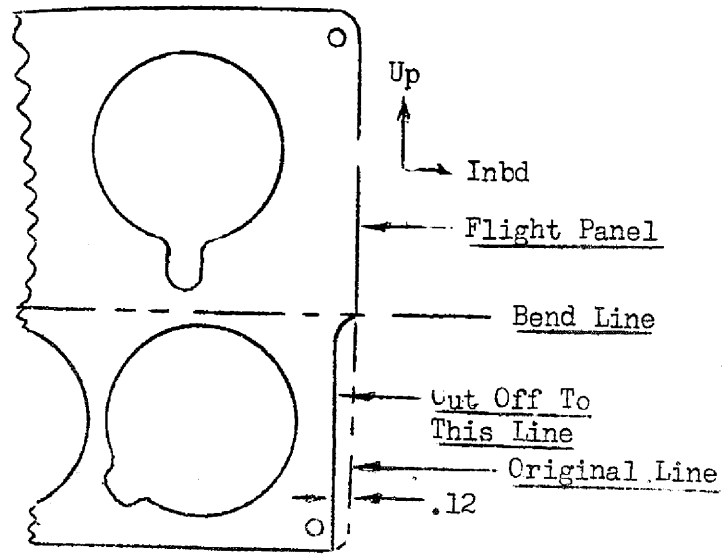
TY-27 Nylon Straps (2)
Joints Between Instruments as Shown

1. Remove the flight panel from the aircraft.
- *2. Modify the base panel cutout as indicated on Page 3, Detail A (located on Page 2 top).
- *3. Modify the flight panel as shown on Page 2, Detail B (located on Page 2 top).

- *4. Modify the base panel in the area of the master switch as indicated on Page 2, Detail C (located on Page 2 top).
5. If a rotary file, hand file, or grinder is used to remove the metal from the base and flight panel, the instrument should be removed from the panel. The vibration caused by filing and grinding could easily damage the sensitive bearings of the instruments.
