Rock Slope Remediation at the Penobscot Narrows Bridge

**Bryan C. Steinert, P.E., Laura Krusinski, P.E., Amber B. Granger, P.G., and
Wayne A. Chadbourne, P.E.**

Abstract

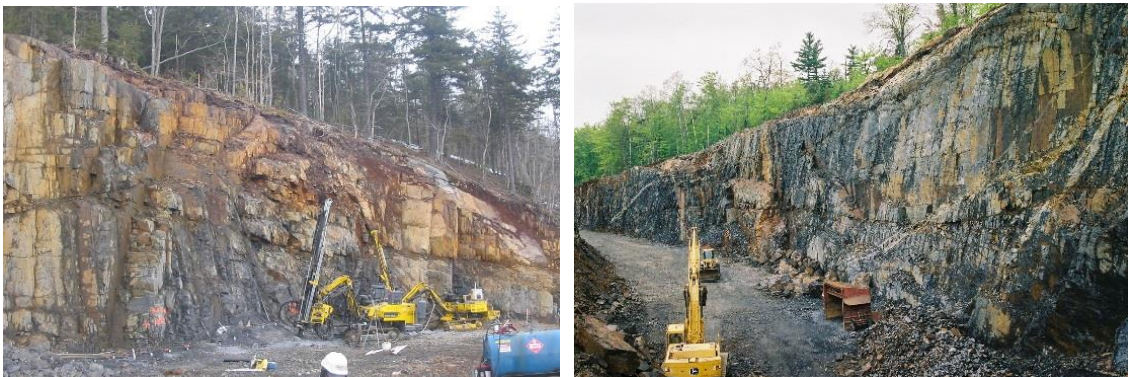
Figure 6 – Blasting and Rock Slope Excavation

Perimeter control and production blasting and excavation of the rock slope began in late 2004/early 2005 and was substantially complete by June 2005. Construction progress photographs are shown below on Figure 6. The completed rock slope is shown on Figure 7.

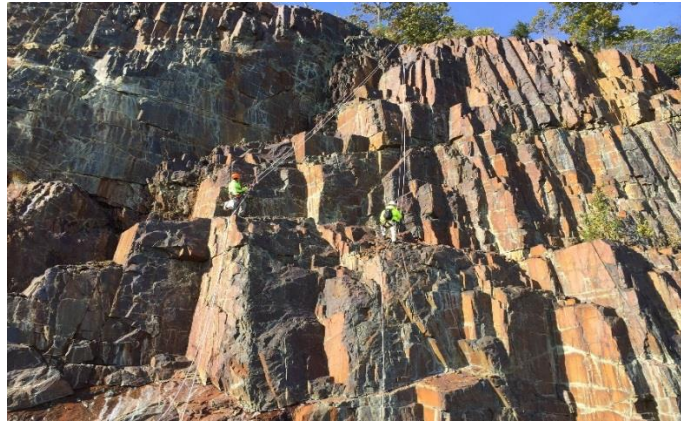
Figure 8 – Site Inspection using Rope Access Techniques

A site inspection was completed by a two-person team of Haley & Aldrich engineering geologists in October 2015 that allowed for a detailed examination of several rock slope Areas previously ranked as “most critical” and “moderately critical”. Rope access techniques were used, as shown in Figure 8, to descend the rock slope face from the area above the top of the slope.

The rope access approach allowed Haley & Aldrich personnel to directly observe rock structure and the spatial relationships between rock blocks that were not visible or discernable by routine observations made from the base (roadway level) or from the top of the rock slope. Observed attributes included near-vertical separation joint orientations controlling potential block release, zones of weakened and sheared rock, sliding plane conditions where controlling joints dip out of the rock slope face towards the roadway, and measurements of rock block and other critical area dimensions. Observation and documentation of the rock slope conditions also included determining the structural geologic properties of the bedrock (e.g., discontinuity dip and dip direction, frequency, infilling, visible seepage, persistence, aperture) and rock mass properties (e.g. weathering/ alteration, estimation of intact rock compressive strength).
