# Problem solving

**Maki Onari, William D. Marscher, Eric Olson, and Chad Pasho, Mechanical Solutions Inc., USA**, introduce a specialised testing method to resolve problems that can arise in natural gas turbines.

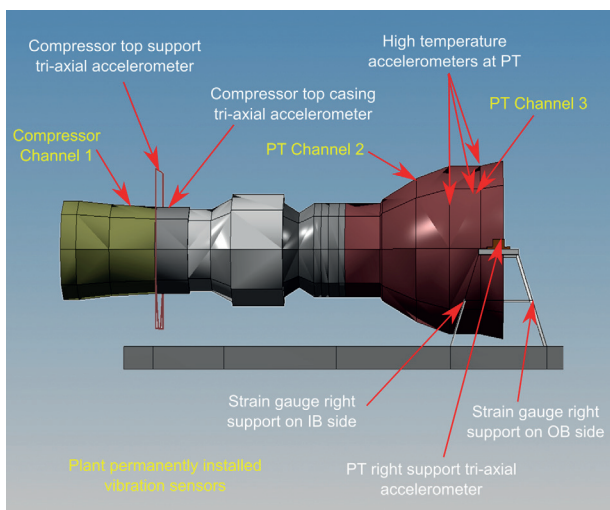
**Figure 2.** Gas turbine test instrumentation utilised starting at the LP compressor (left) to the PT (right).

Figures 2 and 3 show some of the temporarily installed accelerometers, radial proximity probes, strain gauges and a shaft torque gauge using a telemetry system. This CM test gathered vibration, strain, and torque data during idle operation for 2.5 hr and loaded operation for an additional 3.5 hr on the

same day. The data indicated that the PT vibration amplitude was reduced by over a factor of 2 when the PT speed increased by only 7% from 6850 rpm to 7355 rpm. Figure 5 shows the trend plot from the strain gauges mounted on each side of the PT support 'A' frame (see Figure 2). This strain indicated that once the turbine is loaded, the strain value increased by a factor of 2 in tension, when the vibration was reduced considerably. This implies that during idle operation, the supports of the turbine need additional pre-load to reduce this high vibration. The correct pre-load needs to be applied between the pylons and the pillow-blocks, accounting for the support underneath the turbine. Also, note the variation, or 'hunting', of the right support, suggesting looseness.

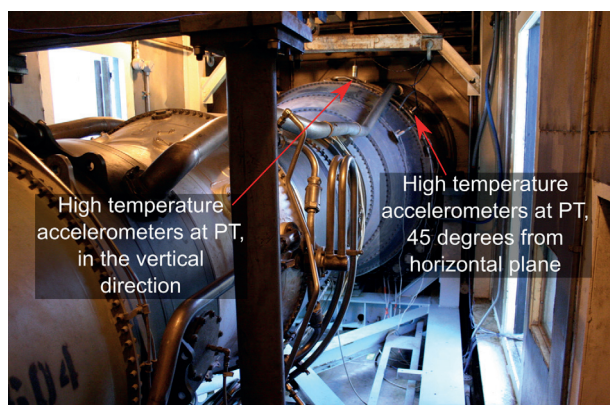
**Figure 3.** A view of some of the high temperature temporary uniaxial accelerometers.
