# VIBRATION FAILURES

DYNAMIC TESTING AND FINITE ELEMENT MODELING HAVE BEEN SUCCESSFUL DIAGNOSTIC METHODS

MAKI ONARI & CHRIS HURRELL  
MECHANICAL SOLUTIONS, INC.

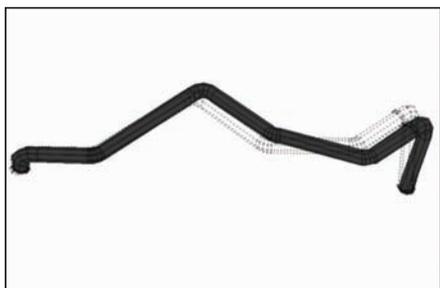
**Figure 5: Mode shape of the discharge piping at natural frequency of 19.8 Hz with the compressor non-operating. Rocking motion seen on the piping pivoting on the flange**

Figure 5 shows the plot of the mode shape in the horizontal direction, where the discharge piping is rocking side to side pivoting on the compressor flange as seen during operation. The compressor and gear box modal testing by itself did not reveal any harmful structural natural frequency on those structures at or close to the running speeds.

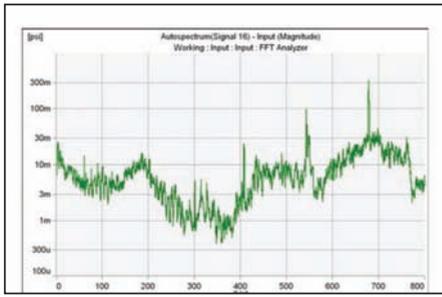
**Figure 6: Dynamic pressure transducer reading from the compressor discharge during full load of the unit**

A dynamic pressure transducer was temporarily installed at the discharge of the compressor. During full load of the compressor, the spectra of the pressure transducer did not reveal any anomaly (e.g., Figure 6).
