RH Effects on Wood Flooring

By David Stutzman, AIA, CSI, CCS, SCIP, LEED AP

Issue

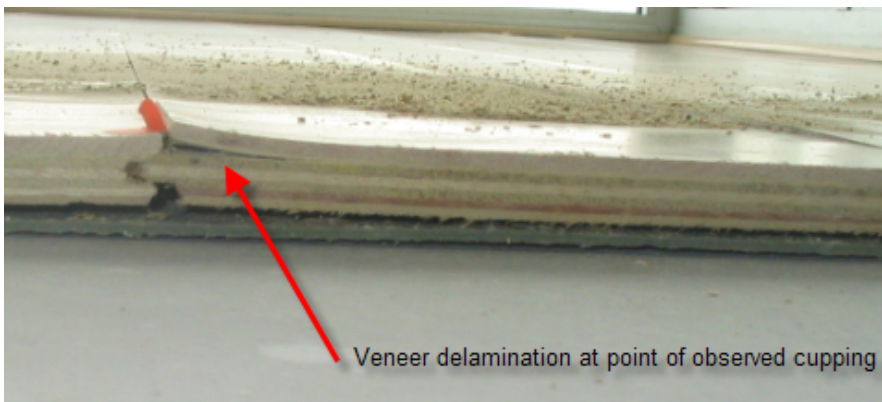
Cupping occurs when the flooring moisture content is unbalanced through the flooring thickness. The condition is caused by the exposed surface drying or by the concealed surface absorbing moisture, possibly from the concrete slab. The condition can be temporary. If the flooring moisture content is returned to an as

installed equilibrium condition, the cupping effect will be reduced, maybe eliminated. When the surface veneer delaminates from the backing the flooring must be replaced. Moisture affects the dimension across the wood grain most. The dimension along the length is affected little by changes in moisture content. Solid maple has a thermal expansion coefficient of 2.7×10^{-6} inches/inch/degree F. Assuming a 40 foot long flooring installation and a 40 degree temperature differential, the wood will expand only 0.05 inches. So temperature has minimal effect. Changing the moisture content from green (saturated condition) to oven dry will cause solid maple to shrink across the grain, 3-5 percent for quarter sawn veneer and 7-10 percent for plain sawn veneer. There is little dimensional change when the wood moisture content is greater than the fiber saturation point (25 to 30 percent moisture content). As a composite, engineered maple flooring will exhibit shrinkage values less than solid lumber content before being manufactured into flooring. Reducing the moisture content in the wood before manufacturing helps minimize dimensional changes as a result of drying when the wood achieves equilibrium with the surrounding environment after installation.

Therefore the wood when properly handled, transported, and delivered to the site should be dimensionally stable. The observed conditions indicate that the moisture content in the wood veneer changed dramatically after the flooring was manufactured. The wood equilibrium moisture content (EMC) is a function of relative humidity and temperature of the surrounding air. As a rule of thumb, a relative humidity of 30 percent gives an EMC of 6 percent and a relative humidity of 65 percent gives an EMC of 12 percent, irrespective of temperature. These ranges are within the maximum moisture content range for milling wood, and they correspond to the recommended relative humidity range for installing engineered wood floors. Observed relative humidity was less than 20 percent. If the flooring was at equilibrium at 20%, the EMC would be 4.5, less than recommended lower limit. The cupping is likely the result of the excessively low EMC.

When selecting wood flooring or any other interior wood products consider the atmosphere in which they will be installed. Will humidity be controlled to remain within the recommended 30 - 65% RH range?

Specify that HVAC systems must be operational and maintaining the facility at design conditions before starting wood flooring installation. Ensure the systems continue to maintain conditions after installation. Require wood products to be delivered to the site and stored with environmental conditions the same as the final construction. Allow time to achieve equilibrium before installation. Size the expansion space at the perimeter of the floor installation to accommodate seasonal dimensional changes from variations in moisture content. The expansion space must be continuous and large enough to accommodate the movement for the size room in which the flooring is installed.
