## Technical Notification

Document number: 95-137253-A

### SAILOR 500 FleetBroadband, SAILOR 250 FleetBroadband, SAILOR 150 FleetBroadband, EXPLORER 727 & EXPLORER 325 – SW ver. 1.16

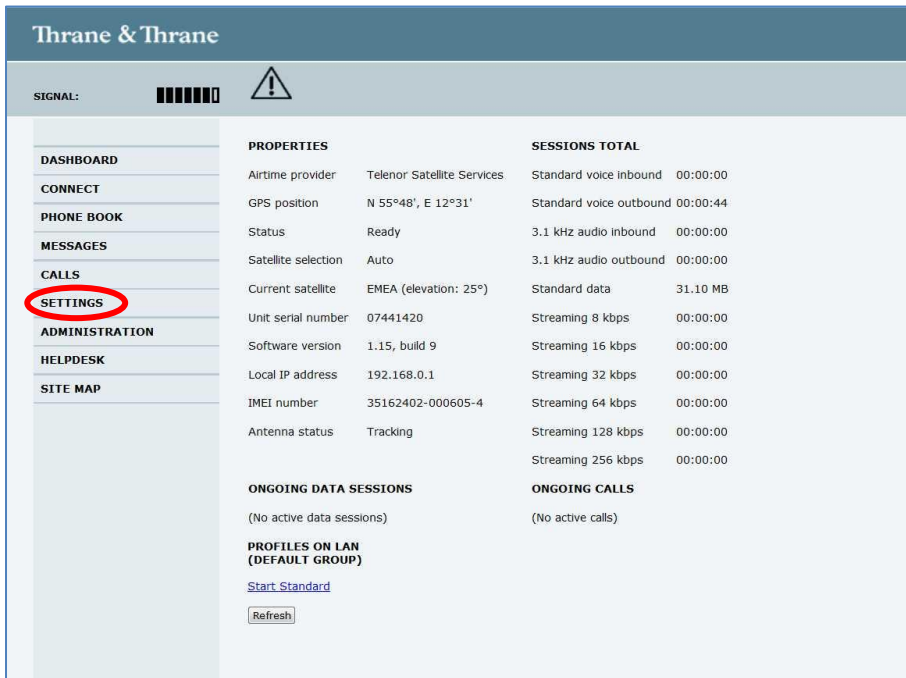
2. Open your web-browser and open the web interface of the terminal at address <http://192.168.0.1/>
3. Select **SETTINGS**.

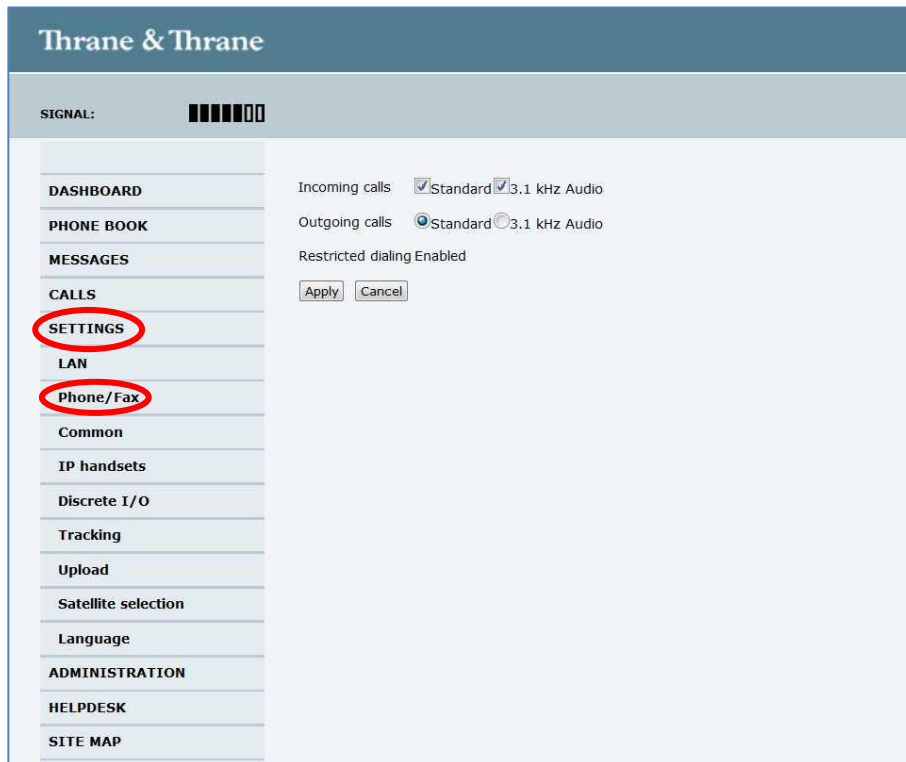
1. From the **DASHBOARD** left navigation pane, select **SETTINGS** → **Phone/Fax**.

**NOTE:** Above picture is showing the default setting of the RJ11 port.

2. When a fax is connected on the RJ11 port, choose only  (check mark) **3.1 kHz Audio** as **Incoming calls** (both boxes can be selected at the same time, but Standard is not needed for fax service) and  (dot) **3.1 kHz Audio** as **Outgoing calls** (only one dot can be set).

**NOTE:** If **Outgoing calls Standard** is selected and applied, the fax will not be reaching the receiver, as the service will be wrong.

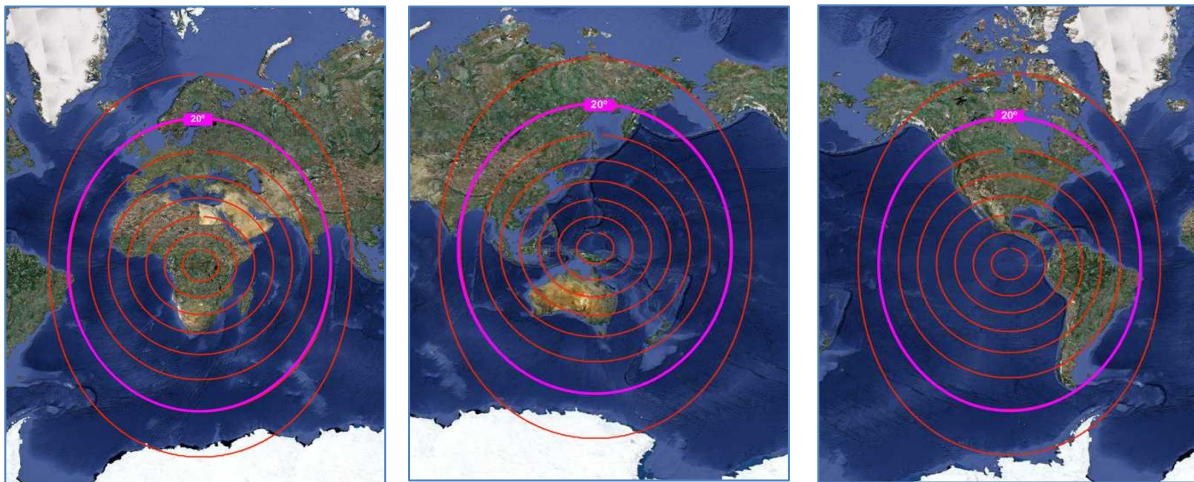
The **3.1 kHz Audio** service for SAILOR 150 FleetBroadband is only available with elevation angle above 20° (pink line on above pictures).
