## Fire Resistance of FRP Rail Platforms

### Engineering Hazard Analysis to Evaluate Type III FRP Materials in a Rail Platform

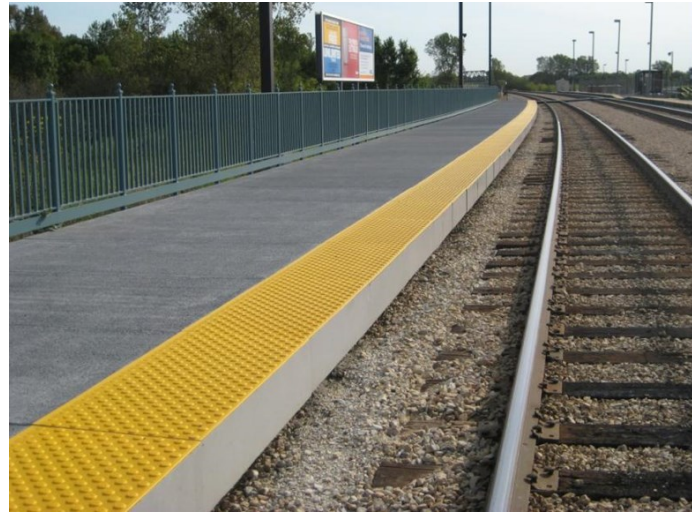
- Type I is Fire Resistive. Concrete is an example of this type.
- Type II is Noncombustible. Steel is an example of this type.
- Type III is Standard. Most FRP materials are this type.

Limited Combustible Material is a sub-category of Type III and FRP materials are in this category.

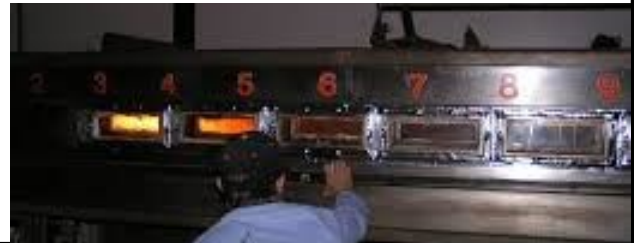
Class 1 or Class A Flame Spread Index refers to a FSI of  $\leq 25$ .

Class 2 or Class B refers to a laminate with a FSI of 30-75.

Class 3 or Class C refers to a FSI of 80-200.

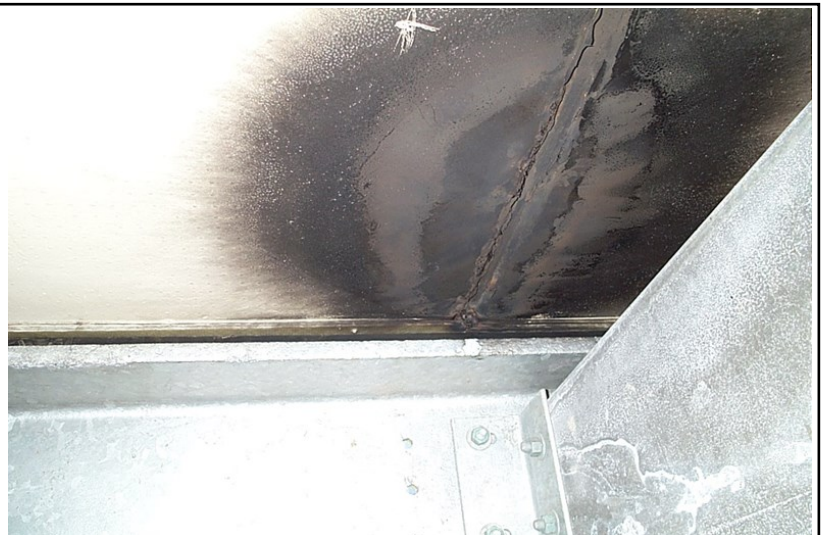
Case history is an FRP Vehicle Bridge Deck in Clark County, Ohio

Vandals used a propane torch in an attempt to burn the bottom of an FRP deck.

The exterior coating burned off and the outer surface of resin was scorched. The high density of fiberglass reinforcement in the panel exterior facing acts as barrier against damage penetration into the panel. Inspection showed that the structural laminate was not damaged.
