PowerScout 3 Plus/PowerScout 24 ViewPoint / Firmware Update Procedure for Serial PowerScout Instruments

Information in this document is relevant for **PowerScout 3 Plus** and **PowerScout 24** instruments running **ViewPoint 3.0 or later only**. For instructions/information with prior generation instruments, please refer to the DENT website or contact Tech Support at: techhelp@dentinstruments.com or 800.388.0770.

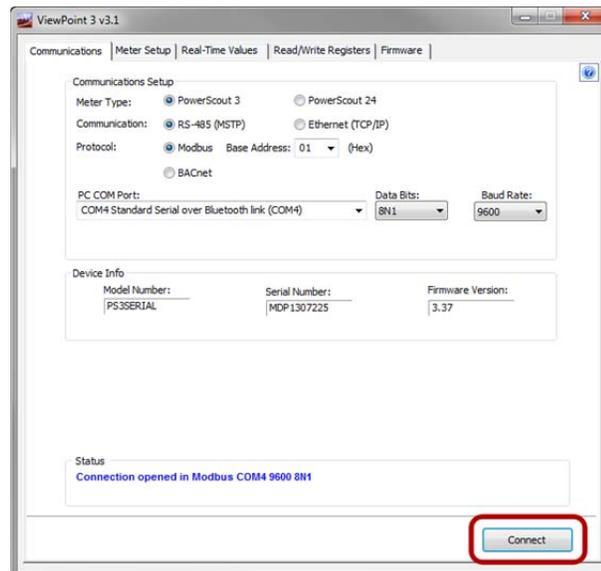
1. Download the zip file containing the firmware. Extract the zip file to a folder on the computer.
2. Connect the computer to the PowerScout instrument. If connectivity fails with the 9600 baud rate, refer to the Troubleshooting section at the end of this appendix.
3. Select the baud rate for loading the firmware to the PowerScout. A baud rate of 9600 downloads the firmware to the PowerScout in approximately 6 minutes. A faster baud rate can be selected to reduce the time by approximately 2.5 minutes. Change the baud rate using the **Communications** tab. Select the desired baud rate from the dropdown box. Selecting a new baud rate synchronizes the PowerScout and ViewPoint when a connection is active.

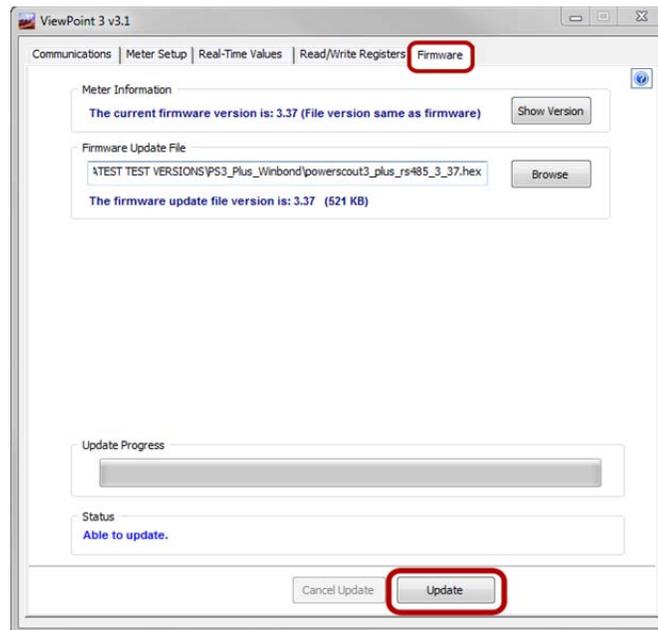
- Select the **Firmware** tab in ViewPoint. Click **Browse** to locate the extracted firmware files. Click **Update** to start the firmware update. A progress bar will be displayed.

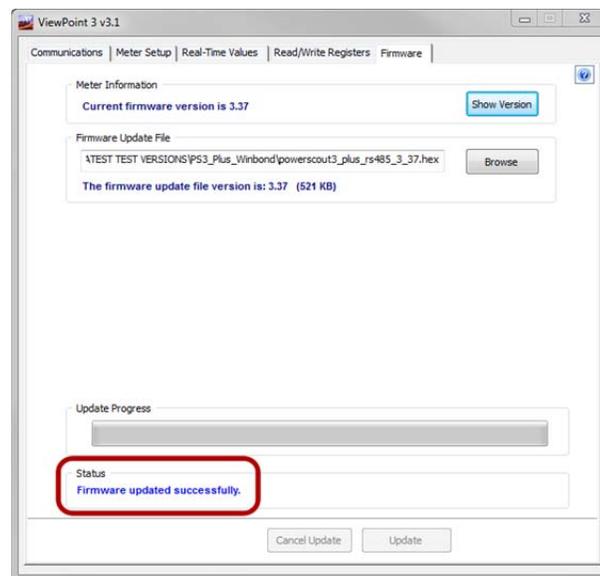
- Once ViewPoint has copied the firmware file to the PowerScout, the instrument will update, and re-start. **Do NOT interrupt power to the PowerScout during this time.** Doing so can cause the PowerScout to lock up.

- When the update is finished, ViewPoint displays a message confirming a successful update.
- If the baud rate was changed for the firmware update, restore the baud rate to its original setting.

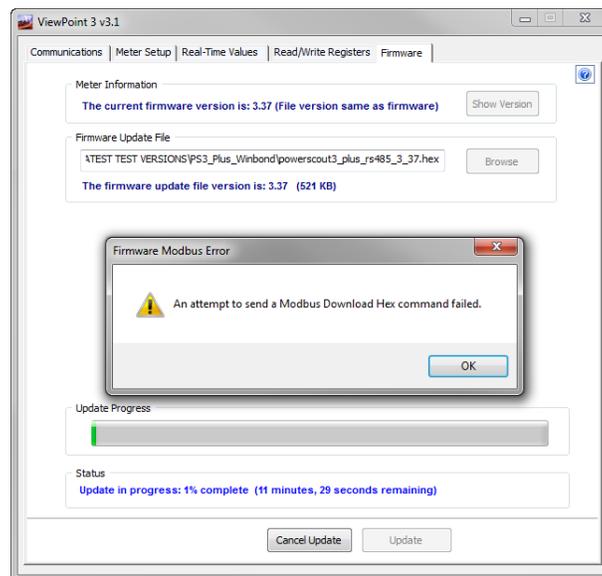
When the baud rate on the ViewPoint **Communications** tab and the PowerScout do not match, communication fails. To correct a baud rate communications error, use the following steps:

1. In ViewPoint, set the **Modbus Base Address Switches** field to 00.
2. On the PowerScout, set all Modbus address switches to 0.
3. Press the **Connect** button in ViewPoint. With both settings at 00, ViewPoint and the PowerScout will communicate at 9600 baud rate regardless of a baud rate mismatch. Communications is established.
4. Next, in ViewPoint, select the same baud rate that the PowerScout is set to.
5. Click **Connect** to reconfirm communications.

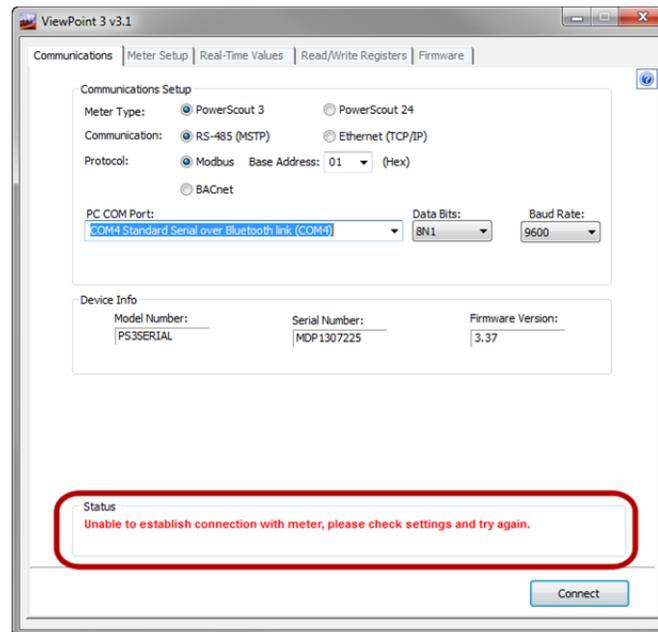
If the firmware update fails, select a slower baud rate and retry the update. If you continue to have issues with the update, please contact Technical Support for assistance.

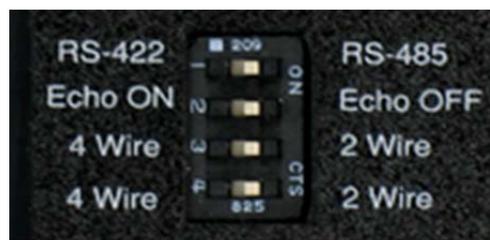
- Check for wiring issues with the RS-485 adapter and the PowerScout. Check for polarity, frayed wires, and/or pinched insulation.
- Verify that the DIP switches on the back of the USB to RS-485 adapter are set to the following (see picture below). Then reboot the computer. Click Connect on the Communications tab in ViewPoint to reestablish communications.
