Technical Bulletin

Channel Mapping the Com1000 using EPG generated PSIP Data

Eliminate digital sub-channel numbers using this technique

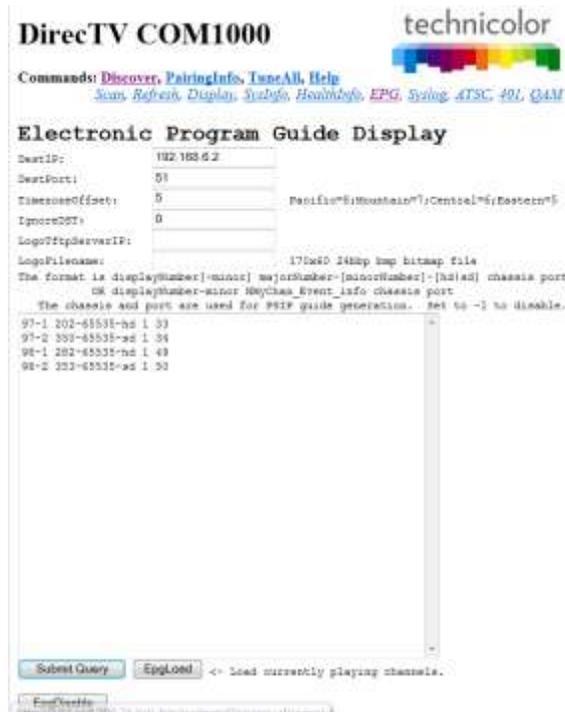
1. Open the EPG guide and locate the channel listings.

For this example, only 4 channels are listed in the guide.

97-1 202-65535-HD 1 33

Channel 97-1 is tuned to DirectTV® channel 202 (CNN), is an HD resolution channel, tuner is located in chassis 1 at port 33.

97-2 350-65535-SD 1 34

Channel 97-2 is tuned to DirectTV® channel 350 (CSP1 “C-Span”), is an SD resolution channel, tuner is located in chassis 1 at port 34.

98-1 282-65535-HD 1 49

Channel 98-1 is tuned to DirectTV® channel 282 (APL “Animal Planet”) is an HD resolution channel, tuner is located in chassis 1 at port 49.

98-2 353-65535-SD 1 50

Channel 98-2 is tuned to Direct TV® channel 353 (BTV “Bloomberg TV”), is an SD resolution channel, tuner is located in chassis 1 at port 50.

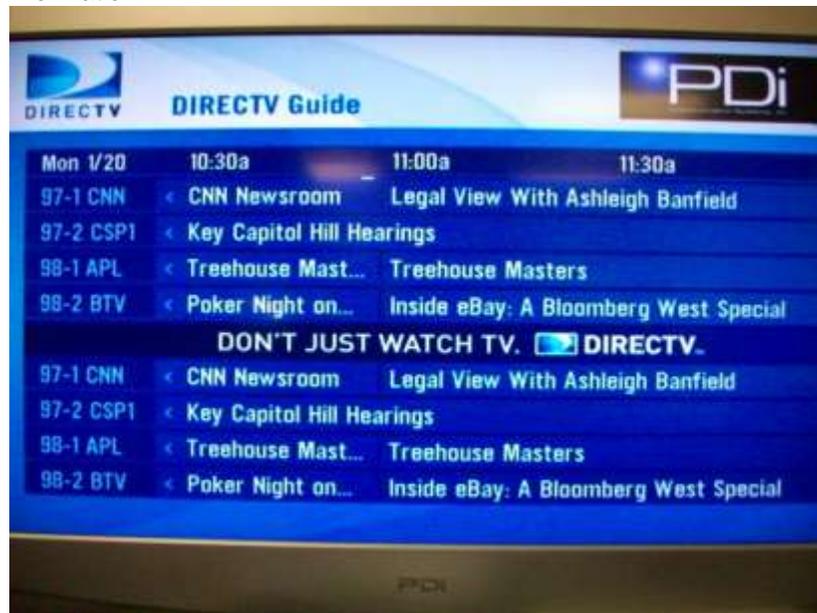
Display of the current channel guide (EPG) verifies the same channel information.

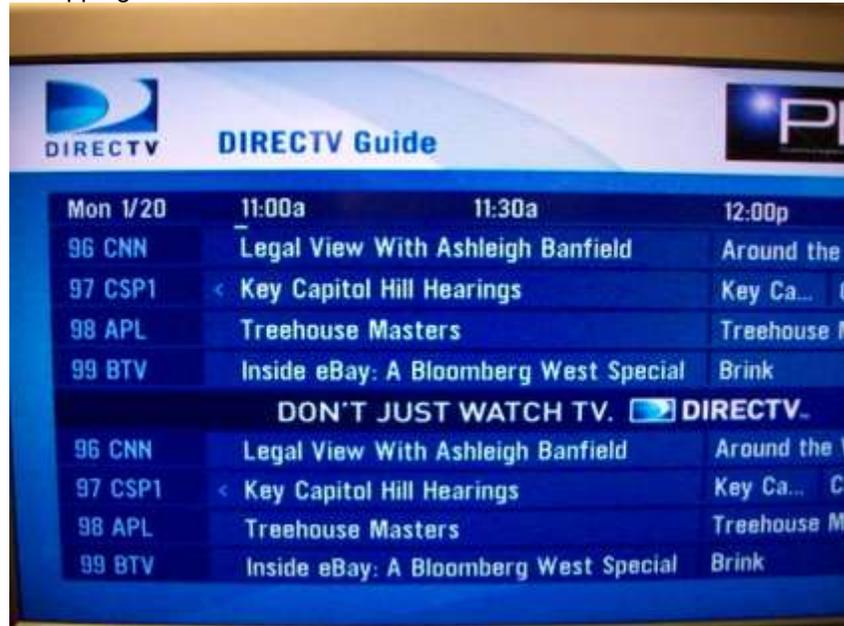
A quick look at the TV's displayed EPG indicates successful channel remapping.

Pressing the “Submit Query” button will upload the new channel guide. A picture of the modified Electronic Program Guide shows the changes.
