# SARASOTA AGRICULTURAL CENTER

ORIGINAL 36<sup>MIL</sup>

► Installed – 1983

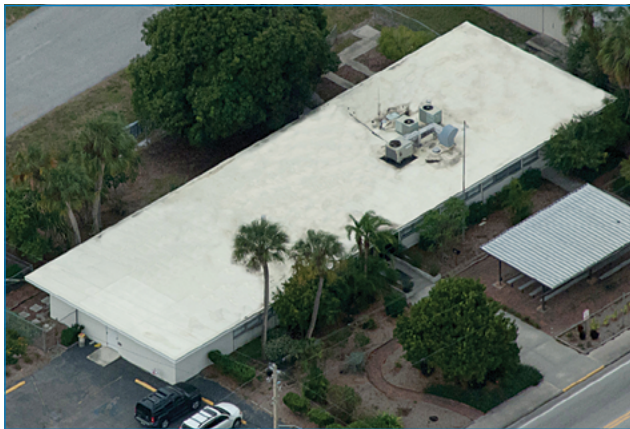
| | Unexposed | Exposed |
| <b>Weight</b><br>ASTM D751<br>oz/yd <sup>2</sup> | 32.1 oz | <b>24.1 oz</b> |
| <b>Total Thickness</b> | 39.0 mils | <b>28.0 mils</b> |
| <b>Thickness over Fiber</b> (face) | 11.18557 mil | <b>4.32990 mil</b> |
| <b>Thickness over Fiber</b> (back) | 12.80928 mil | <b>10.82474 mil</b> |
| <b>Strip Tensile</b><br>ASTM D751<br>Procedure B lb <sub>f</sub> /in | 382 (warp) | <b>334 (warp)<br/>272 (fill)</b> |
| <b>Puncture</b><br>ASTM D751<br>(Ball Tip) lb <sub>f</sub> | 626 | <b>338</b> |
| <b>Puncture</b><br>ASTM D751<br>(Screwdriver) lb <sub>f</sub> | 69 | <b>62</b> |

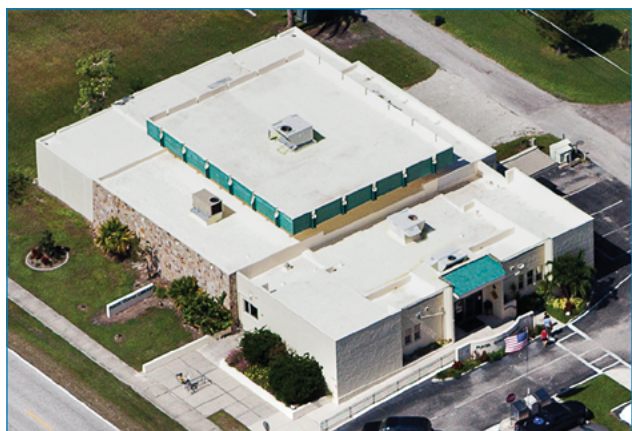
| | Unexposed | Exposed |
| <b>Weight</b><br>ASTM D751<br>oz/yd <sup>2</sup> | 30.6 oz | <b>22.9 oz</b> |
| <b>Total Thickness</b> | 33.0 mils | <b>27.0 mils</b> |
| <b>Thickness over Fiber</b> (face) | 8.29897 mil | <b>3.96907 mil</b> |
| <b>Thickness over Fiber</b> (back) | 14.61340 mil | <b>12.80927 mil</b> |
| <b>Strip Tensile</b><br>ASTM D751<br>Procedure B lb <sub>f</sub> /in | 289 (warp) | <b>276 (warp)<br/>291 (fill)</b> |
| <b>Puncture</b><br>ASTM D751<br>(Ball Tip) lb <sub>f</sub> | 587 | <b>279</b> |
| <b>Puncture</b><br>ASTM D751<br>(Screwdriver) lb <sub>f</sub> | 61 | <b>56</b> |

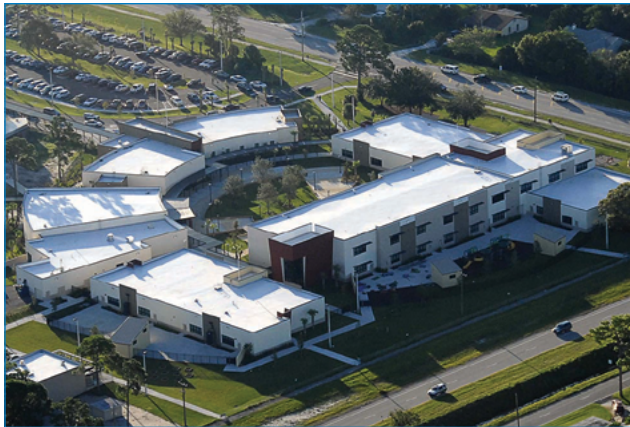
| | Unexposed | Exposed |
| <b>Weight</b><br>ASTM D751<br>oz/yd <sup>2</sup> | 31.2 oz | <b>23.1 oz</b> |
| <b>Total Thickness</b> | 34.0 mils | <b>28.0 mils</b> |
| <b>Thickness over Fiber</b> (face) | 9.20103 mil | <b>4.14948 mil</b> |
| <b>Thickness over Fiber</b> (back) | 14.43530 mil | <b>11.72681 mil</b> |
| <b>Strip Tensile</b><br>ASTM D751<br>Procedure B lb <sub>f</sub> /in | 329 (warp) | <b>319 (warp)<br/>306 (fill)</b> |
| <b>Puncture</b><br>ASTM D751<br>(Ball Tip) lb <sub>f</sub> | 707 | <b>367</b> |
| <b>Puncture</b><br>ASTM D751<br>(Screwdriver) lb <sub>f</sub> | 74 | <b>68</b> |

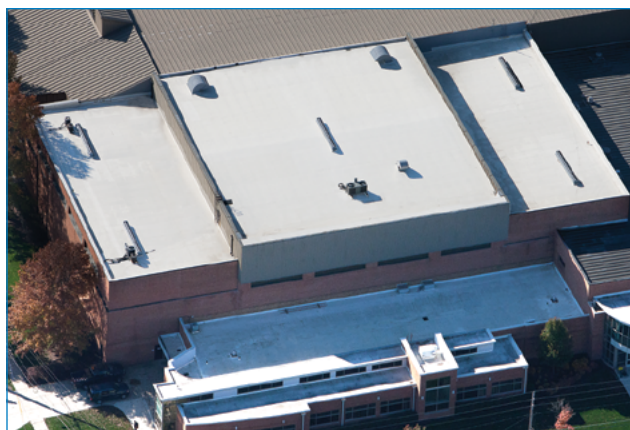
| | Unexposed | Exposed |
| Weight<br>ASTM D751<br>oz/yd <sup>2</sup> | 30.9 oz | 25.9 oz |
| Total Thickness | 33.0 mils | 28.0 mils |
| Thickness<br>over Fiber (face) | 13.89175 mil | 8.840205 mil |
| Thickness<br>over Fiber (back) | 12.62887 mil | 11.54639 mil |
| Strip Tensile<br>ASTM D751<br>Procedure B lb <sub>f</sub> /in | 370 (warp) | 356 (warp)<br>365 (fill) |
| Puncture<br>ASTM D751<br>(Ball Tip) lb <sub>f</sub> | 679 | 619 |
| Puncture<br>ASTM D751<br>(Screwdriver) lb <sub>f</sub> | 81 | 72 |

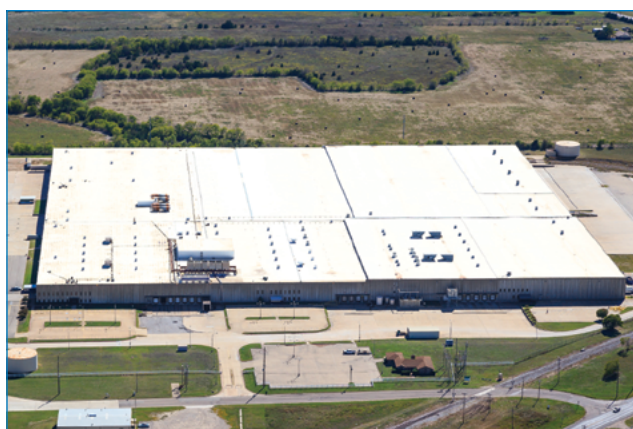
| | Unexposed | Exposed |
| Weight<br>ASTM D751<br>oz/yd <sup>2</sup> | 30.9 oz | <b>23.6 oz</b> |
| Total Thickness | 34.0 mils | <b>27.0 mils</b> |
| Thickness<br>over Fiber (face) | 9.02454 mil | <b>4.32896 mil</b> |
| Thickness<br>over Fiber (back) | 16.41753 mil | <b>12.80928 mil</b> |
| Strip Tensile<br>ASTM D751<br>Procedure B lb <sub>f</sub> /in | 307 (warp) | <b>238 (warp)<br/>278 (fill)</b> |
| Puncture<br>ASTM D751<br>(Ball Tip) lb <sub>f</sub> | 376 | <b>236</b> |
| Puncture<br>ASTM D751<br>(Screwdriver) lb <sub>f</sub> | 73 | <b>49</b> |

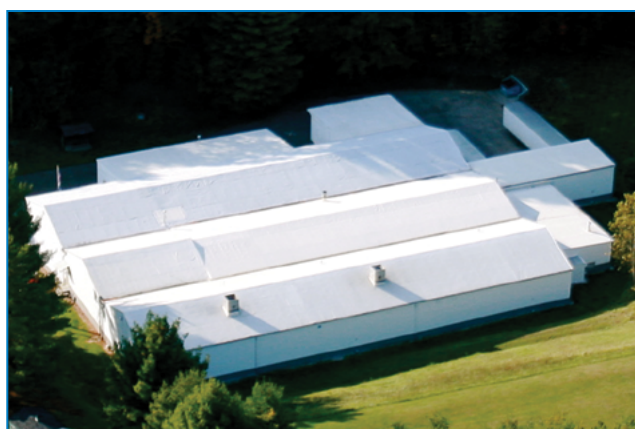
| | Unexposed | Exposed |
| <b>Weight</b><br><b>ASTM D751</b><br>oz/yd <sup>2</sup> | 32 oz | <b>26.6 oz</b> |
| <b>Total Thickness</b> | 35 mils | <b>30 mils</b> |
| <b>Thickness</b><br><b>over Fiber</b> (face) | 10.10309 mil | <b>6.13402 mil</b> |
| <b>Thickness</b><br><b>over Fiber</b> (back) | 12.99226 mil | <b>13.17010 mil</b> |
| <b>Strip Tensile</b><br><b>ASTM D751</b><br>Procedure B lb <sub>f</sub> /in | 367 (warp) | <b>376 (warp)</b><br><b>342 (fill)</b> |
| <b>Puncture</b><br><b>ASTM D751</b><br>(Ball Tip) lb <sub>f</sub> | 634 | <b>461</b> |
| <b>Puncture</b><br><b>ASTM D751</b><br>(Screwdriver) lb <sub>f</sub> | 79 | <b>78</b> |

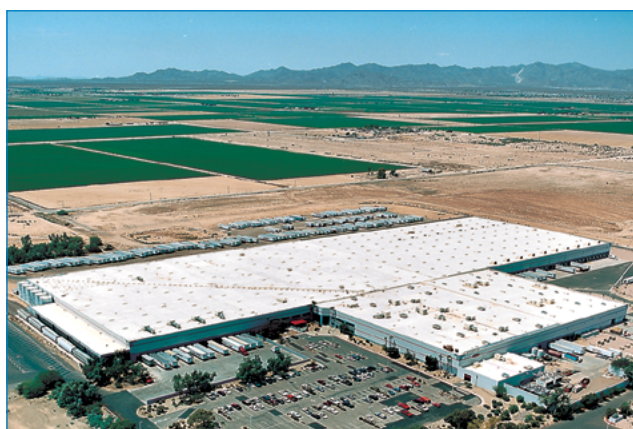
| | Unexposed | Exposed |
| Weight<br>ASTM D751<br>oz/yd <sup>2</sup> | N/A | 24.6 oz |
| Total Thickness | 28.8 mils | 22.3 mils |
| Thickness<br>over Fiber (face) | 9.56185 mil | 5.41838 mil |
| Thickness<br>over Fiber (back) | 11.54639 mil | 9.38144 mil |
| Strip Tensile<br>ASTM D751<br>Procedure B lb <sub>f</sub> /in | N/A* | 356 (warp)<br>365 (fill) |
| Puncture<br>ASTM D751<br>(Ball Tip) lb <sub>f</sub> | N/A* | 291 |
| Puncture<br>ASTM D751<br>(Screwdriver) lb <sub>f</sub> | N/A* | 67 |

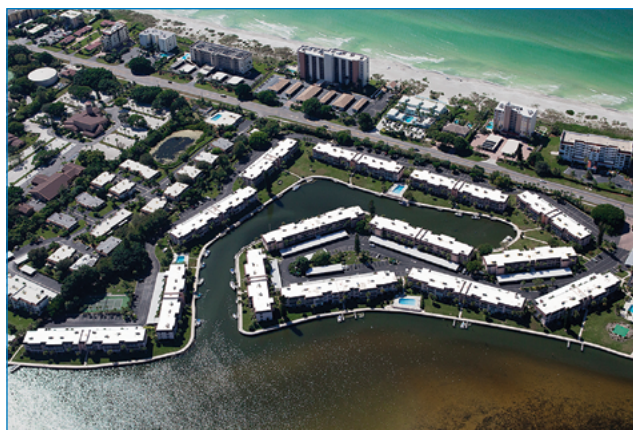
| | Unexposed | Exposed |
| Weight<br>ASTM D751<br>oz/yd <sup>2</sup> | 29.9 oz | <b>22.1 oz</b> |
| Total Thickness | 34.0 mils | <b>25.0 mils</b> |
| Thickness<br>over Fiber (face) | 9.56185 mil | <b>5.78464 mil</b> |
| Thickness<br>over Fiber (back) | 12.80928 mil | <b>9.92268 mil</b> |
| Strip Tensile<br>ASTM D751<br>Procedure B lb <sub>f</sub> /in | 351 (warp) | <b>320 (warp)<br/>292 (fill)</b> |
| Puncture<br>ASTM D751<br>(Ball Tip) lb <sub>f</sub> | 614 | <b>313</b> |
| Puncture<br>ASTM D751<br>(Screwdriver) lb <sub>f</sub> | 78 | <b>63</b> |

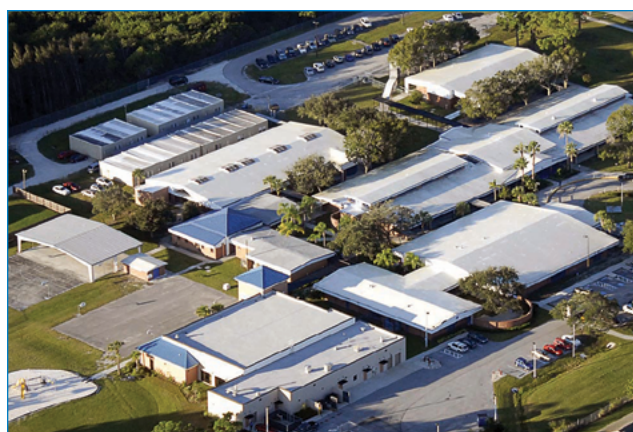
| | Unexposed | Exposed |
| <b>Weight</b><br>ASTM D751<br>oz/yd <sup>2</sup> | 32.1 oz | <b>21.4 oz</b> |
| <b>Total Thickness</b> | 36.0 mils | <b>28.0 mils</b> |
| <b>Thickness over Fiber</b> (face) | 12.26804 mil | <b>4.69072 mil</b> |
| <b>Thickness over Fiber</b> (back) | 15.87629 mil | <b>12.08763 mil</b> |
| <b>Strip Tensile</b><br>ASTM D751<br>Procedure B lb <sub>f</sub> /in | 317 (warp) | <b>234 (warp)<br/>242 (fill)</b> |
| <b>Puncture</b><br>ASTM D751<br>(Ball Tip) lb <sub>f</sub> | 594 | <b>283</b> |
| <b>Puncture</b><br>ASTM D751<br>(Screwdriver) lb <sub>f</sub> | 57 | <b>58</b> |

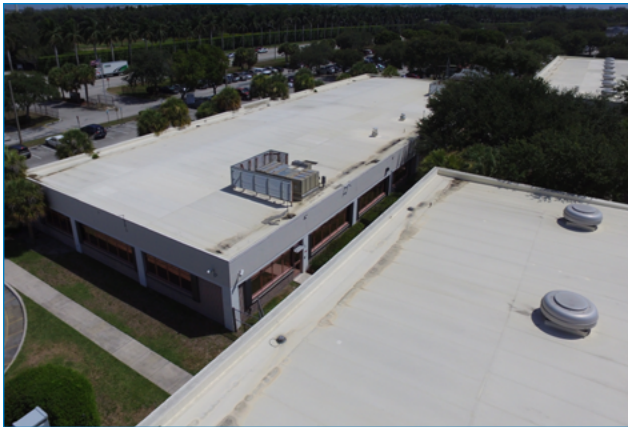
| | Unexposed | Exposed |
| <b>Weight</b><br><b>ASTM D751</b><br>oz/yd <sup>2</sup> | not available* | <b>23.2 oz</b> |
| <b>Total Thickness</b> | not available* | <b>30.4 mil</b> |
| <b>Thickness</b><br><b>over Fiber</b> (face) | not available* | <b>3.6257 mil</b> |
| <b>Thickness</b><br><b>over Fiber</b> (back) | not available* | <b>9.5476 mil</b> |
| <b>Strip Tensile</b><br><b>ASTM D751</b><br>Procedure B lb <sub>f</sub> /in | not available* | <b>267 (warp)</b> |
| <b>Puncture</b><br><b>ASTM D751</b><br>(Ball Tip) lb <sub>f</sub> | not available* | <b>277</b> |
| <b>Puncture</b><br><b>ASTM D751</b><br>(Screwdriver) lb <sub>f</sub> | not available* | <b>64</b> |

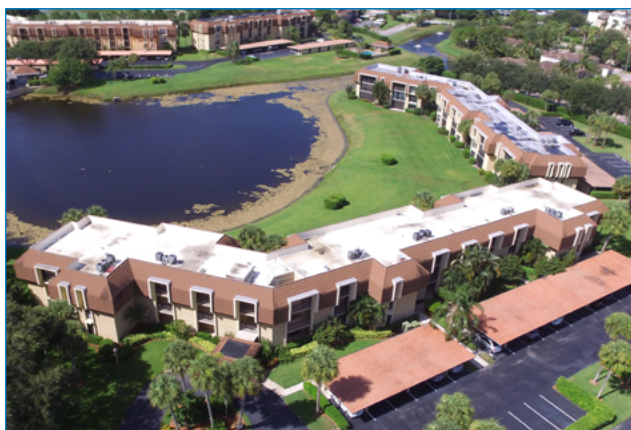
| | Unexposed | Exposed |
| Weight<br>ASTM D751<br>oz/yd <sup>2</sup> | not available* | 25.5 oz |
| Total Thickness | 33.4 mil | 26.3 mil |
| Thickness<br>over Fiber (face) | 7.7360 mil | 5.3950 mil |
| Thickness<br>over Fiber (back) | 9.7720 mil | 7.7360 mil |
| Strip Tensile<br>ASTM D751<br>Procedure B lb <sub>f</sub> /in | not available* | 342 (warp)<br>292 (fill) |
| Puncture<br>ASTM D751<br>(Ball Tip) lb <sub>f</sub> | not available* | 484 |
| Puncture<br>ASTM D751<br>(Screwdriver) lb <sub>f</sub> | not available* | 77 |

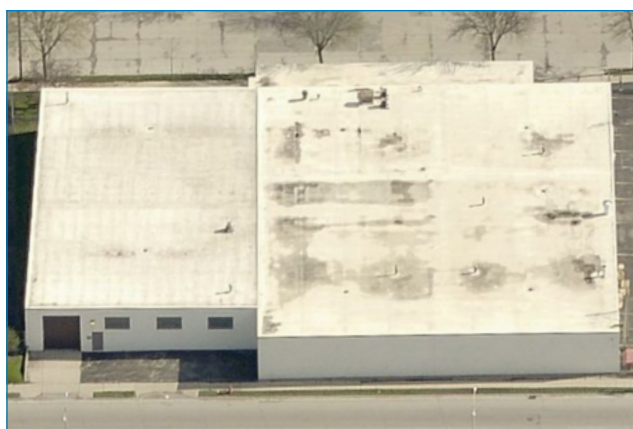
| | Unexposed | Exposed |
| <b>Weight</b><br>ASTM D751<br>oz/yd <sup>2</sup> | 31.3 oz | <b>25.0 oz</b> |
| <b>Total Thickness</b> | 33.0 mil | <b>27.0 mil</b> |
| <b>Thickness over Fiber</b> (face) | 10.1800 mil | <b>5.9000 mil</b> |
| <b>Thickness over Fiber</b> (back) | 10.3800 mil | <b>7.8400 mil</b> |
| <b>Strip Tensile</b><br>ASTM D751<br>Procedure B lb <sub>f</sub> /in | 393 (warp)<br>(fill not available) | <b>315 (warp)</b><br><b>344 (fill)</b> |
| <b>Puncture</b><br>ASTM D751<br>(Ball Tip) lb <sub>f</sub> | 575 | <b>560</b> |
| <b>Puncture</b><br>ASTM D751<br>(Screwdriver) lb <sub>f</sub> | 77 | <b>77</b> |

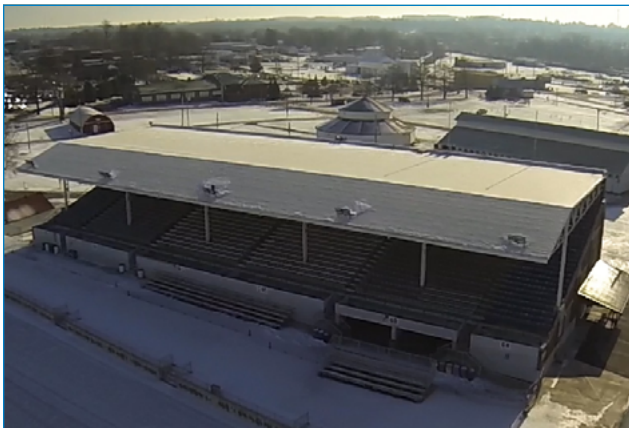
## Weldability of “Aged” FiberTite Membrane

Although repairs are few, FiberTite tested the weldability of a new nominal 36 MIL membrane to another nominal 36 MIL membrane that had been in service for 29 years. Preparation of the aged membrane is key. The repair area must be properly cleaned prior to the welding process with a non-abrasive cleaner to remove excessive dirt and/or contamination. Acetone is then used to clean the lap area to prepare the surface in order to achieve a proper weld.

The successful weld will be water tight to achieve a reliable roof repair that will perform for the remaining years the roofing system is in service.
