Roofing – Screw it or Glue it?

WHITE PAPER • DECEMBER 2012

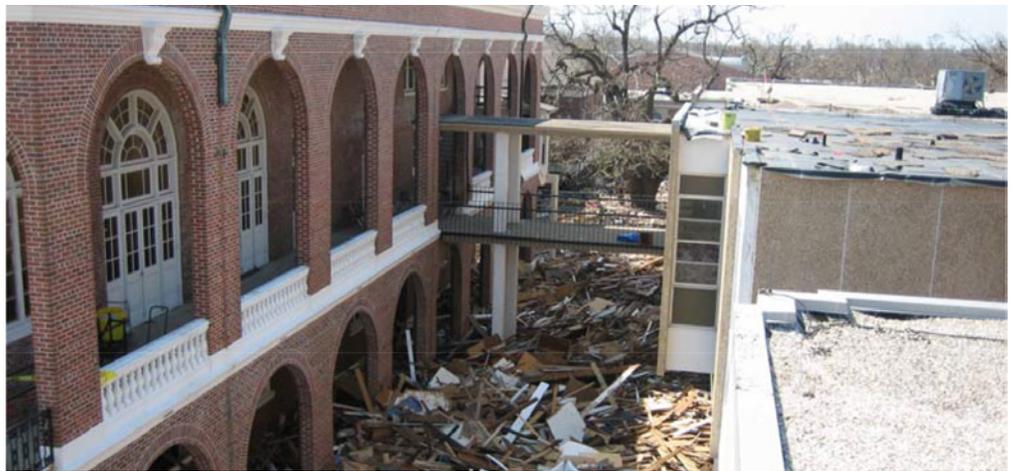
PASS CHRISTIAN

One of the logistics teams investigated a private school, just east of ground zero on Henderson Point, sitting on a point at the mouth of St. Louis Bay with no observable roof damage. The school was a three story, cast in place structural concrete building that more closely resembled a parking garage after the storm. The lower two floors were cleaned out by the storm surge. Members of a US Geological Society survey team put the surge (28' 2 inches) just over the second story ceiling. The bedrooms on the third floor were basically intact, windows and all. But the bedrooms appeared to be isolated in time amidst the destruction with bath towels laid out and beds with sheets and covers thrown back.

The roofing system was an aggregate surfaced built up roof. Apart from some general wind scour, and displacement of some of the roof top HVAC, there was no evidence that the 140 mph winds even knew the roof was there. The roof system lacked even the smallest hole, which would have allowed the team to see below the built up roof and confirm how the roof was assembled. The deck was virtually airtight and this worked in conjunction with the three-foot parapet walls to help the roofing system resist the pressures projected upon it.

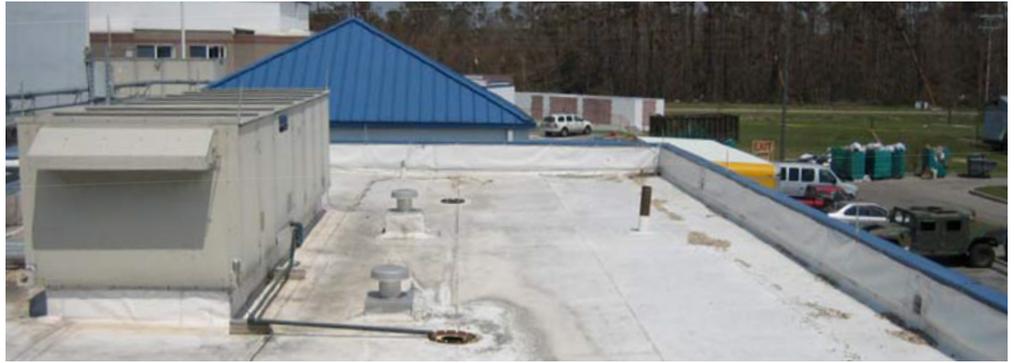
BAY ST. LOUIS

The second structure investigated was a hospital in Bay St. Louis, directly across the bay, west of Henderson Point. The hospital had a 20 year old mechanically fastened EPDM roofing system and some newer areas that used a mechanically fastened vinyl membrane. The deck was steel with lightweight insulating concrete creating a monolithic substrate. The membrane was attached with metal battens, secured through the membrane with fasteners spaced 12 inches on center at 5 foot intervals. The battens were sealed with a cover strip. There was some damage to the blue standing seam metal roof on one of the cupolas at the south east corner of the hospital but the EPDM roof and the smaller vinyl roof areas were intact with almost no damage except for some built up roofing debris from nearby buildings.

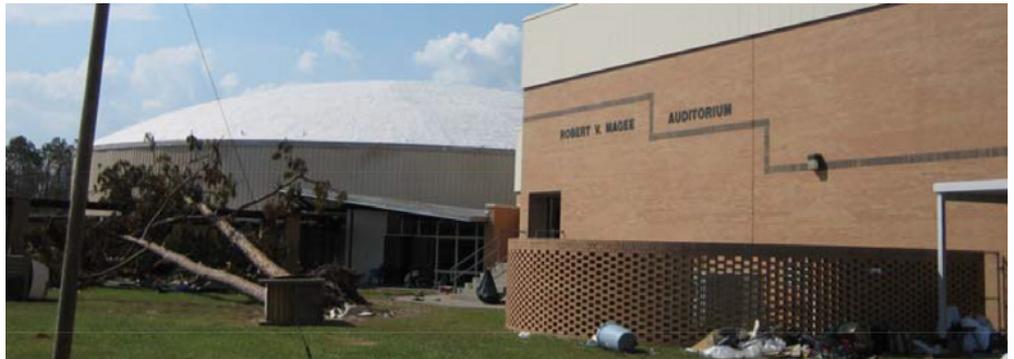
BAY ST. LOUIS SCHOOL AUDITORIUM

The next structure examined was the sprayed polyurethane roof on the dome of a nearby school. The auditorium, a rectangular building to the left of the dome, turned out to be a classic example of building pressurization with no back up to prevent the peeling back of the built up roof. The roof drain was located directly above the rolling freight door. Although it was unclear where the drain assembly ended up, a few of its associates were present, detached but present nonetheless.

The construction started with a steel deck, a mechanically fastened base layer of perlite using only 2 fasteners per 2' x 4' insulation board. The mechanically fastened insulation was barely disturbed. An additional layer of perlite was adhered to the first layer with a ribbon applied, asphaltic adhesive. The roof cover was a smooth surface, multi-ply bur. The smoke hatch lid was completely opened. With this type of dramatic pressurization, the entire roof cover can blow off but in this case it created its own peel stop, although a bit too late. The membrane eventually tore apart as the weight of the air borne portion increased.

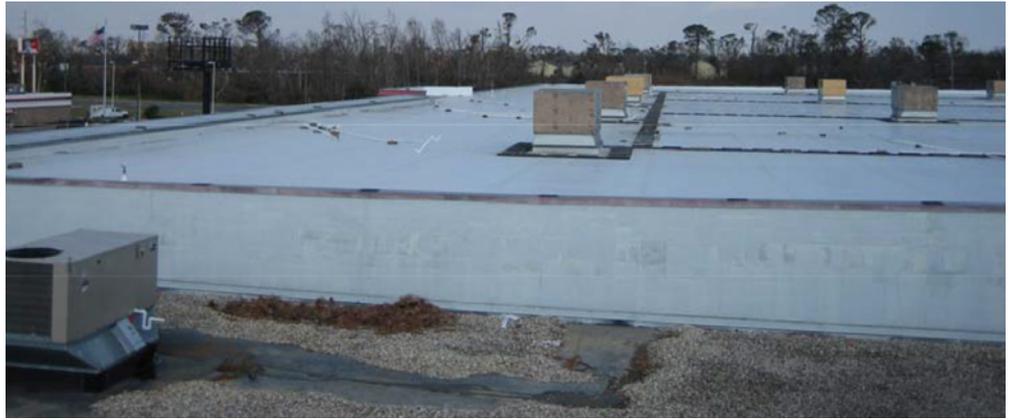
LONG BEACH

The fourth building, a “K-Mart”, was located in an industrial park just outside of Long Beach. This building had a mechanically fastened 10’ TPO and sustained significant winds from the storm. Flying debris left a few scars here and there, but the team was unable to find a loose fastener. Researchers found similar outcomes on this mechanically fastened vinyl roof to the one in Bay St. Louis. Systems that utilized mechanical fasteners to tie the roof cover to the structure, including metal roof systems, seemed to exhibit far less damage in general. In fact, not only did the team discover that the mechanically fastened roofs had well withstood the storm; the team did not find a mechanically fastened “single ply” membrane that had exposed the deck.
