One Dalton Hotel & Residences: Implementation of ground movement control measure for a deep excavation in Boston blue clay

Mark X. Haley P.E., M.ASCE
Jean Louis Z. Locsin Ph.D., P.E.
Jesse D. Siegel P.E.

March 26, 2019

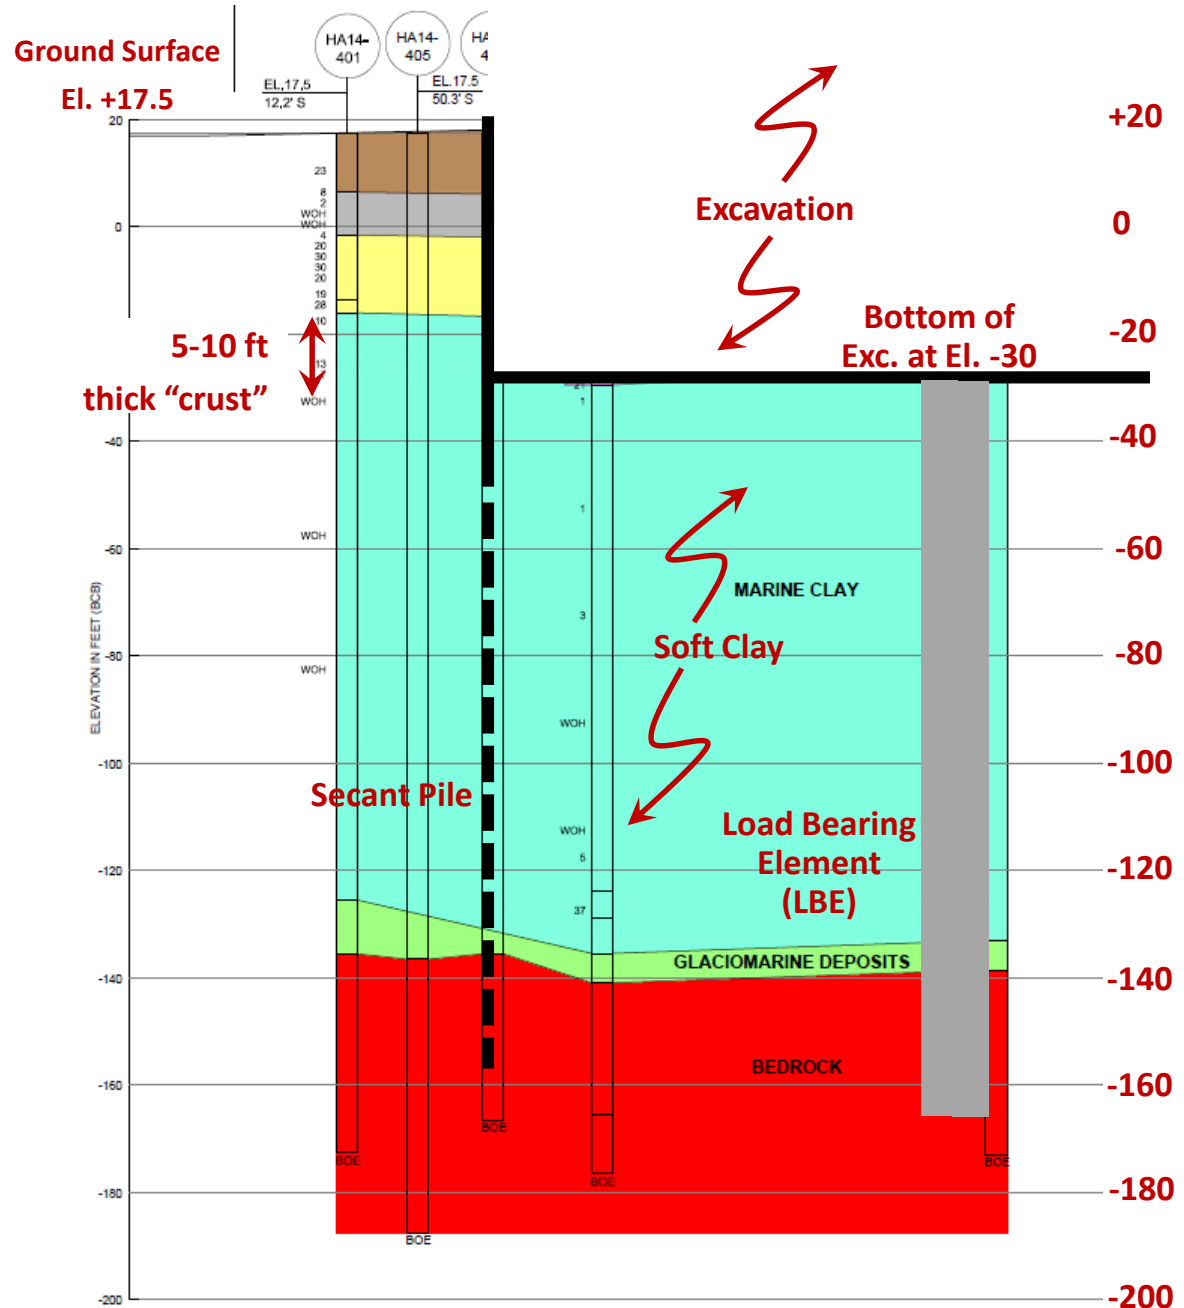
Excavation

- As deep as 48 ft below ground surface
- Bottom of excavation in soft clay

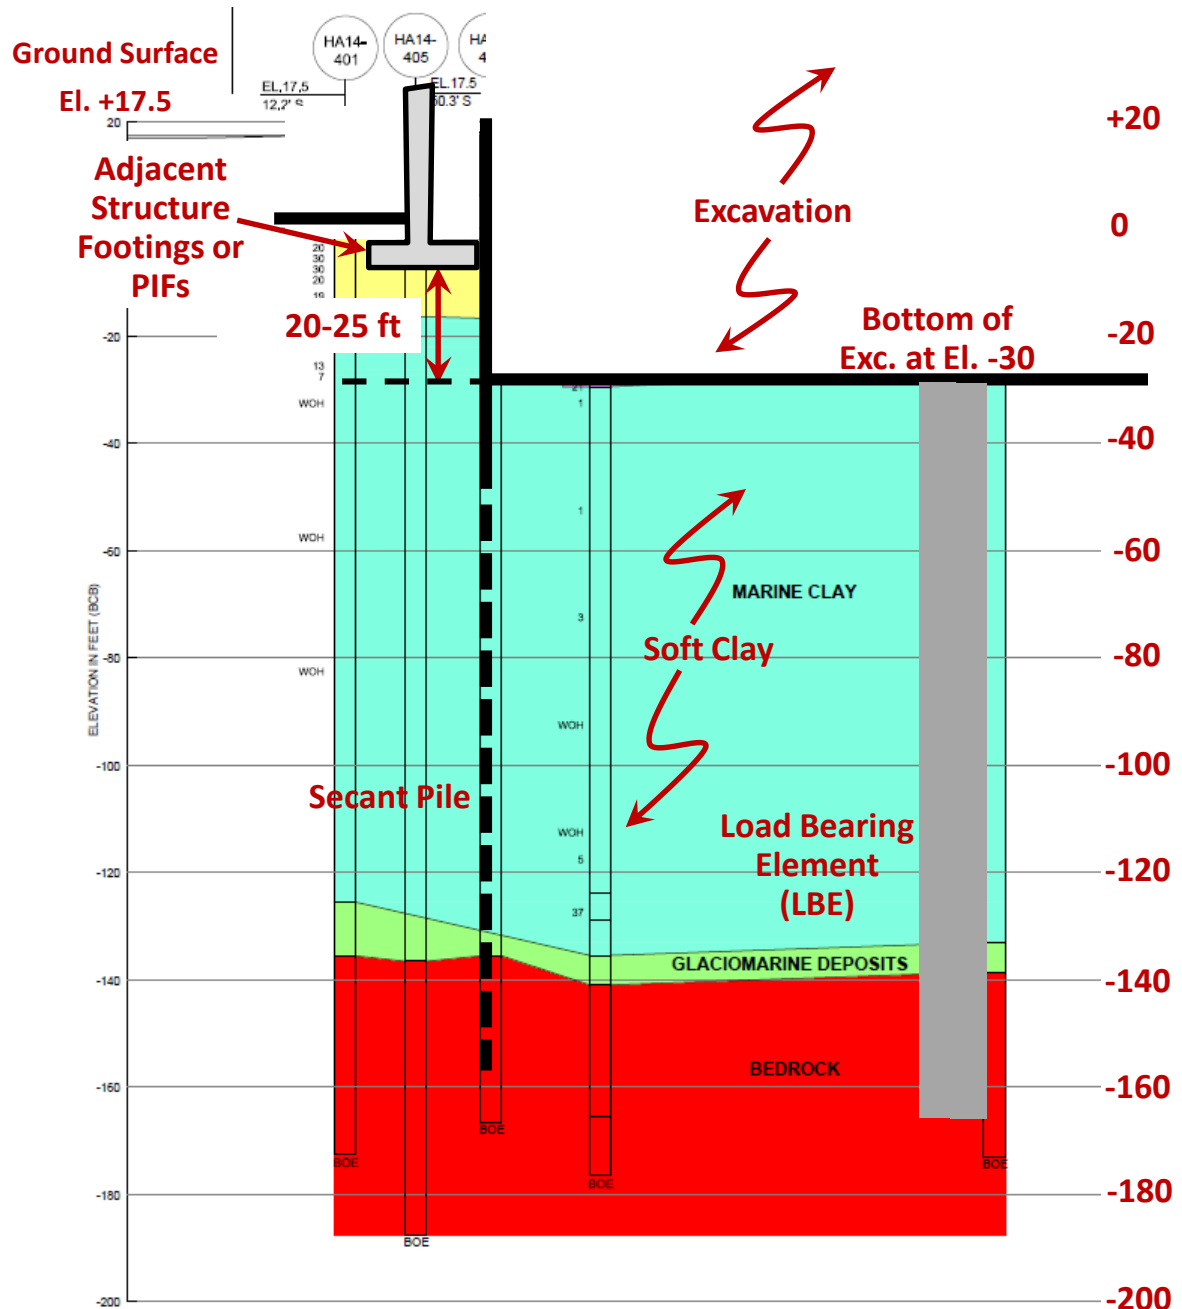
Excavation

- As deep as 48 ft below ground surface
- Bottom of excavation in soft clay
- 20 to 25 ft below adjacent structure foundations

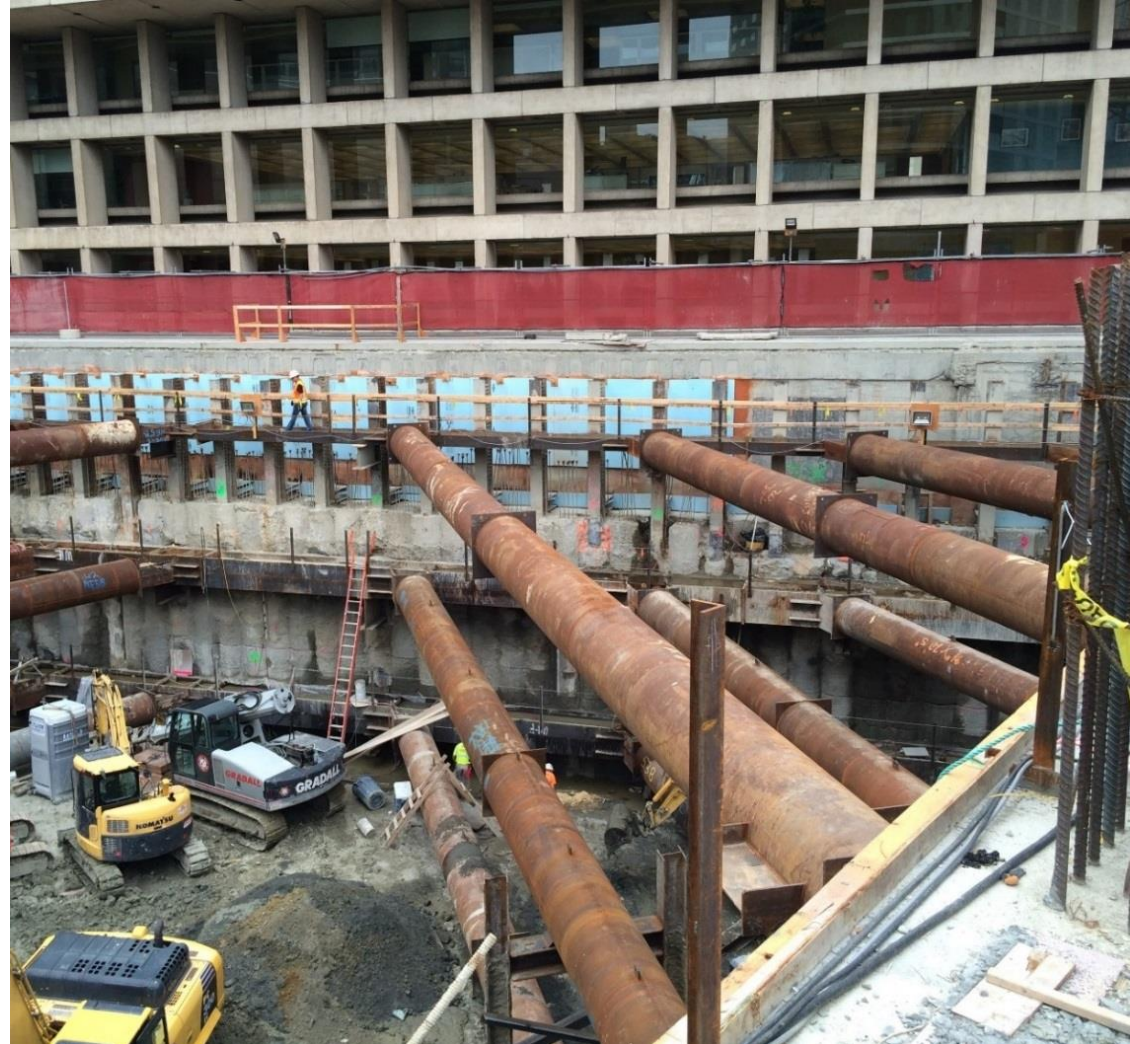
Support of Excavation

- The analysis for 3 bracing levels predicted ~ 1.7 in. lateral deflection along SPW (adjacent to 5-story building)
- Analysis indicated that to control movements, bottom lateral support would be required before excavation
- Solution: subgrade elements and struts

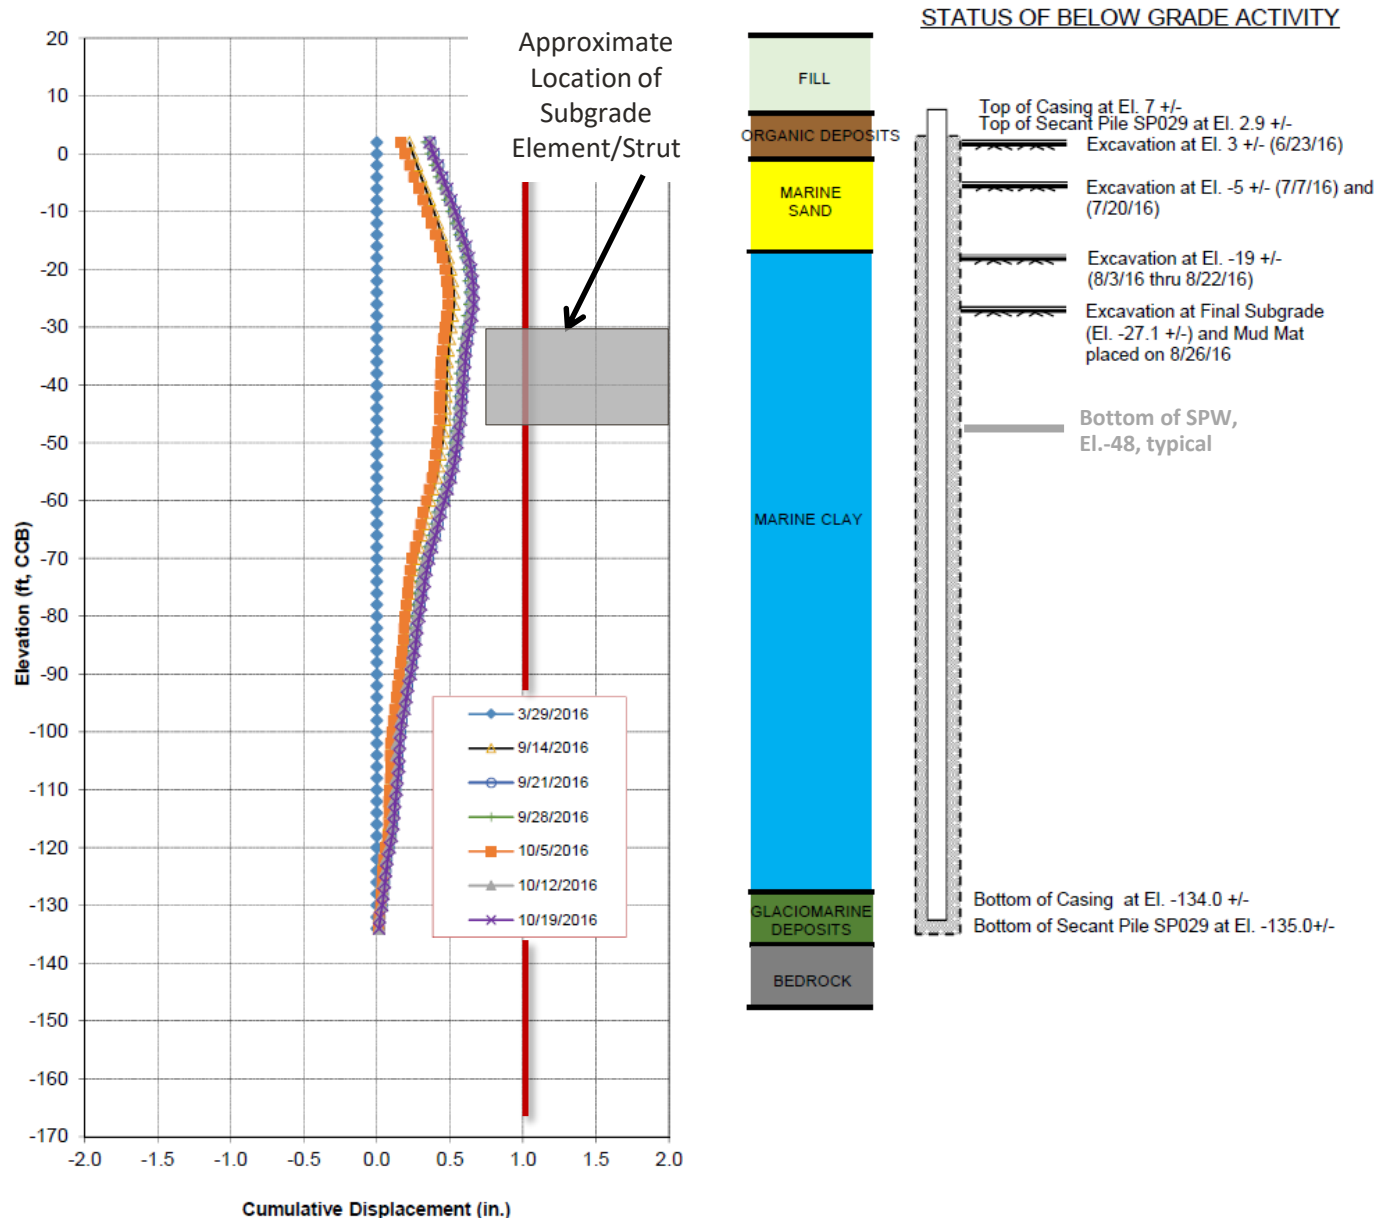
Wall lateral deflection – at end of excavation

- Deflection profile at Secant Pile Wall
- Less than 1 inch lateral deflection
- Effect of subgrade element/strut is apparent

- Excavating through clay crust increases risk of excessive movement
- To control movement, subgrade elements and struts installed before excavation
- Roughly 50% of measured movement occurred during installation of SPW (difficult to predict)
- Owner and Design Team chose to be proactive to mitigate movement and reduce risk by constructing subgrade elements and struts
- Subgrade elements and struts were effective in controlling lateral movement of wall below bottom of excavation and resulting vertical movement of adjacent structure

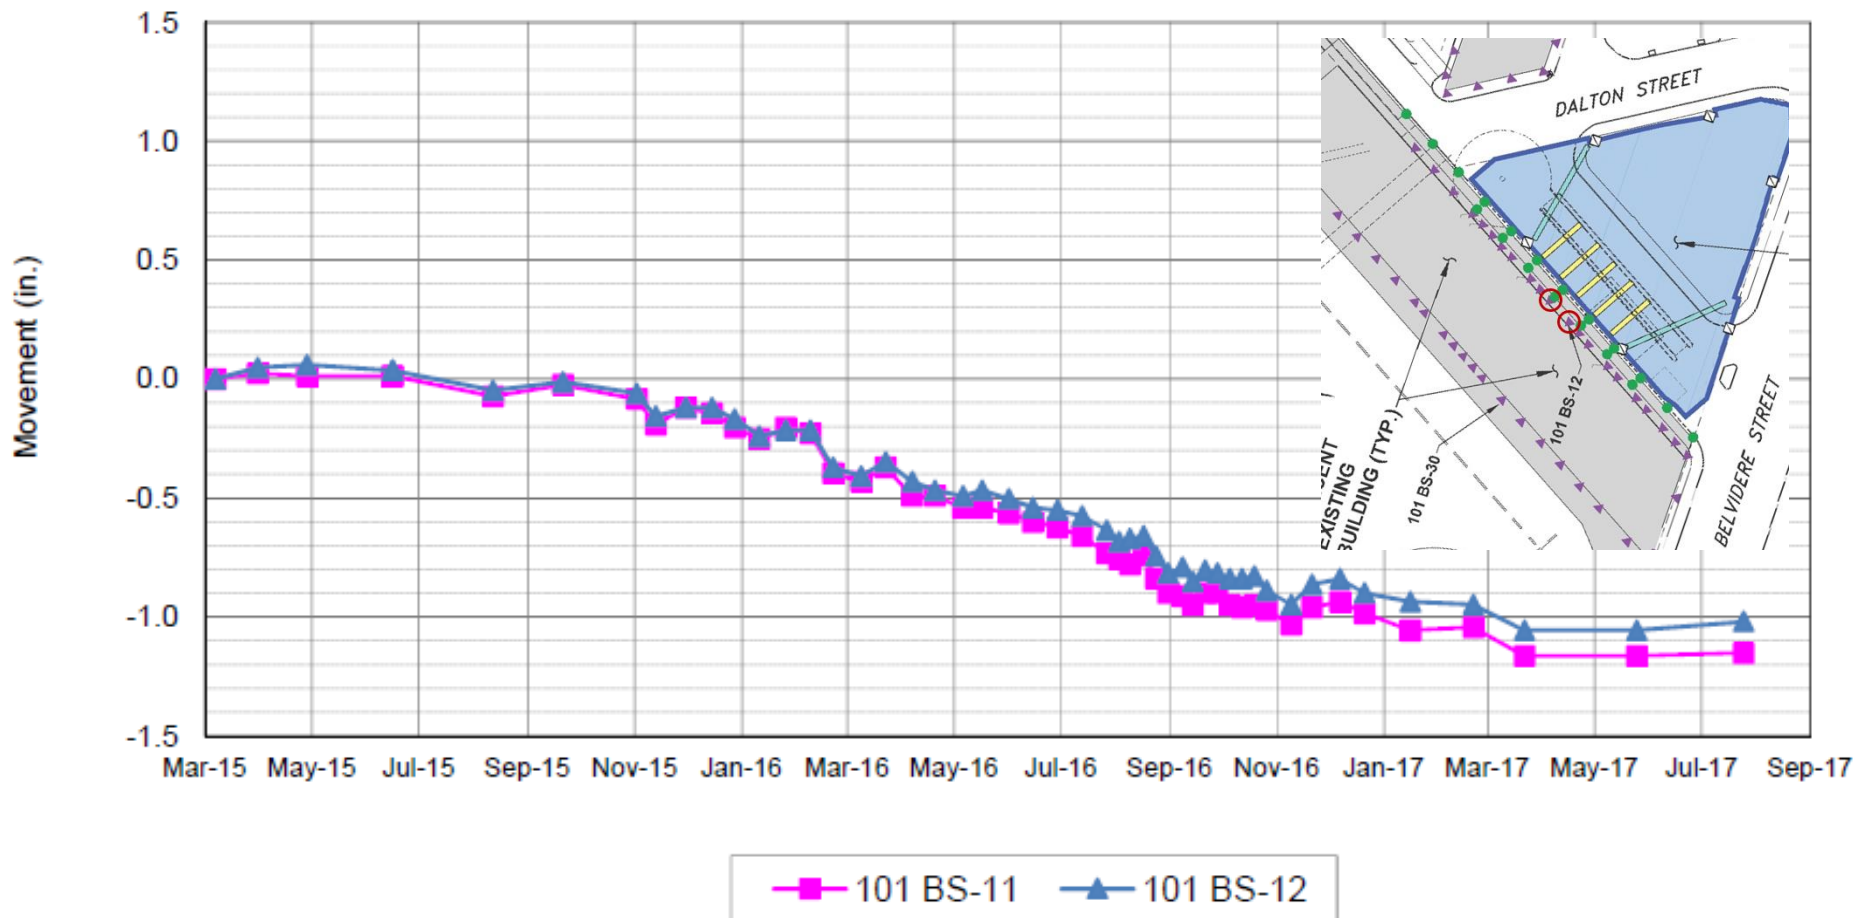
- Survey points on adjacent structure
- Movement monitored during construction
