# Reballed Ball Grid Array Reliability Under Shock and Vibration

Joelle Arnold Dr. Nathan Blattau

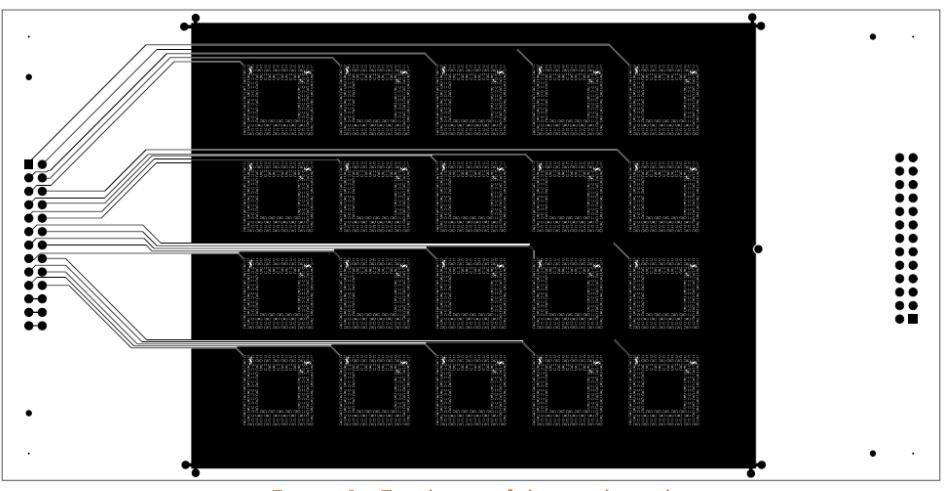
The top surface of the board is designed to allow continuous monitoring of 20 daisy chained 208 I/O BGAs, Figure 1. The boards are 7" by 3.5" by 0.062" thick, FR408 ( $T_g=170^{\circ}C$ ) and four layers thick. The surface finish for the Phase I boards is Organic Solderability Preservative (OSP).

Figure 1: Top layer of the test board

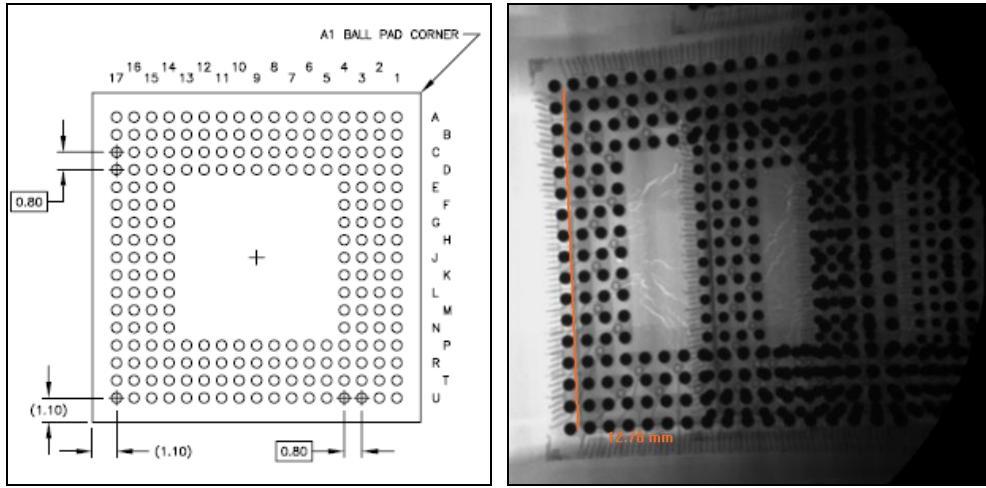
The test components are 208 I/O BGAs, 15mm square with a 12.7mm square die to more accurately represent real components. The array is 0.8mm pitch and the balls are native SAC305 and Sn63/Pb37. The component ball pattern and an x-ray image are shown in Figure 2.

Figure 2: Bottom view of 208 I/O BGA used in the test (left) and X-ray of actual part (right)

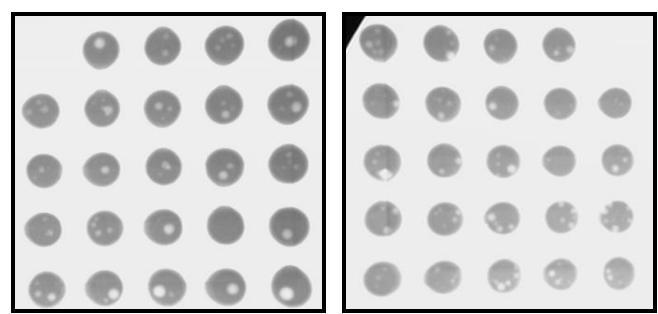
Figure 3: Native SnPb components (left) and native SAC solder balls (right) show minimal voiding.

All samples, whether reballed SnPb, native SnPb or native SAC305, were inspected by x-ray microscopy following assembly. Photos were taken of components with notable defects or inconsistencies, such as large voids or missing balls. The presence of solder flux in the assembly procedure causes some gas pockets to be expected in the joint. Per IPC-610, these voids must not exceed 25% of visible area on a top-down x-ray. In general, it can be said that the joints formed by Reballer E, those with native SnPb joints and those with native SAC305 joints had the best appearance, while those of Reballer A were most concerning.

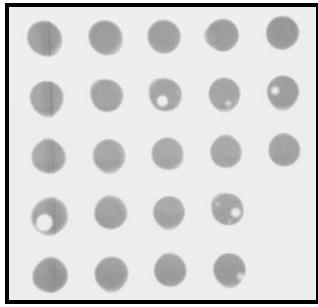
Figure 4: Components reballed by Reballer E were characterized by minimal voiding.

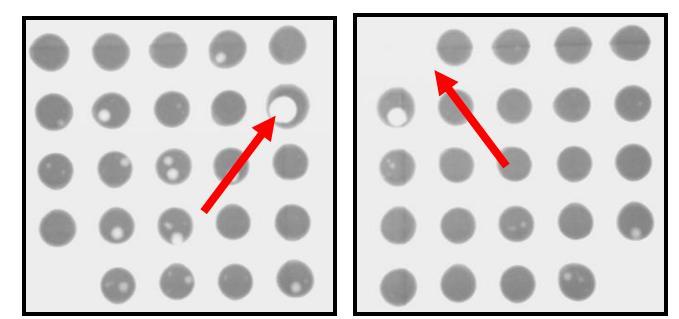
Figure 5: Void in edge ball by Reballer A indicated by red arrow (left) is likely larger than 25% of cross sectional area. Another component reballed by Reballer A was lacking a corner ball (right).

The results for Reballer A are also not surprising. While their process controls appear to be as tight as any of the higher end reballers (indicated by a comparable shape factor), characteristic life is lowest of any reballers studied. They are a low capacity, moderate experience reballer whose joints exhibited numerous defects during x-ray.

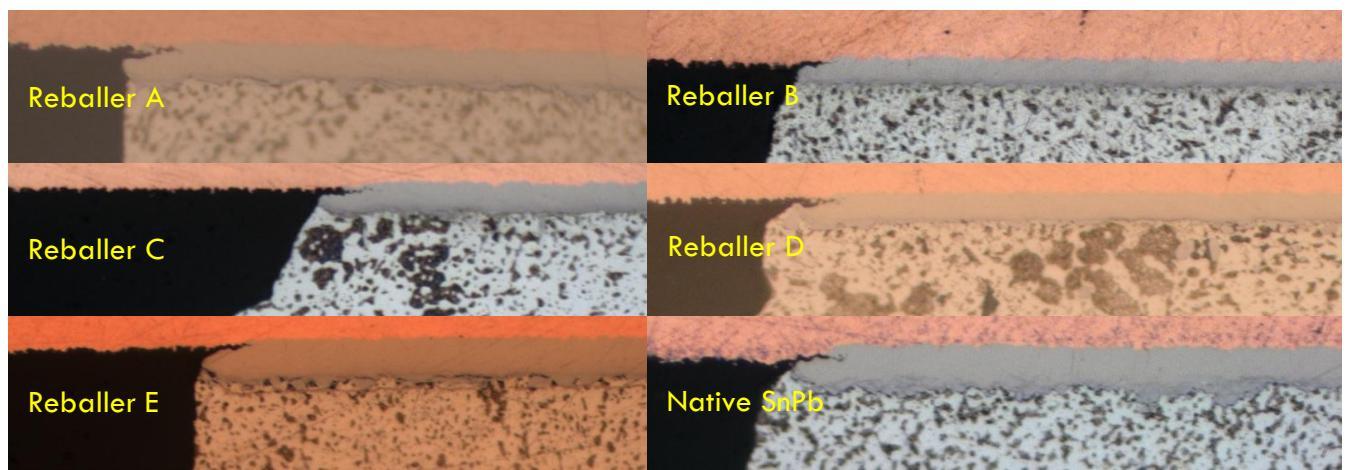
Two major features dominate solder joint appearance. The first is the thickness and regularity of the intermetallic (IMC) region. This area between the copper pad and the solder bulk is strong, brittle and very important to the strength of the joints. No reballed or native joints displayed excessively thick or irregular IMC.

The second feature is the grain structure within the bulk metal of the SnPb joint. The two phases are clearly visible: tin is lighter, lead is darker. In some of these joints, the lead phase has experienced grain growth. This is not necessarily a defect, but indicates excess exposure to high temperatures.

A final note regarding solder joint morphology with regards to width and height: most joints were relatively equal in size, but those submitted by Reballer E appear to have "collapsed." This may indicate that the initial balls were shorter and wider, or that the solder spheres applied were more precisely on the eutectic point and had a lower melting point than the others. Shorter, thicker joints will be stronger in tension because they have a larger cross sectional area. They may, however, also be less compliant because there is less height over which to diffuse shear forces.

Figure 6: Cross sectional view of solder joint IMC for reballers and native SnPb joints.

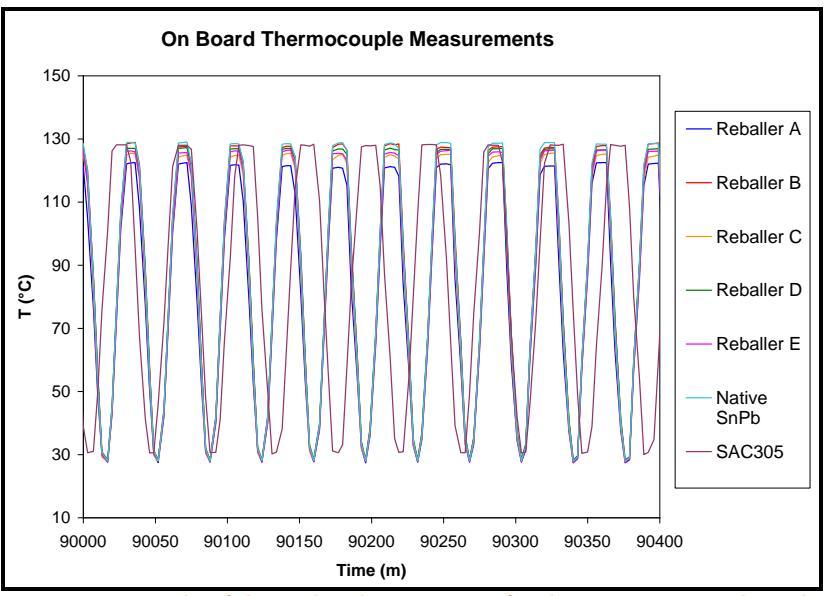
Seven test boards underwent thermal cycling. Each board was populated with 20 components from one of the five reballers, the native SnPb or the native SAC305. The cycling profile was 30°C to 130°C with a 10 minute dwell at the high side, a 5 minute dwell at the low side, and 10°C/minute ramp rates. This results in a cycle of approximately 35 minutes. Throughout the test, thermocouples mounted on the opposite side of the test board from the BGA components were used to log thermal cycles, as can be seen in Figure 7.

Figure 7: Example of thermal cycle monitoring for the respective test boards

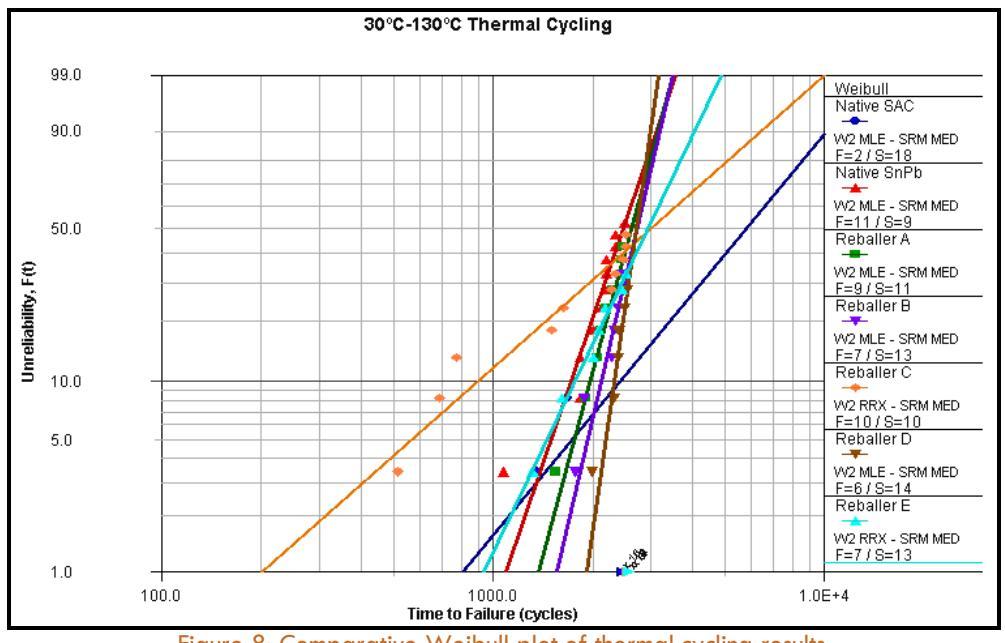
Thermal cycling time to failure results indicate that most reballers can match native SnPb solder joints in reliability with sufficient process control.

Figure 8: Comparative Weibull plot of thermal cycling results.

General comparisons indicate that for applications which undergo regular thermal cycling, a supplier such as Reballer D or B may provide the best reballing results. Not only did these two populations demonstrate the longest time to 1% failure, but they also exhibited the highest  $\beta$  values, indicating good process control.

For characteristic life, all reballed components outperformed Native SnPb joints. This does not, however, indicate that any reballer should be used for these applications. Examination of  $\beta$  values indicates that Reballer C does not have sufficient process control to be recommended. These results are understandable. While Reballer C uses standard techniques similar to those used by Reballer D and Reballer B, they do not perform high volume reballing and do not have as much experience as any other reballers tested.

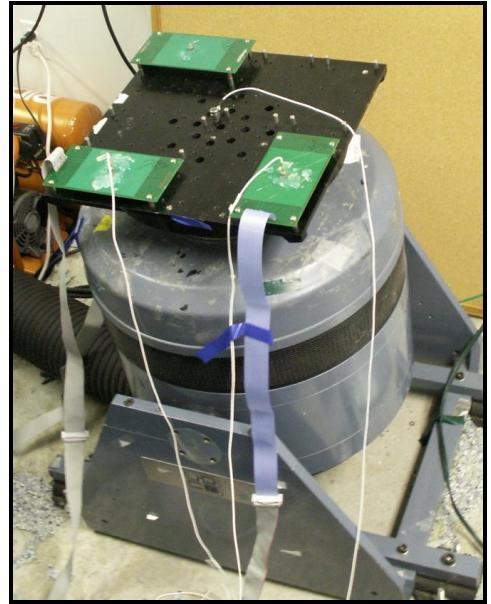
Vibration was controlled using feedback from a table mounted accelerometer, and the board deflection was monitored using accelerometers mounted at the center of each board. The vibration frequency was set to 157Hz, approximately 10-15Hz from resonance. A very low acceleration level was used to "tune" the boards: at 2-3Gs of acceleration, board displacement was measured and compared. Boards experiencing a lower displacement had elastomeric mass added to their centers until all boards displayed the same deflection. The acceleration level was raised to produce the desired test board deflection (Table 1). The acceleration level was held constant and the boards were continuously monitored. Test setup is visible in Figure 9; one accelerometer has been removed.

Figure 9: Vibration table with three test coupons following testing.

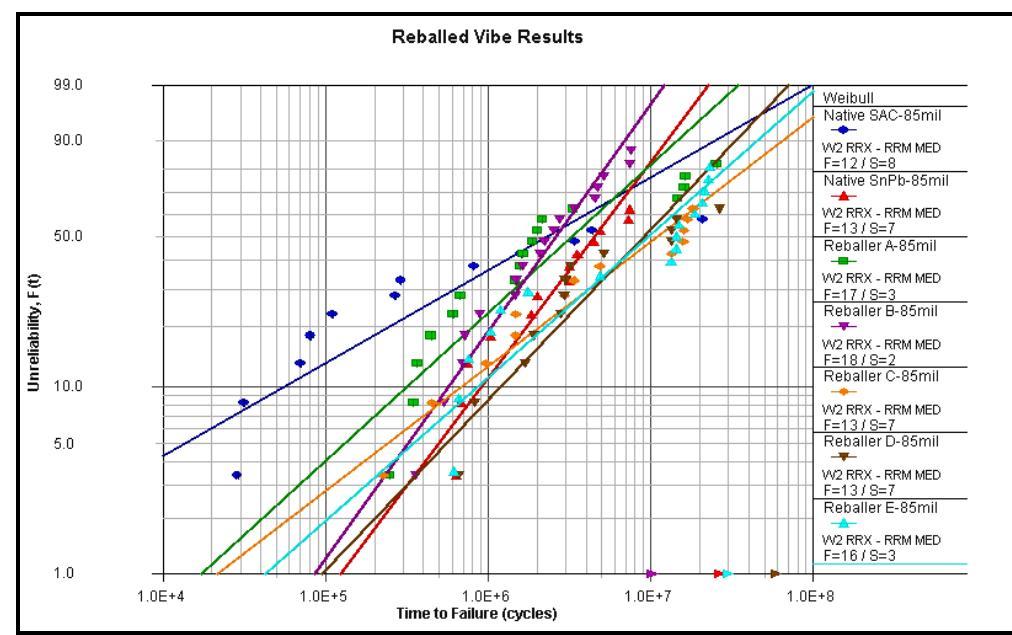
Results are visible in Figure 10. Upon careful inspection of the data, it appears multiple stress levels exist upon the board; therefore, data was adjusted for comparative analysis. Truncations were made on a case-by-case basis to generate an appropriate Weibull fit to the first several failures – which represent the highest stress condition; these results are visible in Figure 11.

Figure 10: Vibration results for reballed and native populations at 157Hz, 85mil initial displacement.

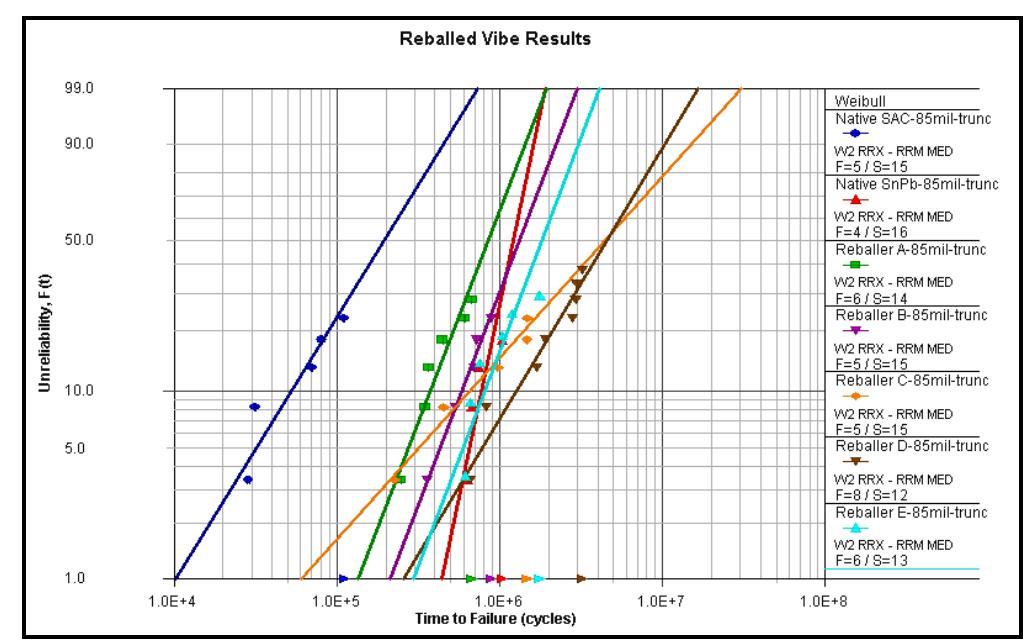
Figure 11: Truncated vibration results for reballed and control native populations at 157Hz, 85mil initial displacement.

Matching the reliability of native SnPb joints under vibration is not as straightforward as for thermal cycling. It is clear that the more experienced and capacity reballers (Reballers B, E, and D) can nearly match, match or exceed the performance of the native joints.

The characteristic life ( $\eta$ ) of Reballer C's population exceeds the characteristic life of that of the native joints, but the 1% failure value is nearly an order of magnitude less. This again is likely due to process controls. These results are understandable: while Reballer C uses standard techniques similar to those used by Reballer D and Reballer B, they do not perform high volume reballing and do not have as much experience as any other reballers tested.

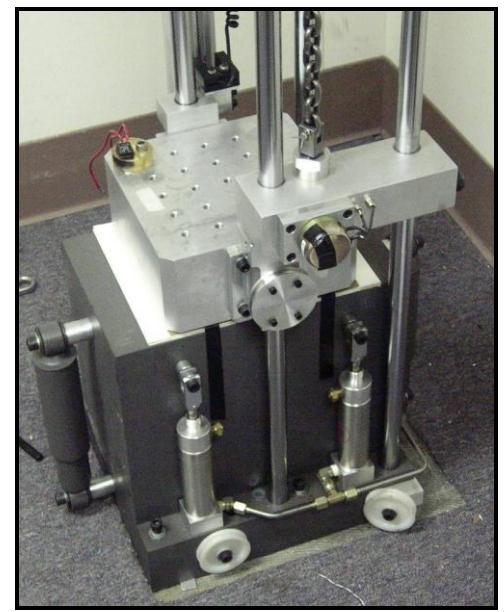
DfR employs a Lansmont M23 tower with a floating, cast iron seismic base with a shock programmer and a 40lb aluminum drop block (Figure 12). The shock load selected for this test is 1500G, 0.5ms pulse, which is achieved by an approximately 15 inch drop height.

Figure 12: Lansmont M23 drop tower

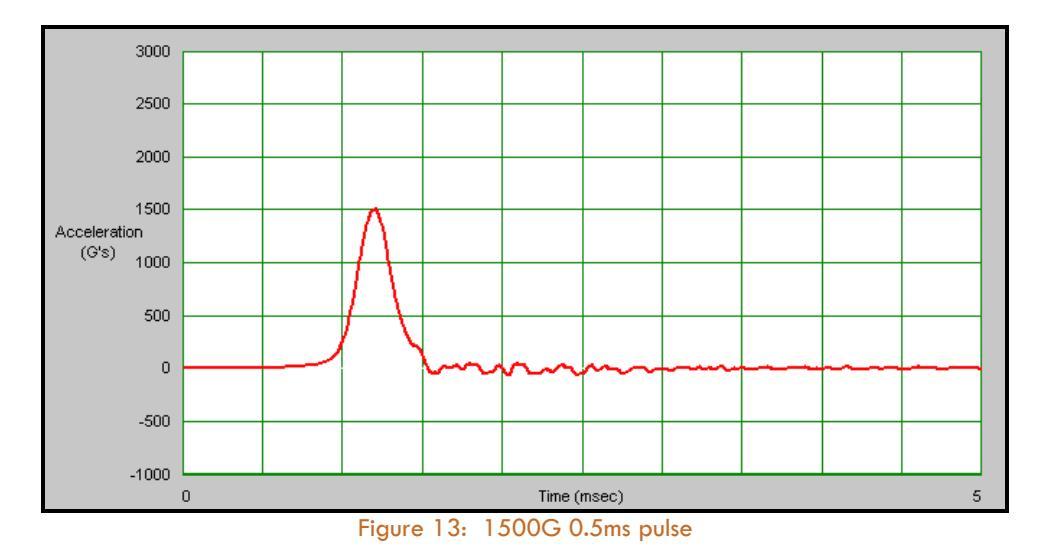
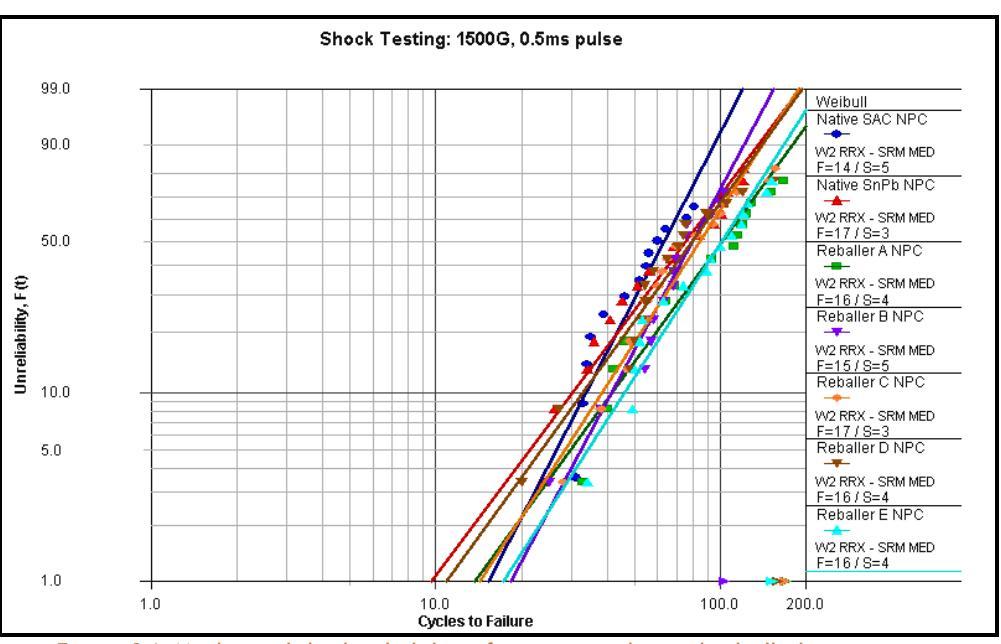
Results of mechanical shock testing, as grouped by precondition, are exhibited in Figure 14-Figure 16.

Mechanical shock results indicate that solder type and precondition play the most important role in resilience to this type of high G stress. The single most influential factor is high temperature preconditioning: it dramatically decreases the mean time to failure of SnPb joints, reballed or not. In fact, the only joint not affected was the native SAC. This population, however, was vulnerable to thermal cycling.

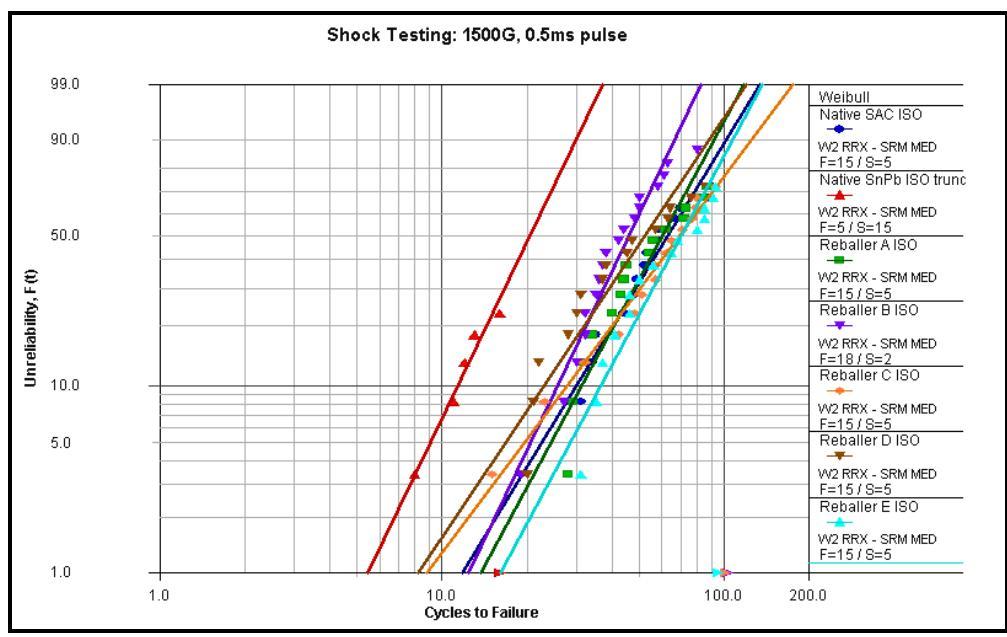
Figure 15: Mechanical shock reliability of 150C isothermally preconditioned reballed components.

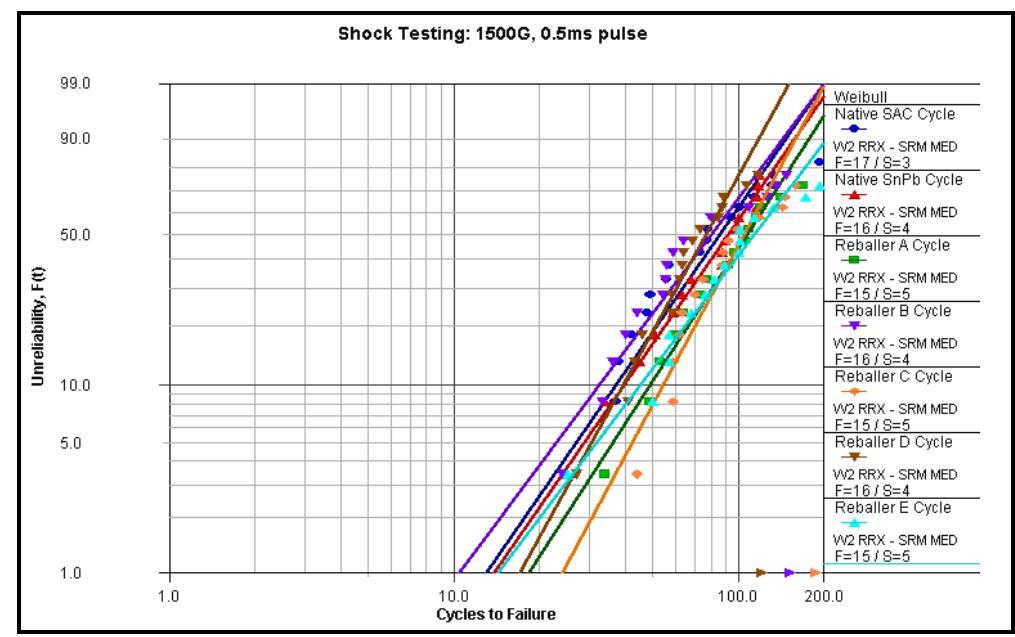
Figure 16: Mechanical shock reliability of -40-85C thermally cycled preconditioned reballed components.
